## COMPLAINT INVESTIGATION REPORT

Project Name:	Mountain Valley Pipeline	Inspector:	Marshall Willis
Inspection Date:	Wednesday, July 16, 2025	Project Contact:	Brian Clauto, Cory Chalmers
Spread I: Franklin County	STA 13643+00 – STA 13645+00 STA 13748+30 – STA 13756+00 STA 13784+00 – STA 13790+50 STA 13827+00 – STA 13835+00 STA 13854+00 – STA 13865+00 STA 13889+00 – STA 13916+00	Weather:	Wet

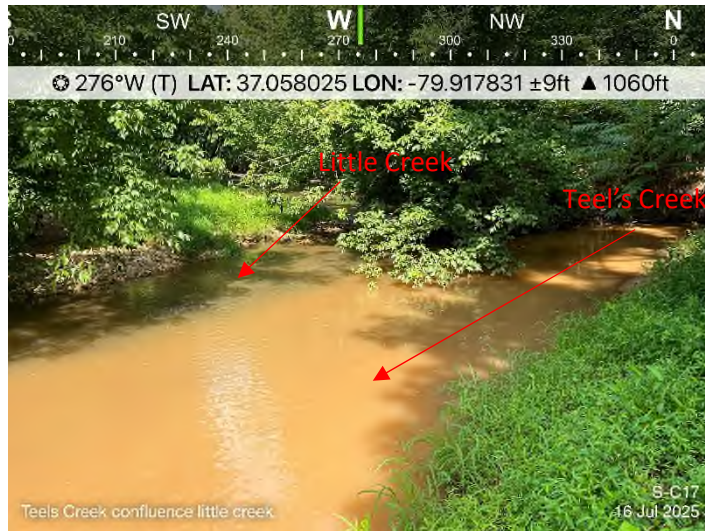
6. No additional sediment discharged off ROW was found during the inspection.
7. Confluence of Teel's Creek and Little Creek show source of turbidity coming from Teel's Creek into Little Creek. See Figure 1.

**Figure 1: STA 13864+00** – Confluence of Teel's Creek and Little Creek. Turbidity source is from Teel's Creek.

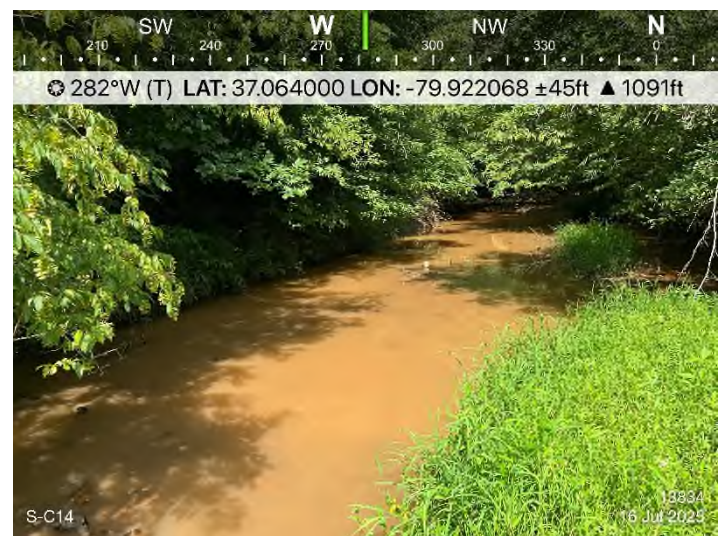
**Figure 2: STA 13834+00** – Turbidity in Teel's Creek at S-C14. ROW is stabilized and controls in place.

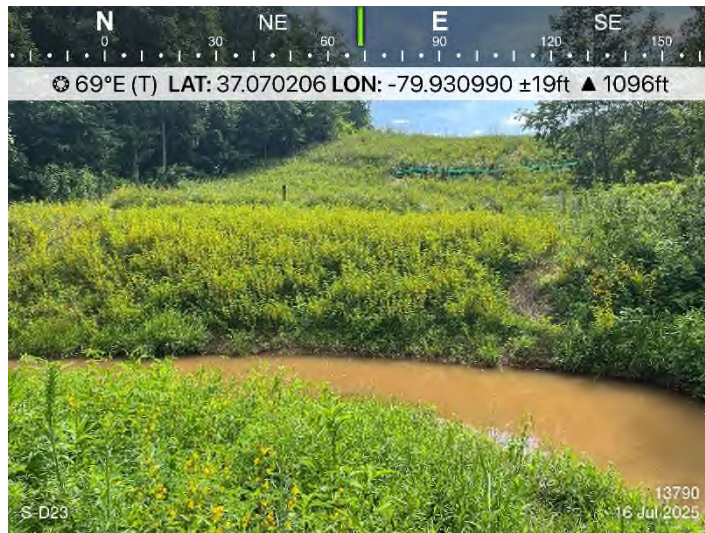
**Figure 2: STA 13790+00** – Turbidity in Teel's Creek at S-D23. ROW is stabilized and controls in place.

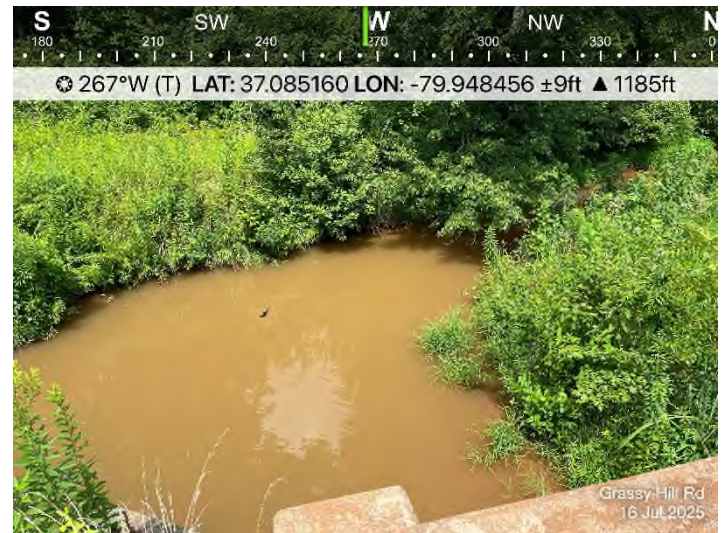
8. Teel's Creek at Grassy Hill Road showing evidence of increased turbidity while Teel's Creek at Leaning Oak Road is clear. See Figures 4, 5 and 6.

1. Potential source of sedimentation into Little Creek via Teel's Creek is likely due to a LDA between Leaning Oak Road and Grassy Hill Road along Teel's Creek.
2. Investigation findings provided to DEQ BRRO for further investigation.

**Figure 4: Grassy Hill Road** – Looking upstream at Teel's Creek from Grassy Hill Road. Turbidity still present.

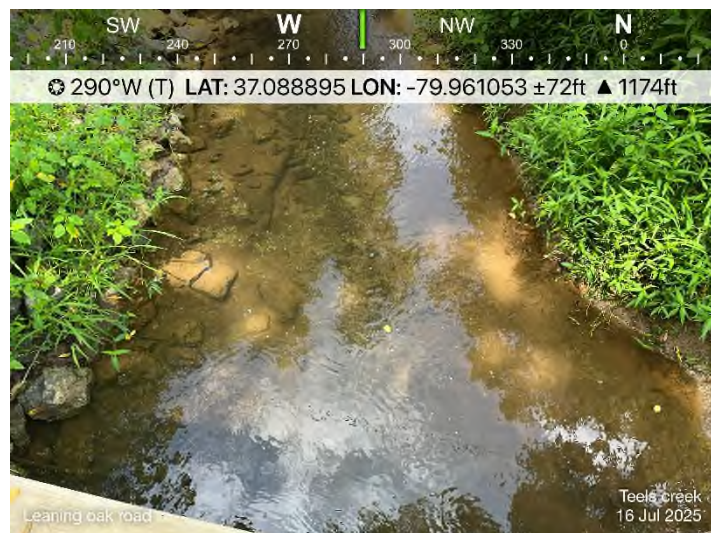
**Figure 5: Leaning Oak Road** – Looking upstream at Teel's Creek from Leaning Oak Road. Stream is absent of turbidity.

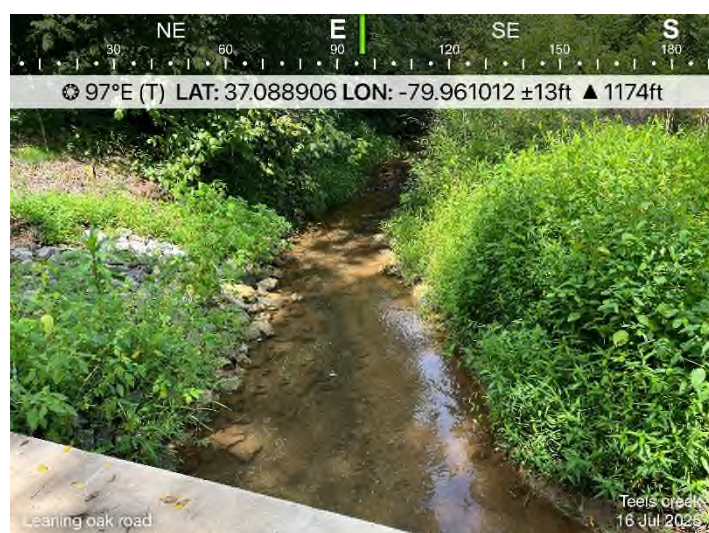
**Figure 6: Leaning Oak Road** – Looking upstream at Teel's Creek from Leaning Oak Road. Stream is absent of turbidity.
