STANDARDS & SPECIFICATIONS SITE INSPECTION REPORT

LEVEL 1 (FIELD REPORT)

Project Name:	Mountain Valley Pipeline	S&S Program:	Mountain Valley Pipeline (SS027)
Inspector:	Marshall Willis	Inspection Date:	Thursday, July 31, 2025
Project Contact:	Cory Chalmers Brian Clauto	Project Contact Email:	cory.chalmers@eqt.com brian.clauto@eqt.com
Spread I: Franklin County	STA 14250+00 - 14311+57 MVP-FR-313	Site Conditions:	Wet

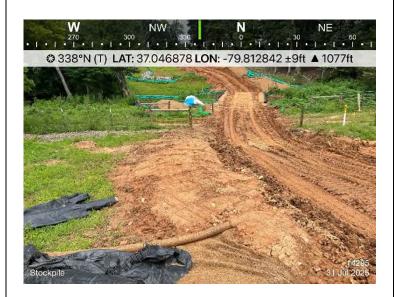
Fig. 1 **STA 14295+00:** Stabilize stockpile.

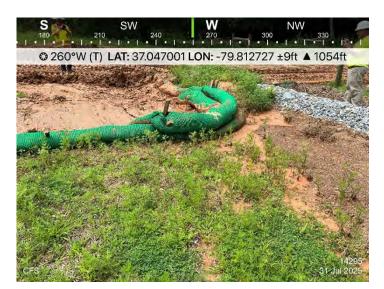
Fig. 2 STA 14295+00: Repair undermined CFS.

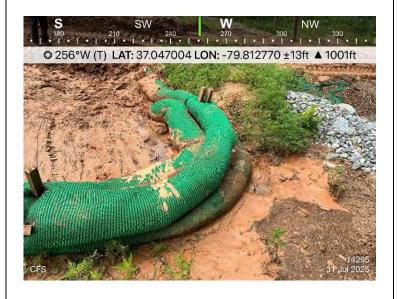
Fig. 3 STA 14295+00: Repair undermined CFS.

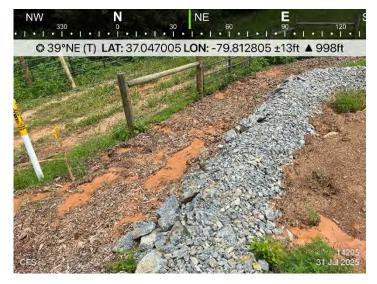
Fig. 4 STA 14295+00: Repair undermined CFS.
