STANDARDS & SPECIFICATIONS SITE INSPECTION REPORT

LEVEL 1 (FIELD REPORT)

Project Name:	Mountain Valley Pipeline	S&S Program:	Mountain Valley Pipeline (SS027)
Inspector:	Marshall Willis	Inspection Date:	Wednesday, July 30, 2025
Project Contact:	Cory Chalmers Brian Clauto	Project Contact Email:	cory.chalmers@eqt.com brian.clauto@eqt.com
Spread H: Roanoke County	STA 12374+00 - 12420+73 MVP-MLV-AR-27	Site Conditions:	Dry

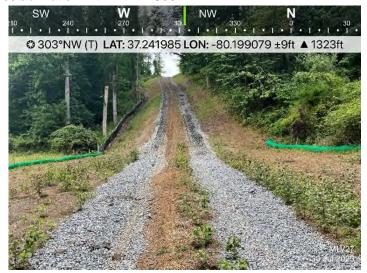
Fig. 1 MVP-MLV-AR-27: Center isle requires reseeding and restabilization with MVP-ES33.1.

3. Areas of offsite sediment deposition observed?								\boxtimes					
	Comments: Inspected the following resources: S-NN19. Routine Maintenance (72-Hr): - MVP-MLV-AR-27: Restabilize/re-seed center isle on gap graded permanent access road. Ineffective Controls (24-Hr): - N/A Corrective Action: N/A													
<u>Deadline:</u> Within 72-Hour of Notification														
The recommended corrective action deadline date applies to all conditions noted on this report unless otherwise noted. If listed condition(s) currently constitute non-compliance and/or corrective actions are not completed by the deadline, other enforcement actions may be issued to the entity responsible for ensuring compliance on the above project.														
Inspector Signature:														
Date	: Wedne	sday, Jul	y 30,	2025

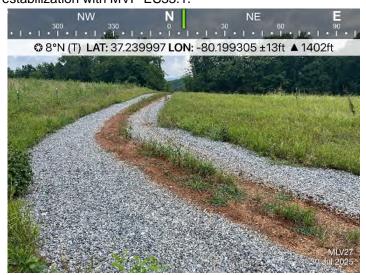
Fig. 2 MVP-MLV-AR-27: Center isle requires reseeding and restabilization with MVP-ES33.1.

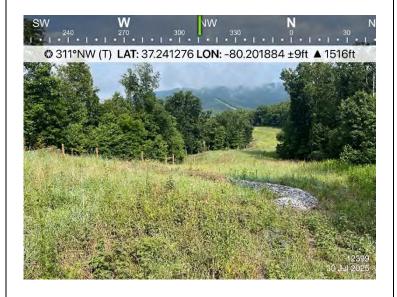
Fig. 3 **STA 12399+00:** Controls in place and functioning properly.

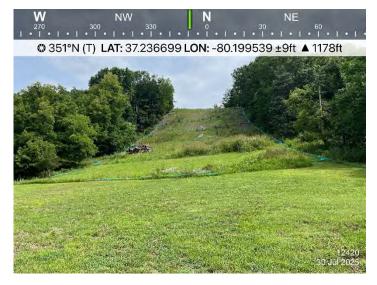
Fig. 4 STA 12420+00: Controls in place and functioning properly.
