STANDARDS & SPECIFICATIONS SITE INSPECTION REPORT LEVEL 1 (FIELD REPORT)

Project Name:	Mountain Valley Pipeline	S&S Program:	Mountain Valley Pipeline (SS027)
Inspector:	Marshall Willis	Inspection Date:	Tuesday, August 5, 2025
Project Contact:	Cory Chalmers Brian Clauto	Project Contact Email:	cory.chalmers@eqt.com brian.clauto@eqt.com
Spread I: Franklin County	STA 14250+00 – 14311+57 MVP-FR-313	Site Conditions:	Wet

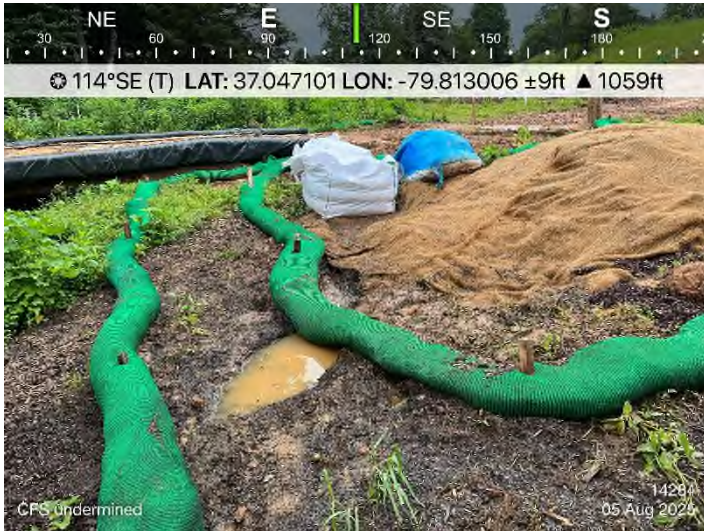
Fig. 1

STA 14294+36: CFS undermined. Repair required.

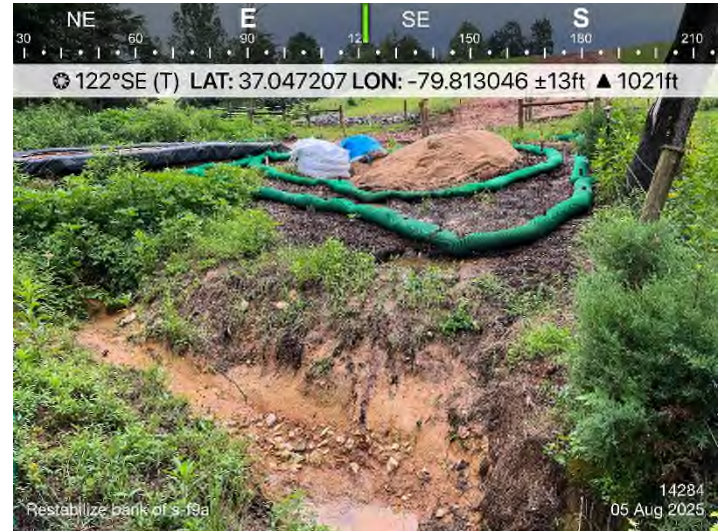
Fig. 2

- STA 14294+36: Re-stabilize banks of CIS S-F9A.

STA 14294+36: Re-stabilize bank.

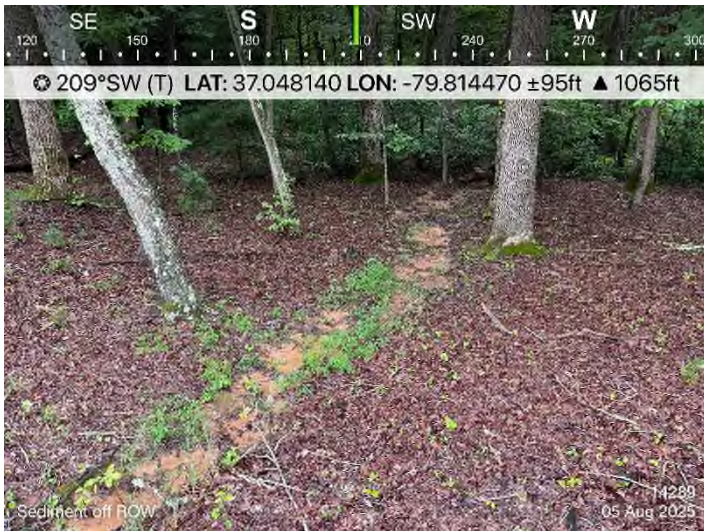
Fig. 3

STA 14289+00: Sediment discharged off ROW. Retrieve and restabilize.

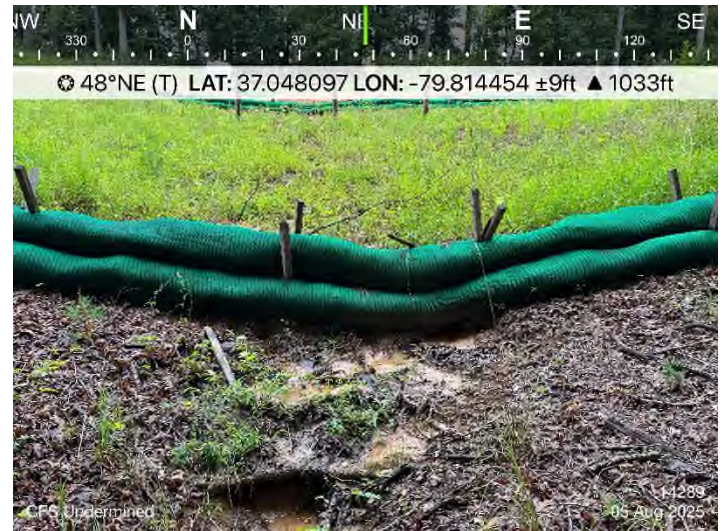
Fig. 4

STA 14289+00: CFS undermined. Repair required.
