STANDARDS & SPECIFICATIONS SITE INSPECTION REPORT LEVEL 1 (FIELD REPORT)

Project Name:	Mountain Valley Pipeline	S&S Program:	Mountain Valley Pipeline (SS027)
Inspector:	Matthew Grant	Inspection Date:	Thursday, August 14, 2025
Project Contact:	Cory Chalmers Brian Clauto	Project Contact Email:	Cory.chalmers@eqt.com Brian.clauto@eqt.com
Spread H: Montgomery County	MLV 28 MN 279, MLV AR 28	Site Conditions:	Dry

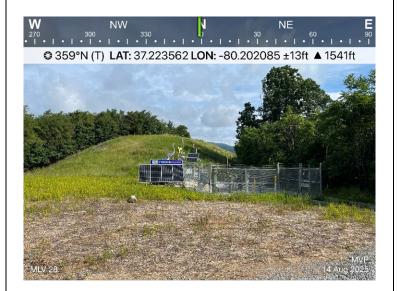
Fig. 1 MLV 28: Portions of the area have been mulched.

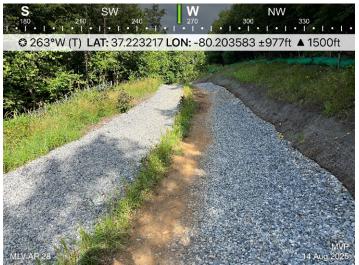
Fig. 2 MLV AR 28: Center strip requires maintenance.

3. Are	eas of offs	ite s	sediment deposition o	bserve	d?				\boxtimes					
	Comments: Inspected the following resources: S-CD12Bb Routine Maintenance: (72-Hour Deadline from Notification) - MLV AR28: restabilize per spec MVP ES33.1 Ineffective Controls: (24-Hour Deadline from Notification) - N/A Corrective Action: Maintain and install all controls per the approved S&S.

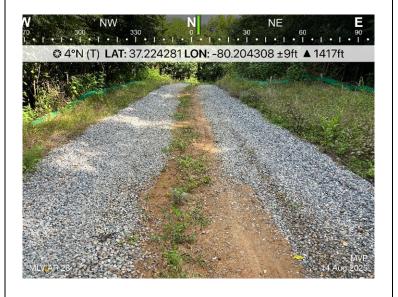
Fig. 3 MLV AR 28: Center strip requires maintenance.

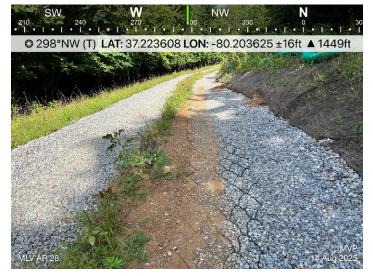
Fig. 4

MLV AR 28: Center strip requires maintenance.
