STANDARDS & SPECIFICATIONS SITE INSPECTION REPORT LEVEL 1 (FIELD REPORT)

Project Name:	Mountain Valley Pipeline	S&S Program:	Mountain Valley Pipeline (SS027)
Inspector:	Matthew Grant	Inspection Date:	Wednesday, August 6, 2025
Project Contact:	Cory Chalmers Brian Clauto	Project Contact Email:	Cory.chalmers@eqt.com Brian.clauto@eqt.com
Spread G: Giles County	STA 11205-11254, 11170-11165 MLV AR025 ATWS 1347, 1370	Site Conditions:	Rainy

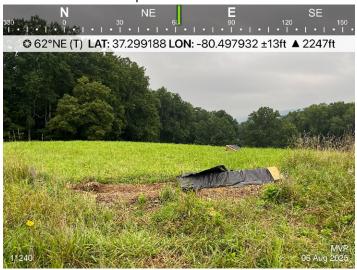
Fig. 1 STA 111240: reinstall perimeter control.

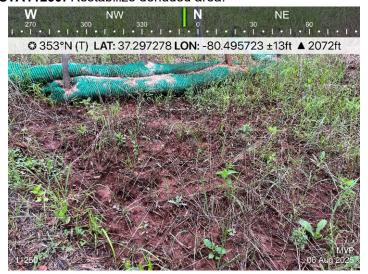
Fig. 2 STA11250: Restabilize denuded area.

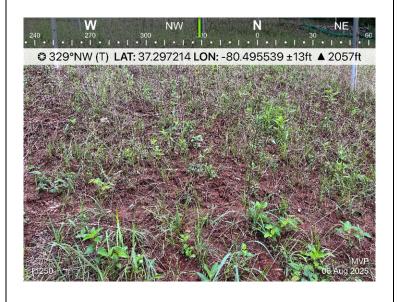
Fig. 3 **STA 11250**: restabilize denuded area.

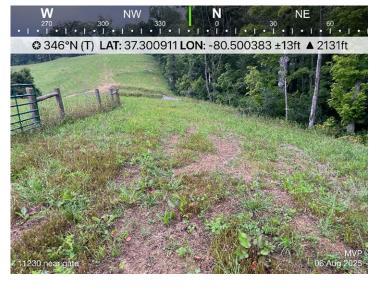
Fig. 4

STA 11230: restabilize denuded area.
