STANDARDS & SPECIFICATIONS SITE INSPECTION REPORT LEVEL 1 (FIELD REPORT)

Project Name:	Mountain Valley Pipeline	S&S Program:	Mountain Valley Pipeline (SS027)
Inspector:	Matthew Grant	Inspection Date:	Tuesday, August 5, 2025
Project Contact:	Cory Chalmers Brian Clauto	Project Contact Email:	Cory.chalmers@eqt.com Brian.clauto@eqt.com
Spread G: Giles County	STA 11354-11254 GI 253.02, 256 ATWS 633A	Site Conditions:	Wet

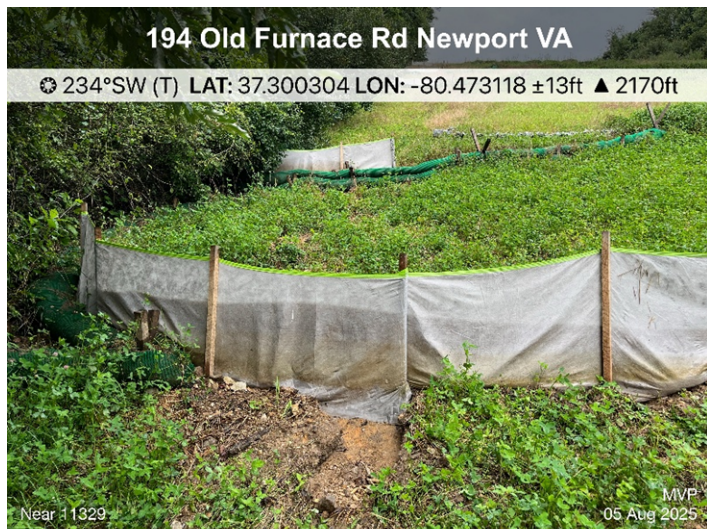
Fig. 1
Near STA 11329: P1 is undermined.

- STA 11291 undermined CFS requires repair/reinstall.
- STA 11329-11330. ATWS 633A: undermined P1 requires repair/reinstall.

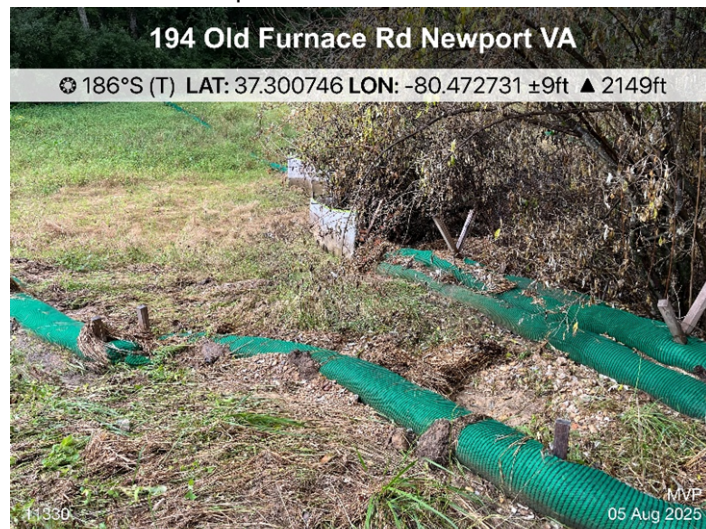
Fig. 2
STA 11330: CFS requires maintenance.

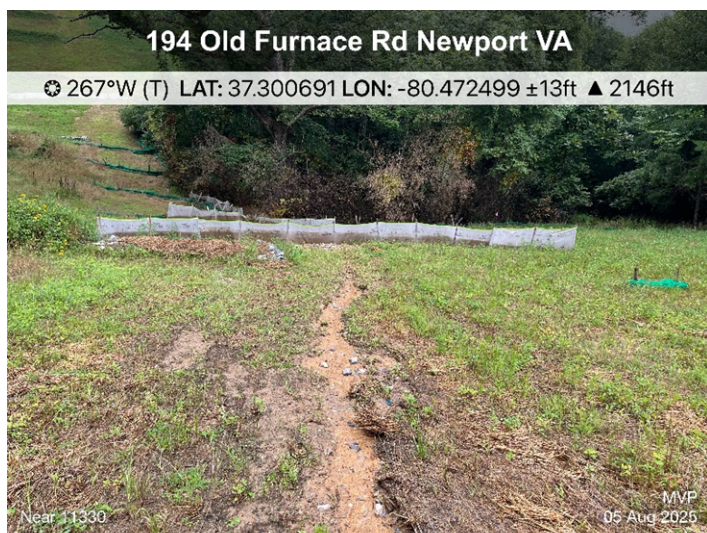
Fig. 3
Near STA 11330: rill erosion has occurred.

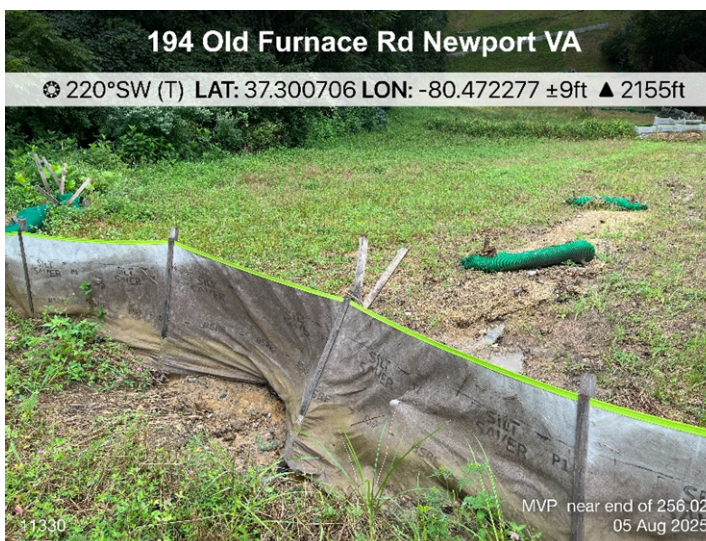
Fig. 4
STA 11330: P1 is undermined.

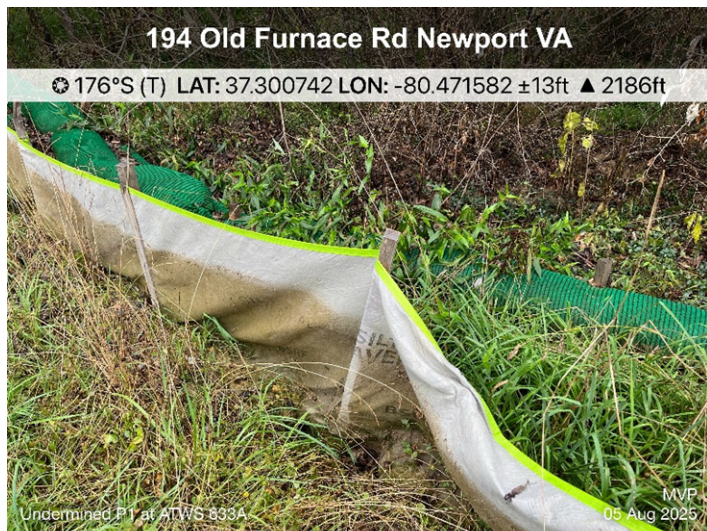
Fig. 5

ATWS 633A: P1 is undermined.

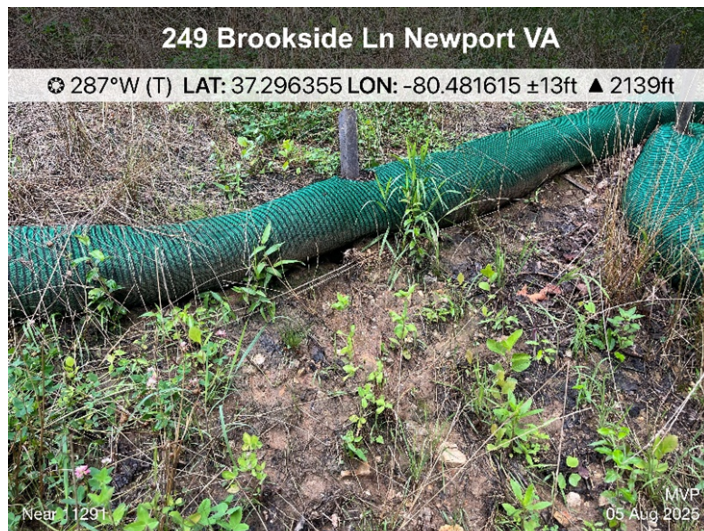
Fig. 6

Near Sta 11291: CFS is undermined.

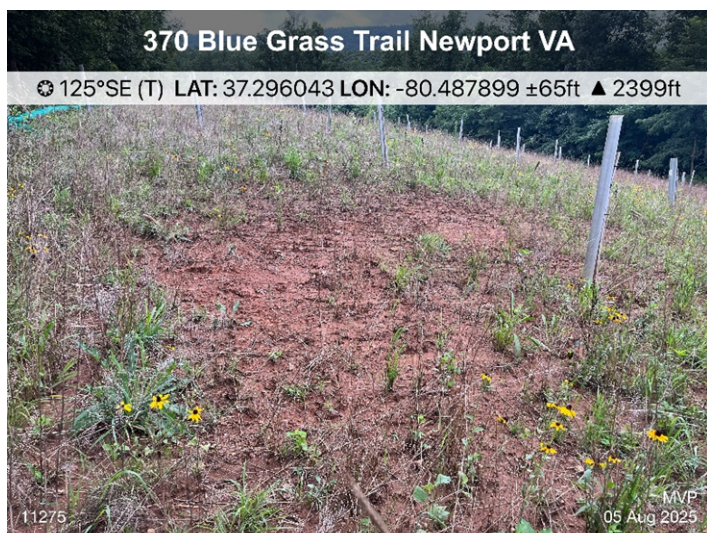
Fig. 7

STA 11275: denuded area requires additional stabilization.

- STA 11275 restabilize denuded area.
- STA 11260 repair erosion and restabilize area.
- STA 11262 waterbar requires maintenance along flow path and stabilization.

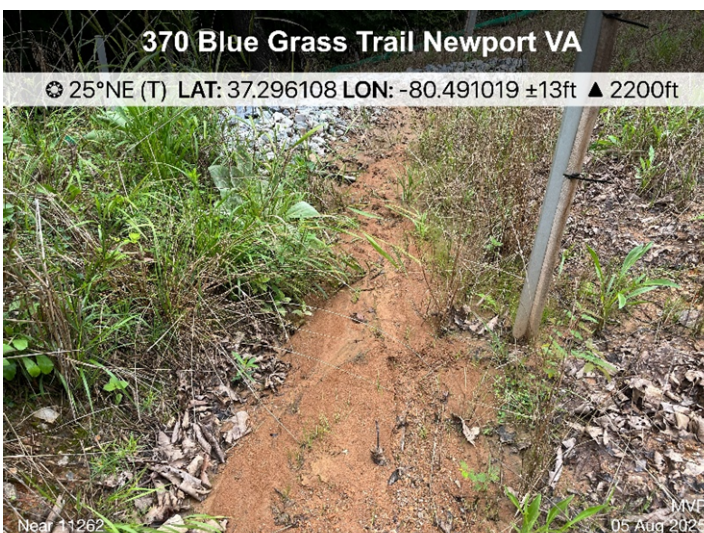
Fig. 8

Near STA 11262: waterbar requires maintenance.

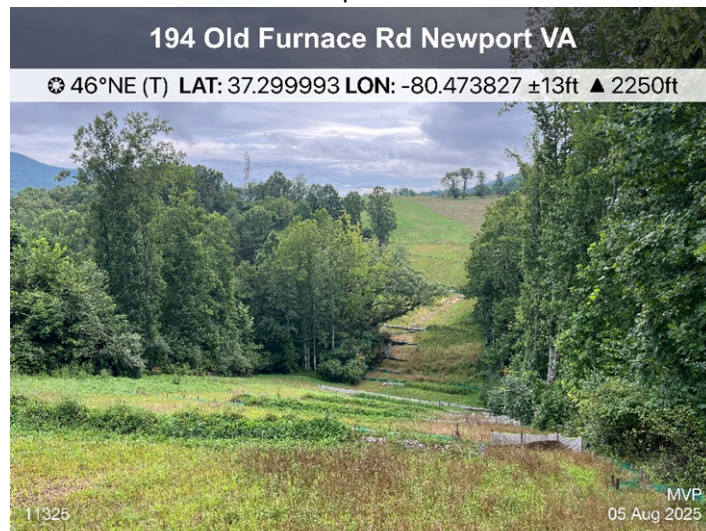
Fig. 10
STA 11325: ECD's remain in place.

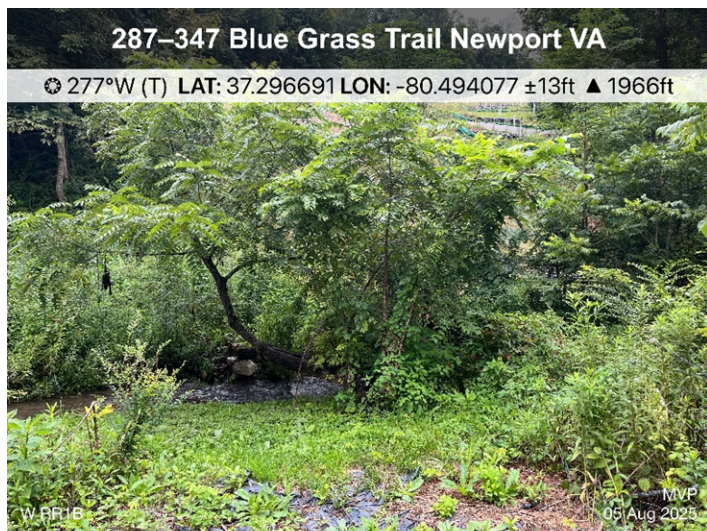
Fig. 11
Designated Crossing W-RR1B: upland ECD's remain in place.

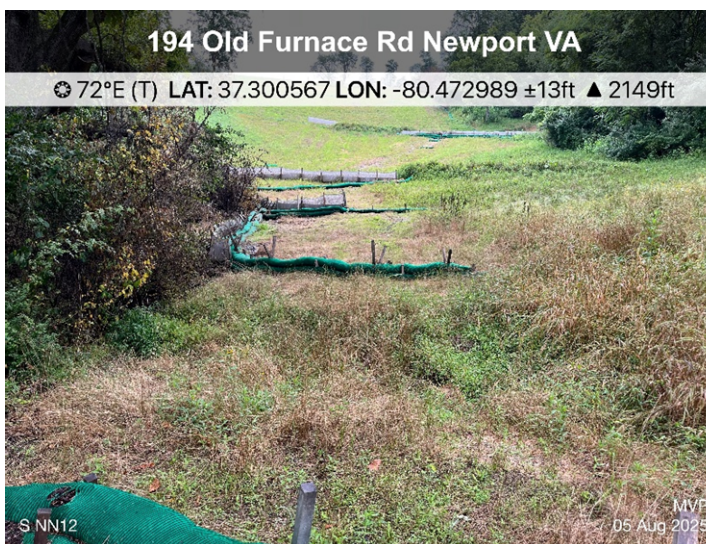
Fig. 12
Designated Crossing S-NN12: ECD's remain in place.
