## FIELD INSPECTION REPORT

| <b>Project Name:</b> | Mountain Valley Pipeline | <b>Inspector:</b> | Marshall Willis |

## FIELD INSPECTION PHOTO LOG

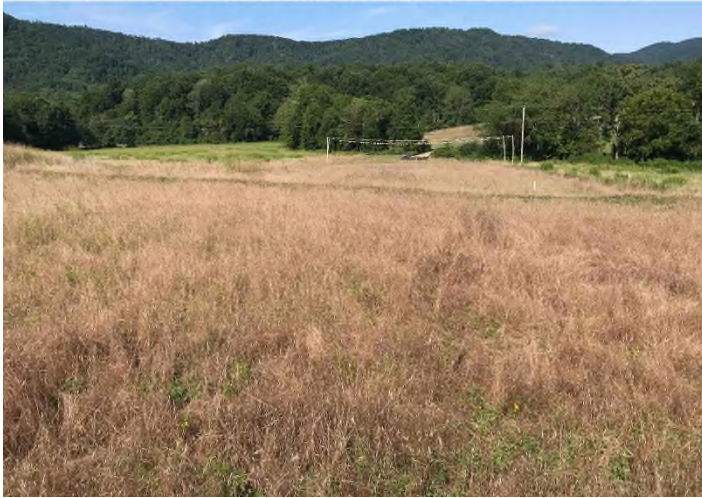
**Figure 1: STA 13315+00** – Controls in place and functioning properly.

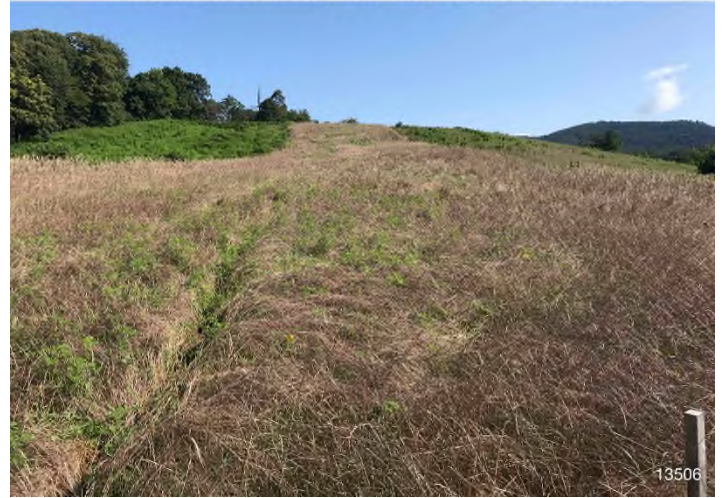
**Figure 2: STA 13506+00** – Controls in place and functioning properly.

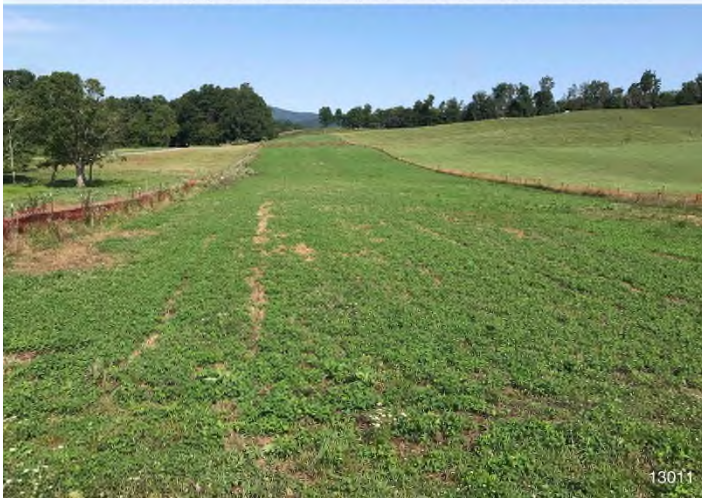
**Figure 3: STA 13011+00** – Controls in place and functioning properly along the Blue Ridge Parkway.

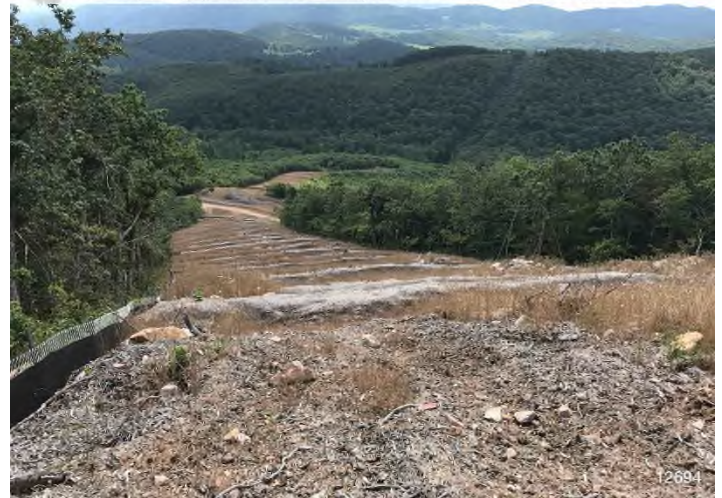
**Figure 4: STA 12694+00** – Controls in place and functioning properly. Area stabilized with erosion matting and Earth Guard.
