## FIELD INSPECTION REPORT

| <b>Project Name:</b> | Mountain Valley Pipeline | <b>Inspector:</b> | Marshall Willis |
| <b>Inspection Date:</b> | Thursday, July 30, 2020 | <b>Project Contact:</b> | Brian Clauto, Cory Chalmers |
| <b>Spread H:<br/>Montgomery County</b> | STA 12373+28 – 12435+16<br>ATWS 724/1507/1506/726/725<br>MVP-MN-279/279.02<br>MVP-MLV-AR-27 | <b>Weather:</b> | Dry |

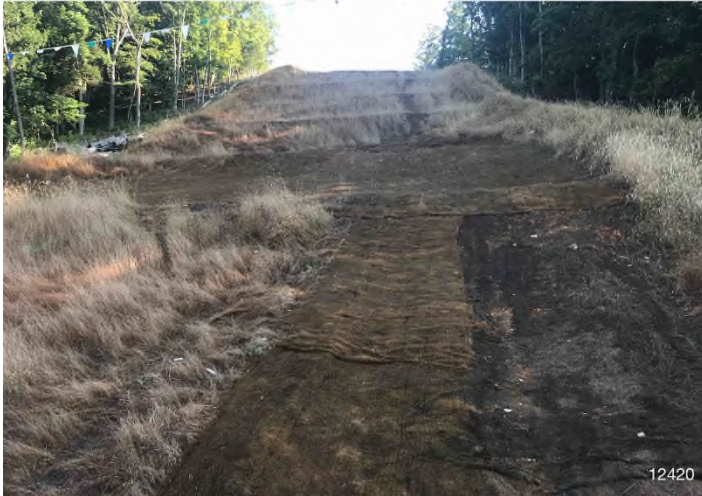
**Figure 1: STA 12420+00** – Controls in place and functioning properly.

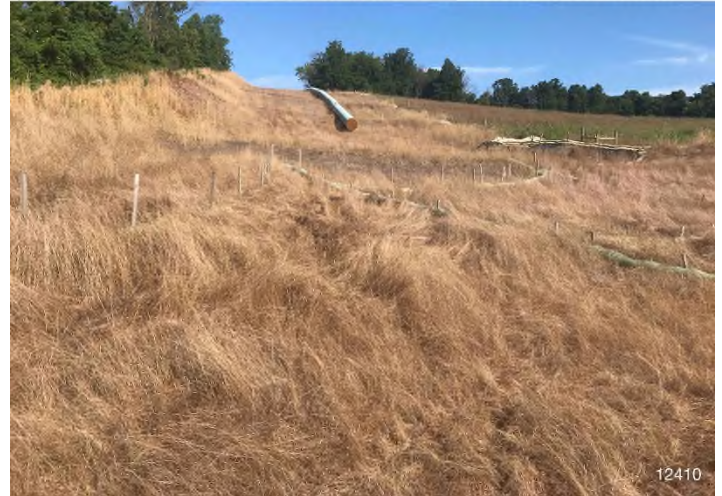
**Figure 2: STA 12410+00** – Controls in place and functioning properly.

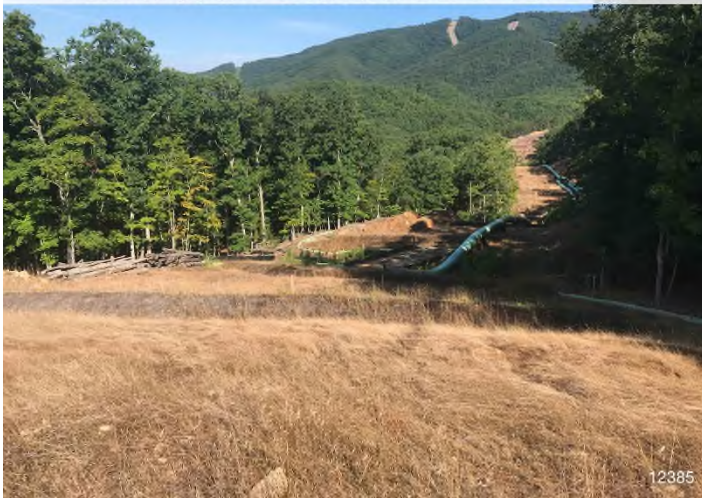
**Figure 3: STA 12385+00** – Controls in place and functioning properly.

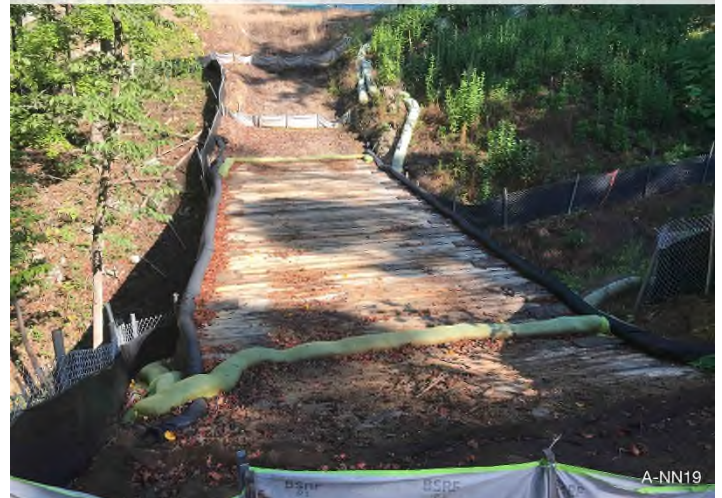
**Figure 4: Stream S-NN19** – Controls in place and functioning properly around stream crossing.
