## FIELD INSPECTION REPORT

| <b>Project Name:</b> | Mountain Valley Pipeline | <b>Inspector:</b> | Marshall Willis |
| <b>Spread H:<br/>Montgomery County</b> | STA 12001+00 – 12036+00<br>ATWS 473/473A/474/474A<br>MVP-MN-268/268.01 | <b>Weather:</b> | Dry |

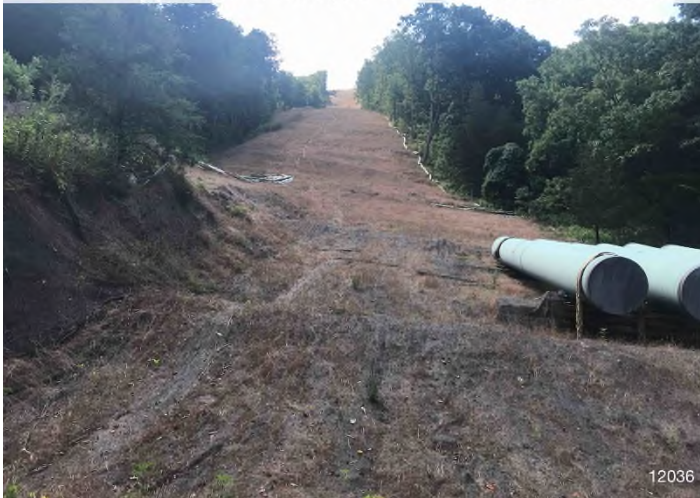
**Figure 1: STA 12036+00** – Controls in place and functioning properly.

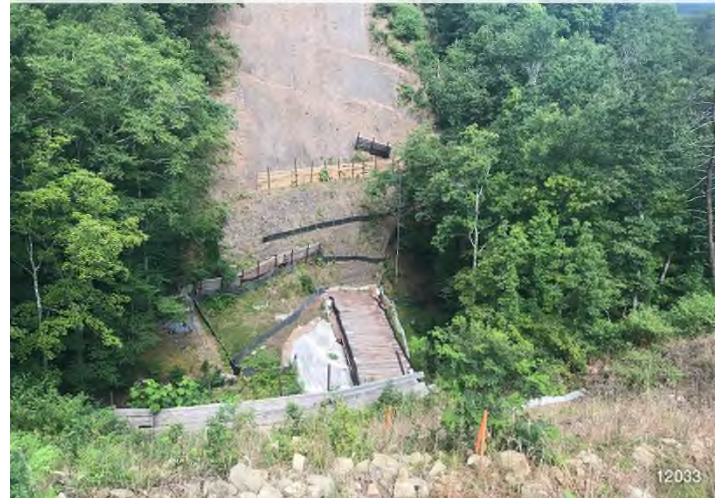
**Figure 2: STA 12033+00** – Controls in place and functioning properly.

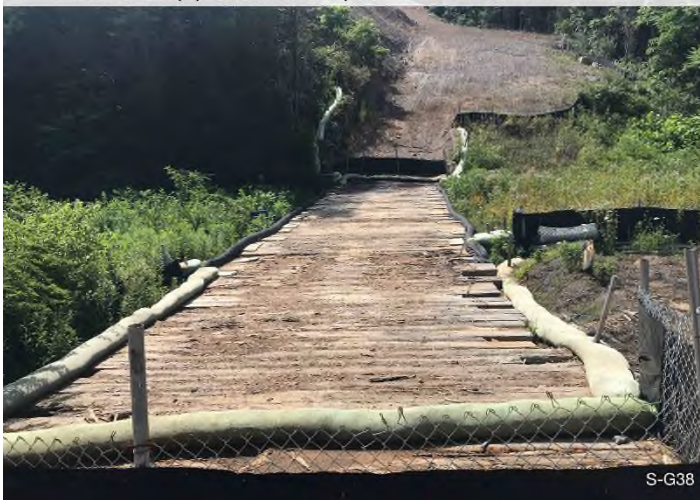
**Figure 3: Stream S-G38** – Controls in place and functioning properly around stream crossing.

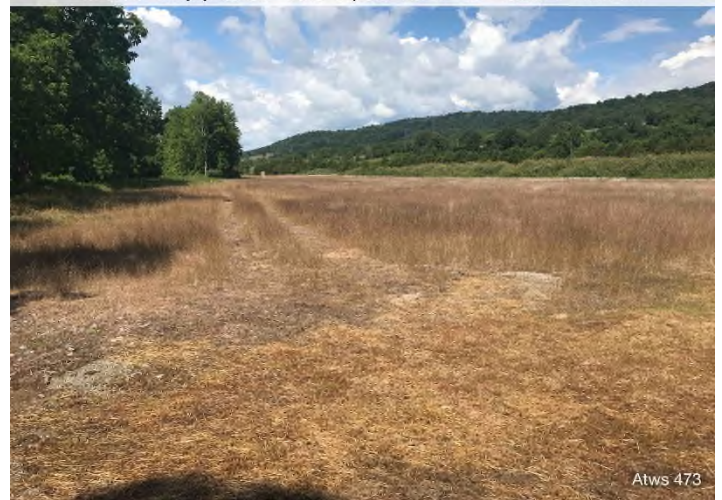
**Figure 4: ATWS 473** – Controls in place and functioning properly.
