FIELD INSPECTION REPORT

Project Name:	Mountain Valley Pipeline	Inspector:	Marshall Willis
Inspection Date:	Tuesday, September 15, 2020	Project Contact:	Brian Clauto, Cory Chalmers
Spread G: Giles County Craig County	STA 11392+57 – 11471+52 STA 11600+00 – 11618+91 MVP-CR-258.01	Weather:	Dry

FIELD INSPECTION PHOTO LOG

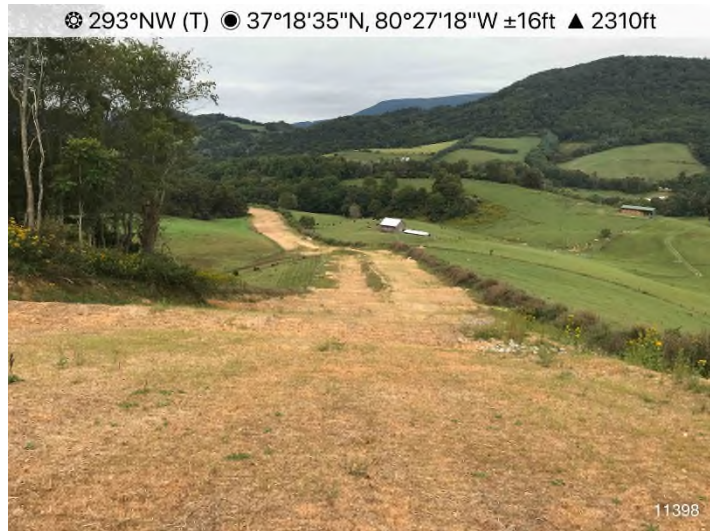
Figure 1: STA 11398+00 – Controls in place and functioning properly area stabilized with straw.

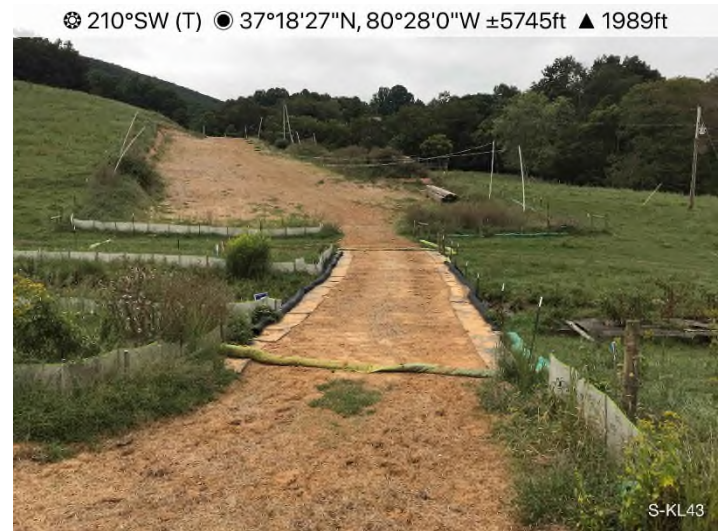
Figure 2: Stream S-KL43 – Controls in place and functioning properly around stream S-KL43 crossing. Area stabilized with straw.

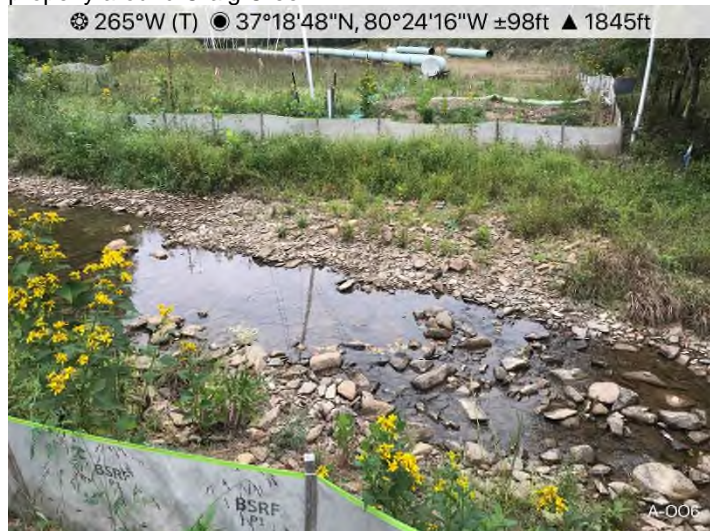
Figure 3: Stream S-006 – Controls in place and functioning properly around Craig Creek.

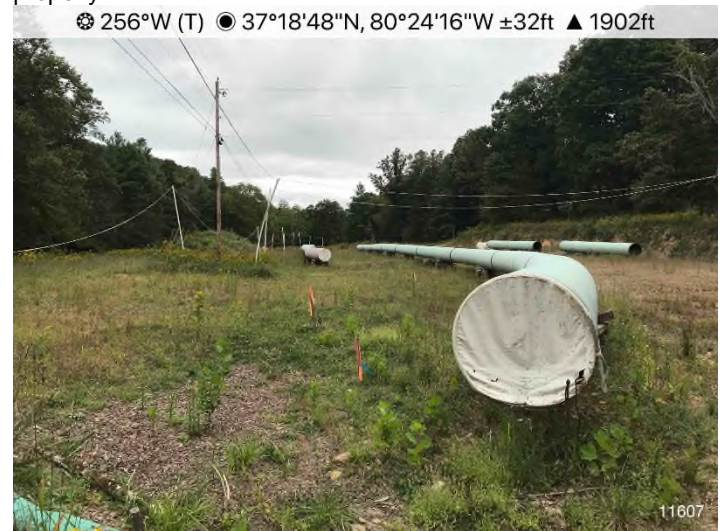
Figure 4: STA 11607+00 – Controls in place and functioning properly.
