## FIELD INSPECTION REPORT

| <b>Project Name:</b> | Mountain Valley Pipeline | <b>Inspector:</b> | Marshall Willis |
| <b>Spread H:<br/>Montgomery County</b> | STA 12071+80 – 12119+17<br>ATWS 1162/1163<br>MVP-MN-270 | <b>Weather:</b> | Dry |

## FIELD INSPECTION PHOTO LOG

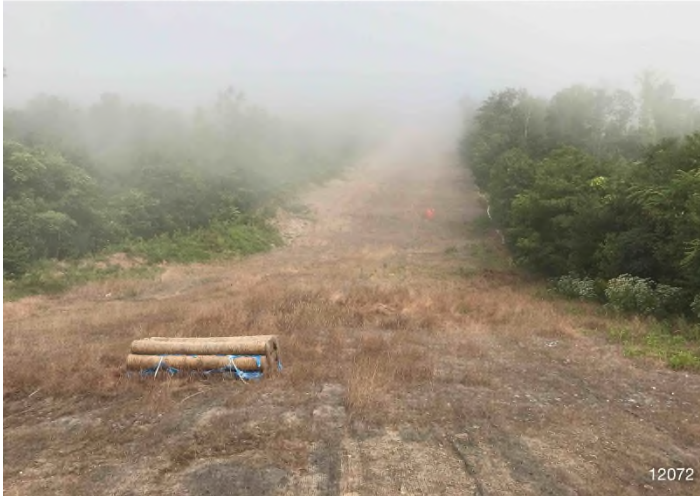
12072

**Figure 1: STA 12072+00** – Controls in place and functioning properly.

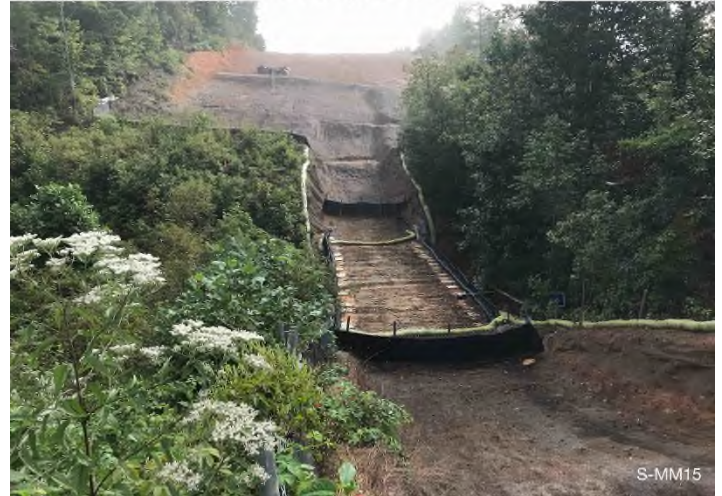
**Figure 2: Stream S-MM15** – Controls in place and functioning properly around stream S-MM15 crossing.

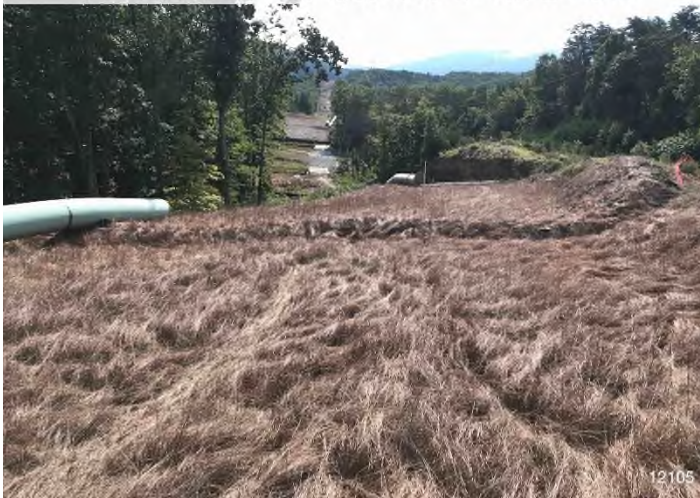
12105

**Figure 3: STA 12105+00** – Controls in place and functioning properly.

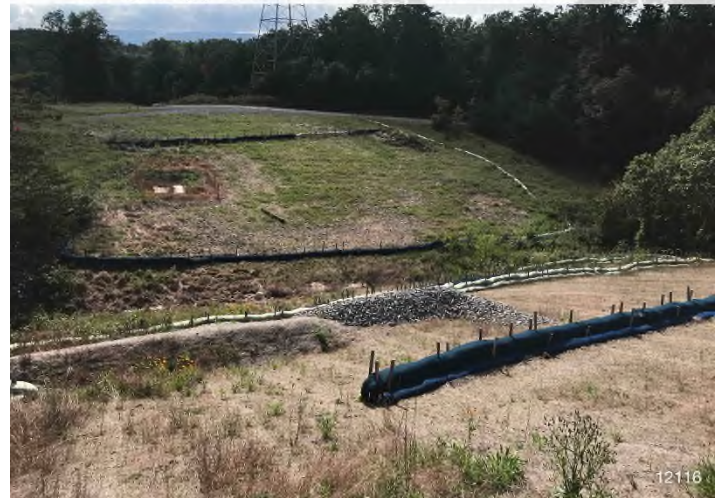
12116

**Figure 4: STA 12116+00** – Controls in place and functioning properly.
