## FIELD INSPECTION REPORT

| <b>Project Name:</b> | Mountain Valley Pipeline | <b>Inspector:</b> | Marshall Willis |

## FIELD INSPECTION PHOTO LOG

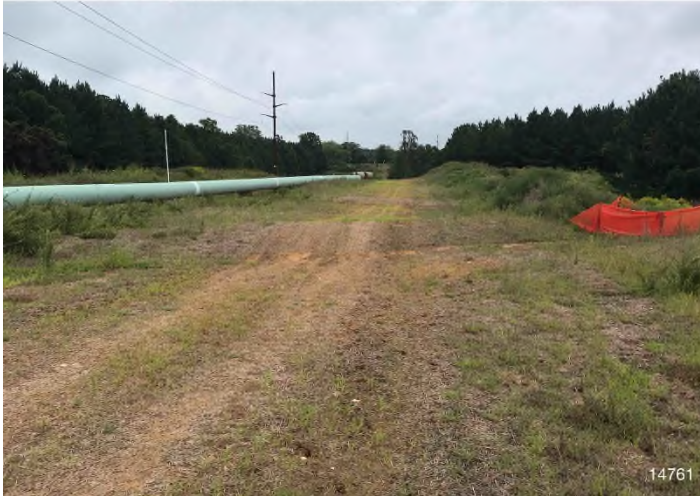
**Figure 1: STA 14761+00** – Controls in place and functioning properly. Area stabilized with straw.

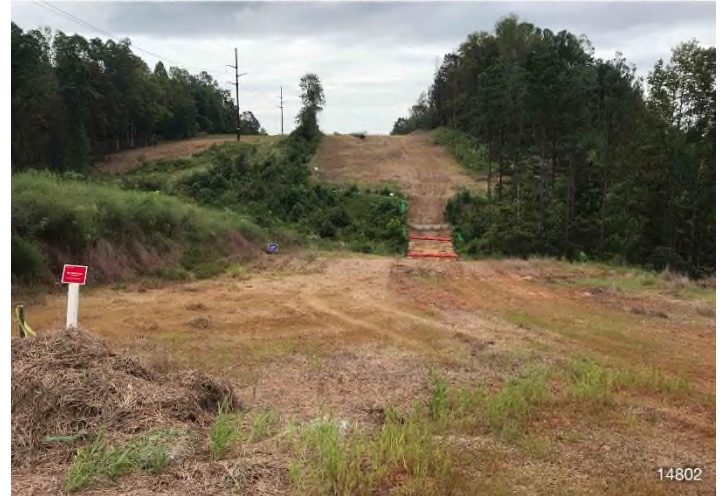
**Figure 2: STA 14802+00** – Controls in place and functioning properly. Area stabilized with straw.

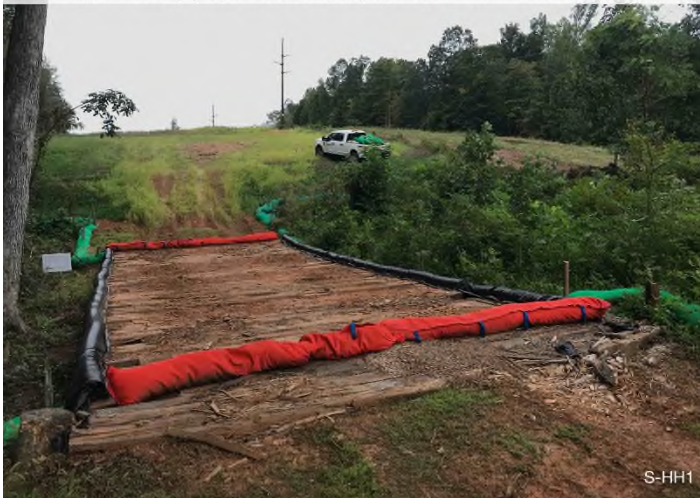
**Figure 3: Stream S-HH1** – Controls in place and functioning properly around stream S-HH1 crossing.

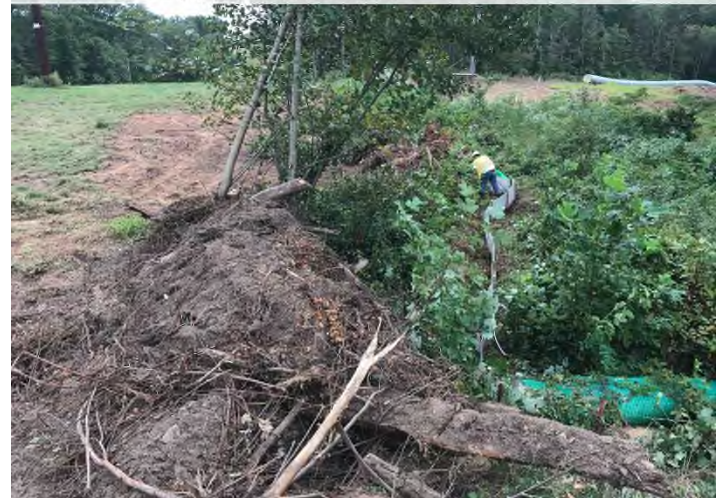
**Figure 4: STA 14815+75** – Unauthorized offsite LDA impacting perimeter MVP controls. Controls being repaired.
