## FIELD INSPECTION REPORT

| <b>Project Name:</b> | Mountain Valley Pipeline | <b>Inspector:</b> | Marshall Willis |
| <b>Spread H:<br/>Montgomery County</b> | STA 12373+76 – 12422+32<br>MVP-MN-279.02<br>ATWS 724 | <b>Weather:</b> | Wet |

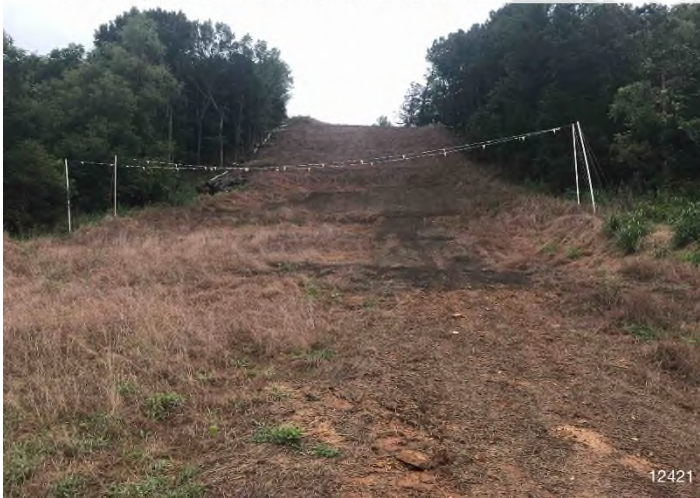
**Figure 1: STA 12421+00** – Controls in place and functioning properly. Area stabilized with erosion matting and straw.

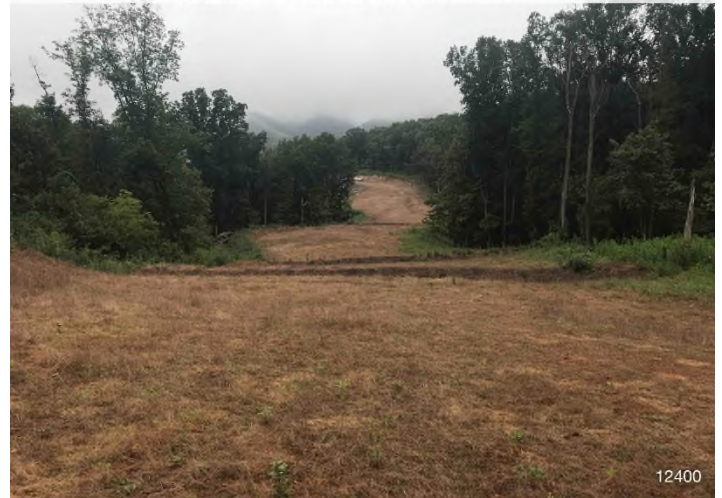
**Figure 2: STA 12400+00** – Controls in place and functioning properly. Area stabilized with erosion matting and straw.

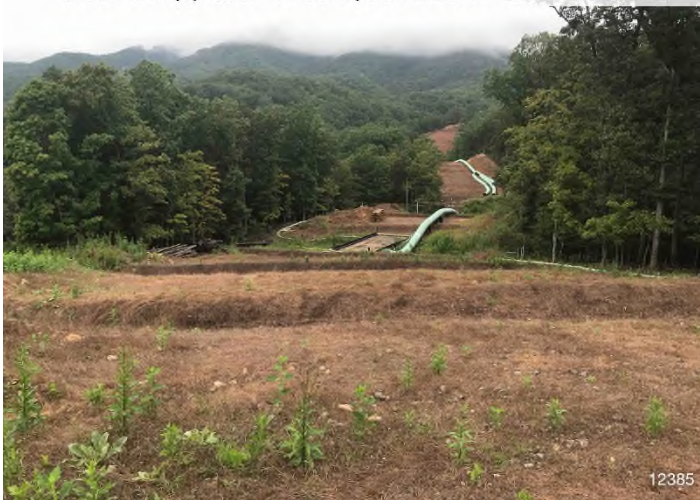
**Figure 3: STA 12385+00** – Controls in place and functioning properly. Area stabilized with erosion matting and straw.

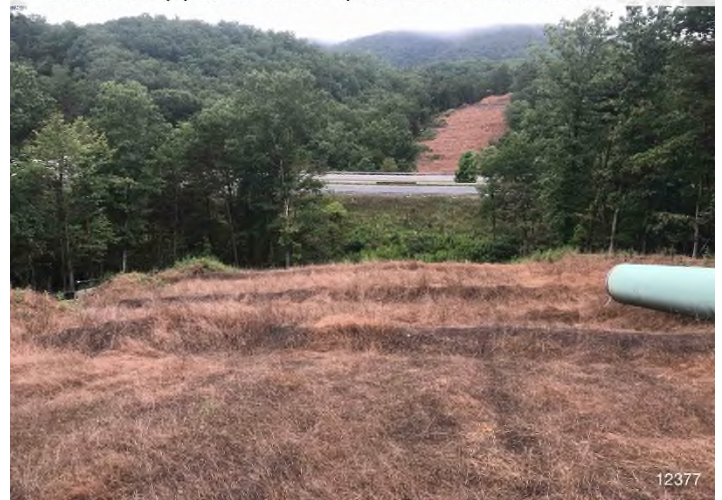
**Figure 4: STA 12377+00** – Controls in place and functioning properly. Area stabilized with erosion matting and straw.
