## FIELD INSPECTION REPORT

| <b>Project Name:</b> | Mountain Valley Pipeline | <b>Inspector:</b> | Marshall Willis |
| <b>Spread H:<br/>Montgomery County</b> | STA 12422+00 – 12443+12<br>MVP-MN-279<br>ATWS 727/726/725/1506/1507 | <b>Weather:</b> | Dry |

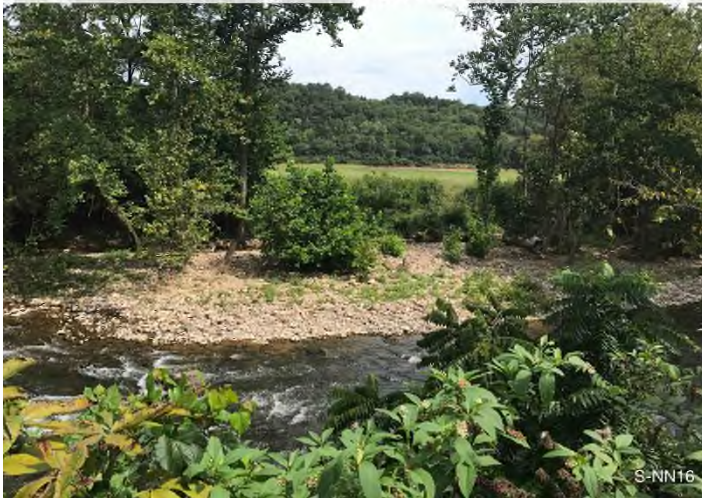
**Figure 1: Stream S-NN16** – Controls in place and functioning properly around stream S-NN16.

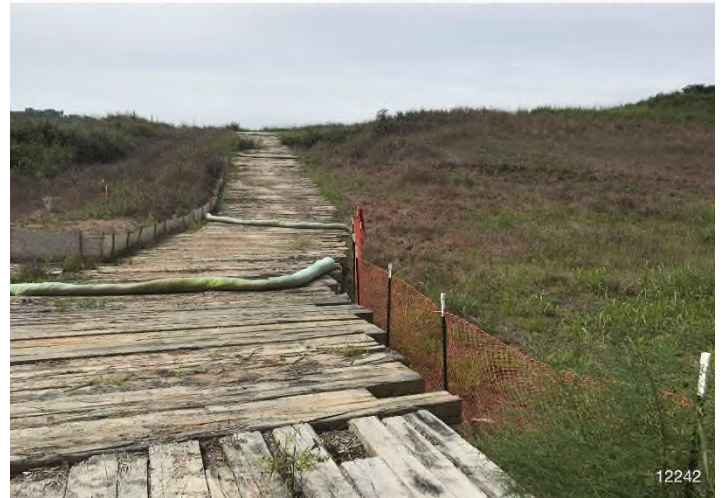
**Figure 2: STA 12442+00** – Controls in place and functioning properly.

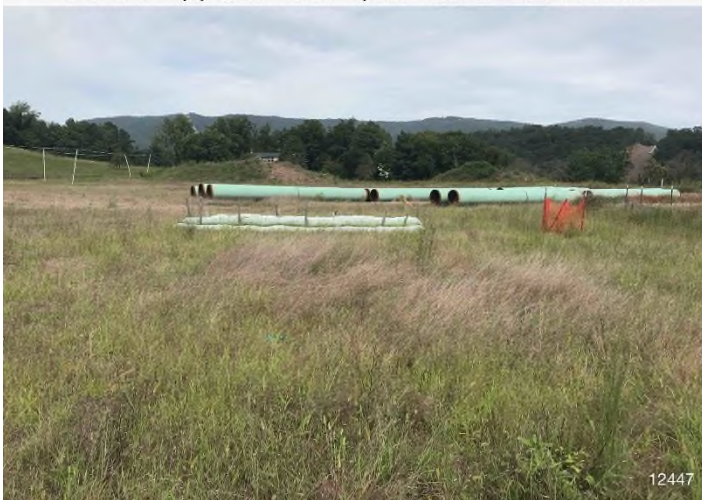
**Figure 3: STA 12447+00** – Controls in place and functioning properly.

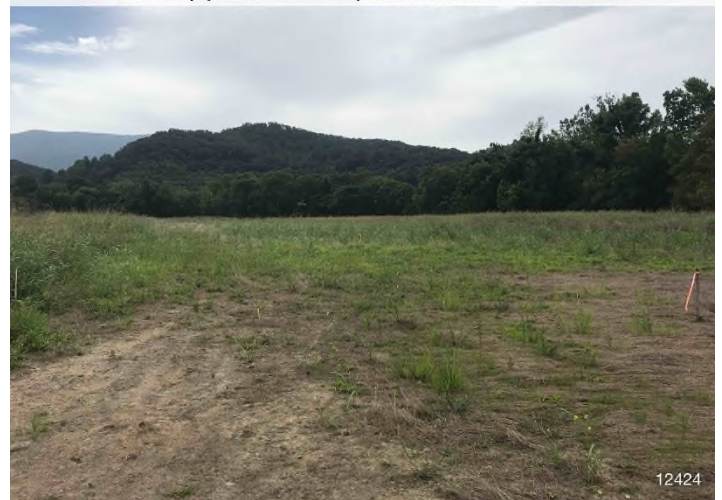
**Figure 4: STA 12424+00** – Controls in place and functioning properly.
