FIELD INSPECTION REPORT

Project Name:	Mountain Valley Pipeline	Inspector:	Marshall Willis			
Inspection Date:	Thursday, August 27, 2020	Project Contact:	Brian Clauto, Cory Chalmers			
Spread I: Franklin County	STA 14454+22 – 14546+75 ATWS 527/359/1340/360/528/362	Weather:	Dry

FIELD INSPECTION PHOTO LOG

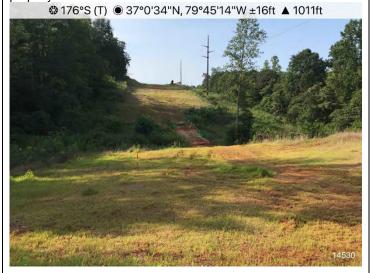
Figure 1: STA 14460+00 — Controls in place and functioning properly.

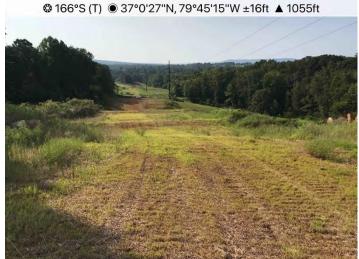
<u>Figure 4</u>: **STA 14537+00** – Controls in place and functioning properly.
