## FIELD INSPECTION REPORT

| Project Name: | Mountain Valley Pipeline | Inspector: | Marshall Willis |
| Spread H:<br>Franklin County | STA 13316+13 – 13342+67<br>ATWS 1412 | Weather: | Dry |

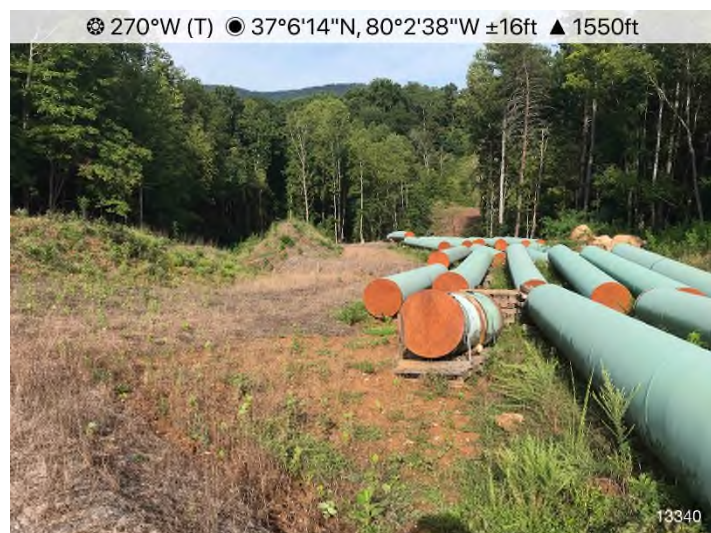
**Figure 1: STA 13340+00** – Controls in place and functioning properly.

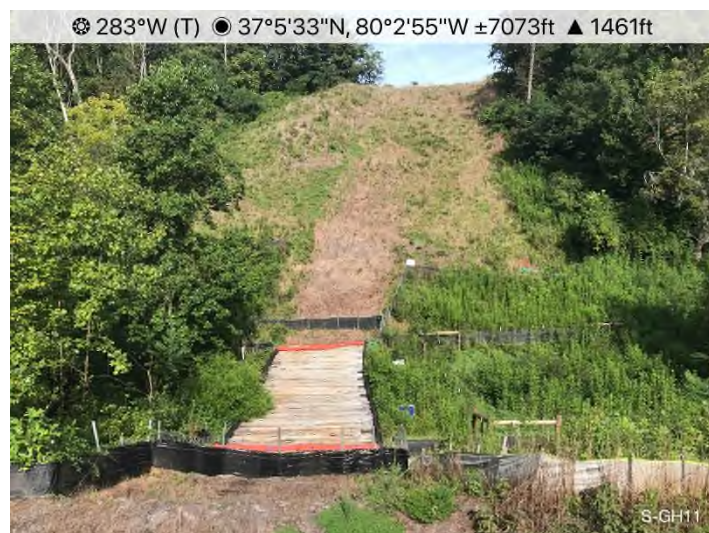
**Figure 2: Stream S-GH11** – Controls in place and functioning properly around S-GH11 crossing.

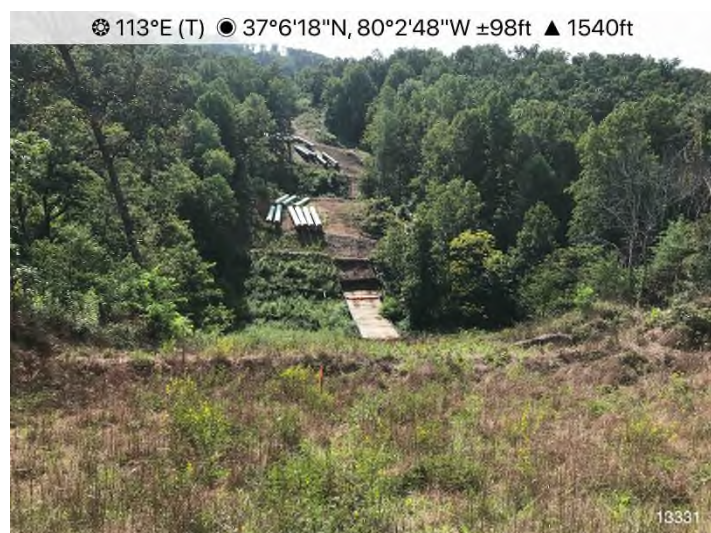
**Figure 3: STA 13331+00** – Controls in place and functioning properly.

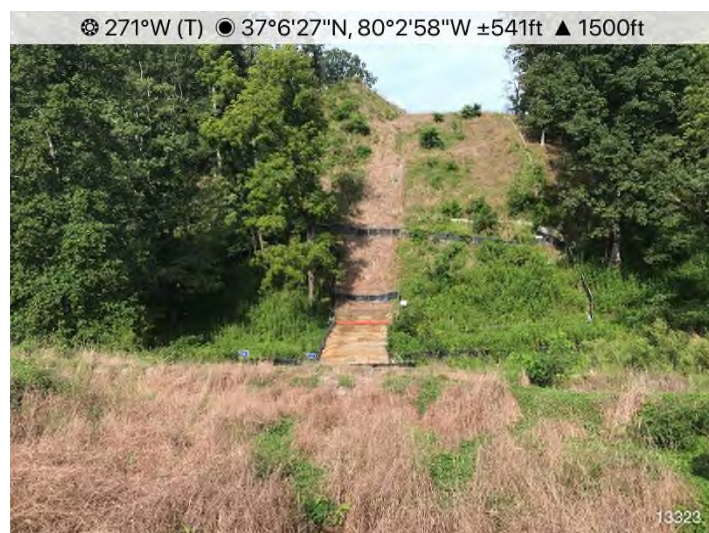
**Figure 4: STA 13323+00** – Controls in place and functioning properly.
