FIELD INSPECTION REPORT

Project Name:	Mountain Valley Pipeline	Inspector:	Marshall Willis
Inspection Date:	Wednesday, August 19, 2020	Project Contact:	Brian Clauto, Cory Chalmers
Spread H: Montgomery County	STA 12102+69 – 12119+17 STA 12153+28 – 12190+81 MVP-MN-270.01/273/274	Weather:	Dry

FIELD INSPECTION PHOTO LOG

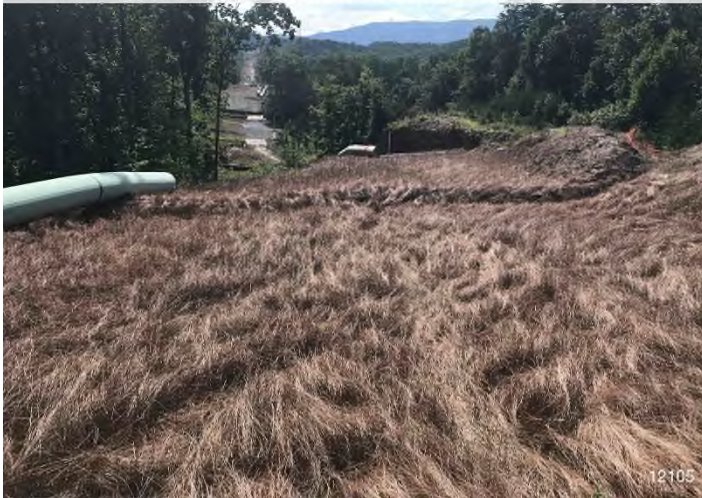
Figure 1: STA 12105+00 – Controls in place and functioning properly.

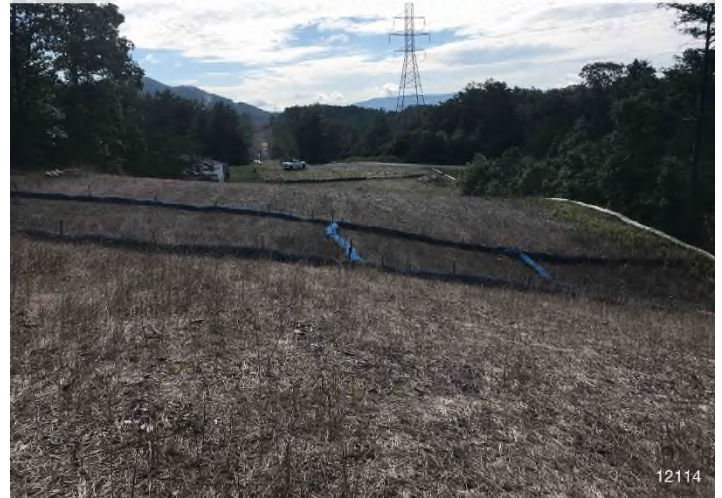
Figure 2: STA 12114+00 – Controls in place and functioning properly.

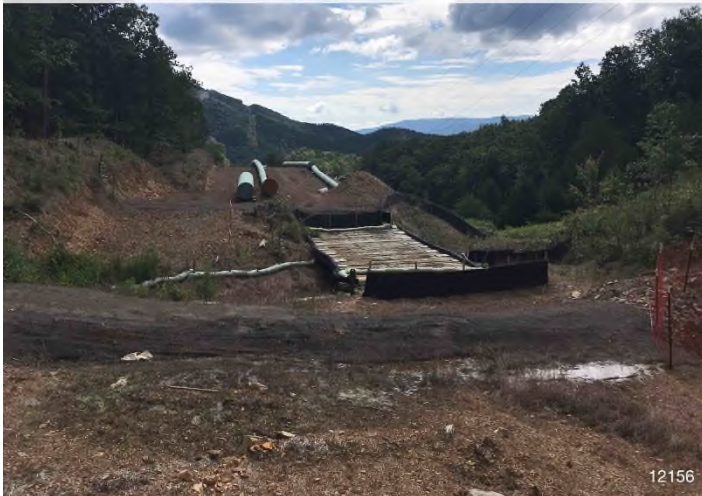
Figure 3: STA 12156+00 – Controls in place and functioning properly.

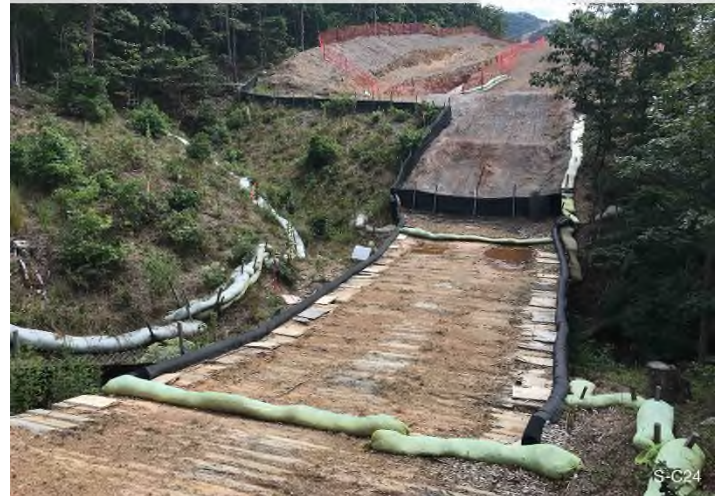
Figure 4: Stream S-C24 – Controls in place and functioning properly around S-C24 crossing.
