## FIELD INSPECTION REPORT

| Project Name: | Mountain Valley Pipeline | Inspector: | Marshall Willis |
| Spread H:<br>Roanoke County | STA 12975+00 – 12964+00<br>MVP-RO-288 | Weather: | Dry |

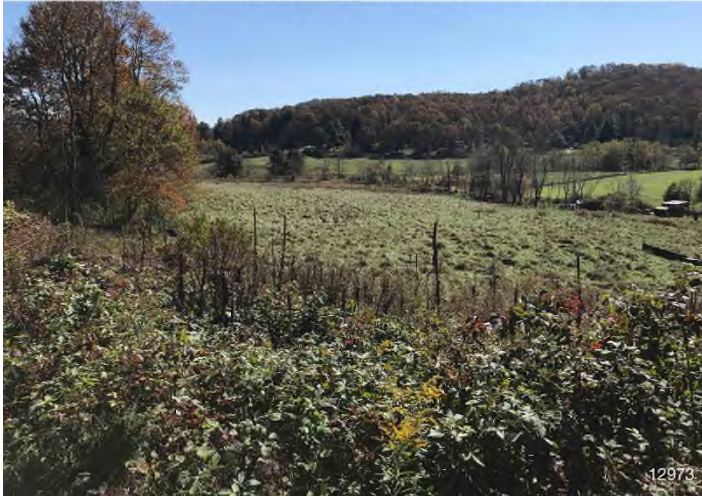
**Figure 1: STA 12973+00** – Controls in place and functioning properly.

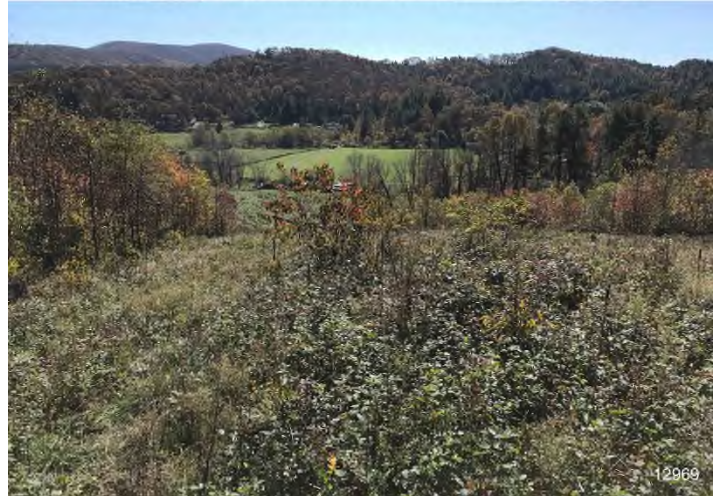
**Figure 2: STA 12969+00** – Controls in place and functioning properly.

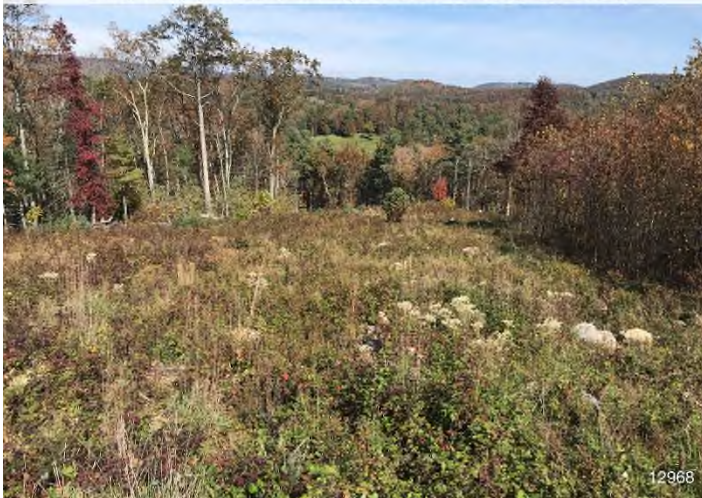
**Figure 3: STA 12968+00** – Controls in place and functioning properly.

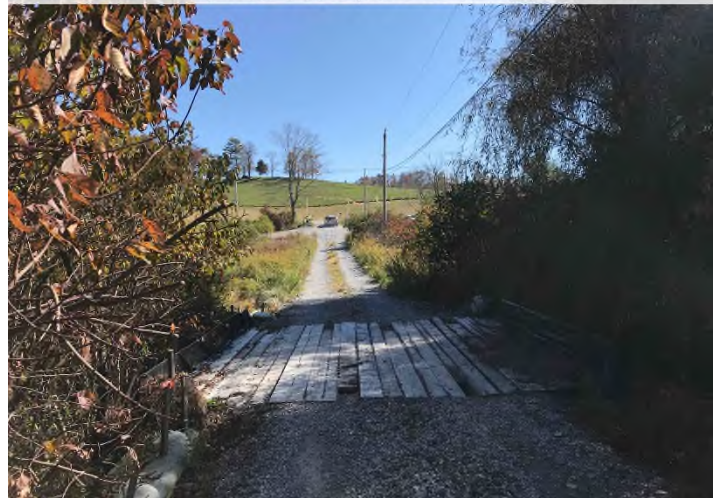
**Figure 4: MVP-RO-288** – Controls in place and functioning properly at S-KL4 crossing.
