FIELD INSPECTION REPORT

Project Name:	Mountain Valley Pipeline	Inspector:	Marshall Willis
Inspection Date:	Monday, October 19, 2020	Project Contact:	Brian Clauto, Cory Chalmers
Spread H: Montgomery County	STA 12373+28 – 12435+16 MVP-MLV-AR-27 MVP-MN-279/279.02	Weather:	Dry

FIELD INSPECTION PHOTO LOG

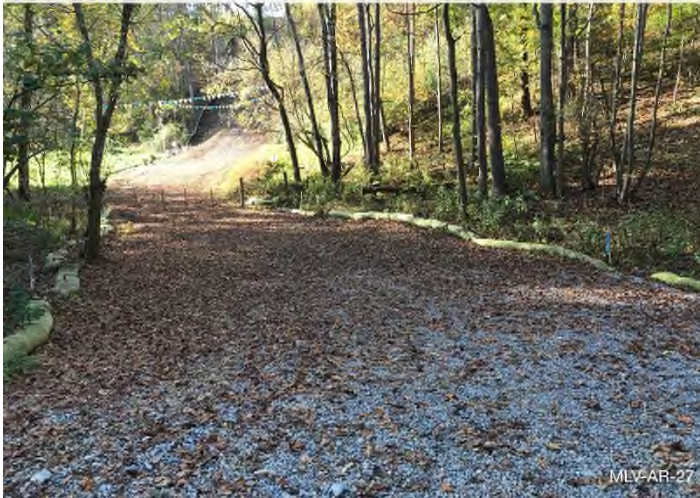
MLV-AR-27

Figure 1: MVP-MLV-AR-27 – Controls in place and functioning properly.

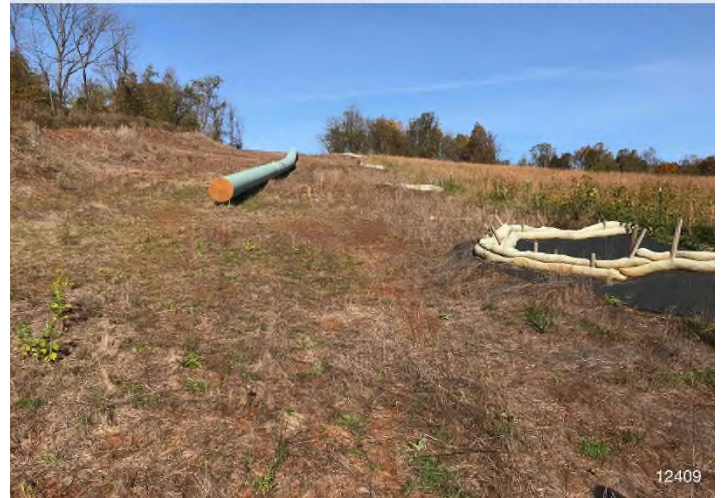
12409

Figure 2: STA 12409+00 – Controls in place and functioning properly.

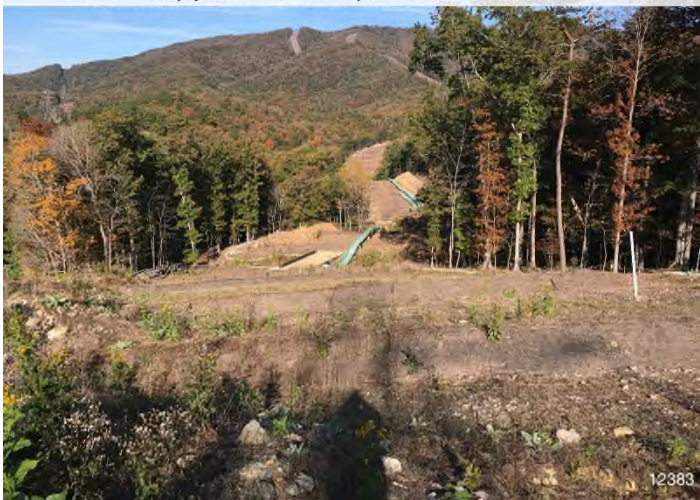
12383

Figure 3: STA 12383+00 – Controls in place and functioning properly.

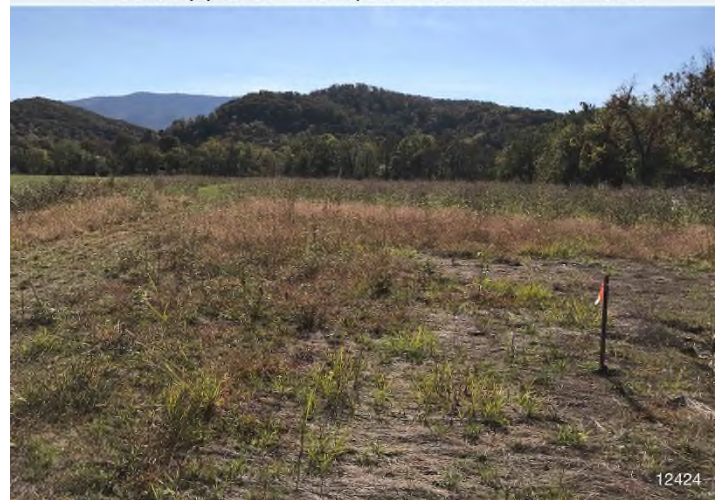
12424

Figure 4: STA 12424+00 – Controls in place and functioning properly.
