## FIELD INSPECTION REPORT

| <b>Project Name:</b> | Mountain Valley Pipeline | <b>Inspector:</b> | Marshall Willis |
| <b>Spread I:<br/>Franklin County</b> | STA 13415+51 – 13438+31<br>ATWS 1343/1342/1351<br>MVP-FR-293.02 | <b>Weather:</b> | Dry |

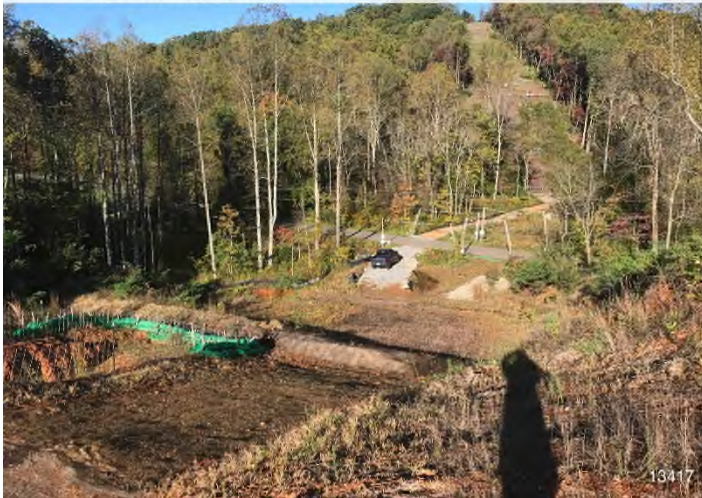
**Figure 1: STA 13417+00** – Controls in place and functioning properly. Area stabilized with erosion matting and Earth Guard.

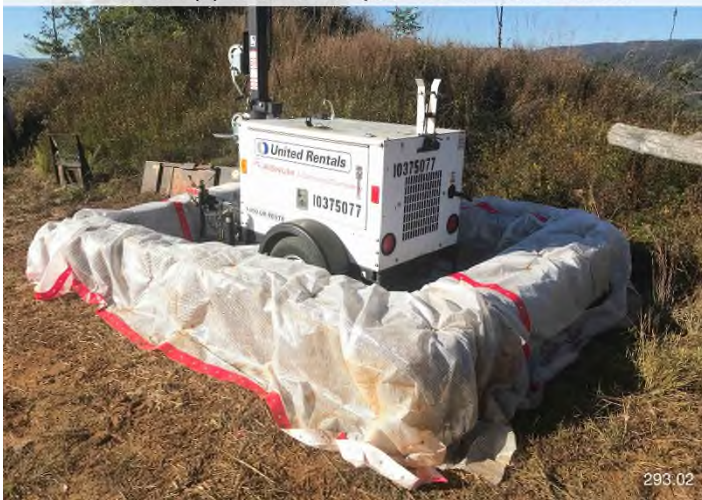
**Figure 3: MVP-FR-293.02** – Secondary containment in place and functioning properly.

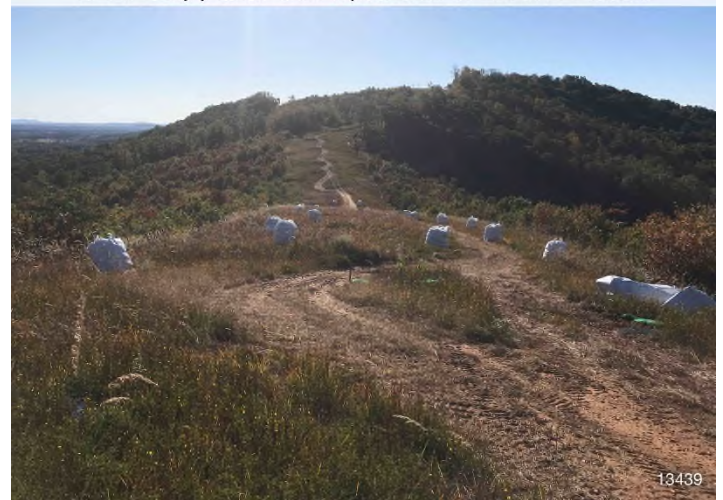
**Figure 4: STA 13439+00** – PPL actively working to replace CFS in area.
