## FIELD INSPECTION REPORT

| <b>Project Name:</b> | Mountain Valley Pipeline | <b>Inspector:</b> | Marshall Willis |
| <b>Inspection Date:</b> | Wednesday, September 30, 2020 | <b>Project Contact:</b> | Brian Clauto, Cory Chalmers |
| <b>Spread H:<br/>Montgomery County</b> | STA 12119+17 – 12140+00<br>STA 12187+00 – 12200+00<br>MVP-MN-274/275 | <b>Weather:</b> | Wet |

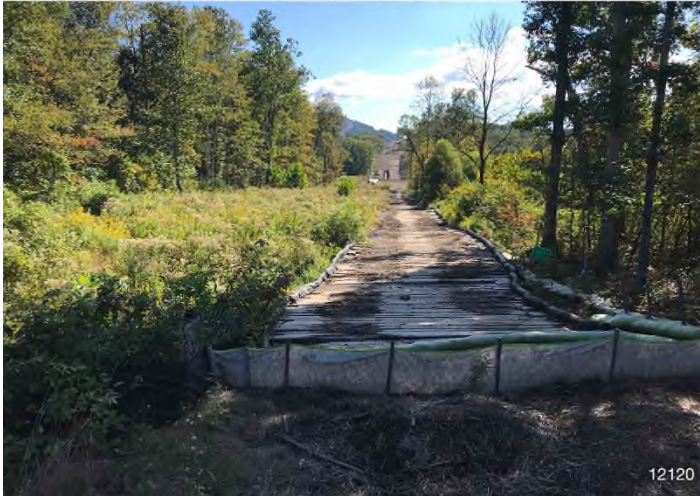
**Figure 1: STA 12120+00** – Controls in place and functioning properly.

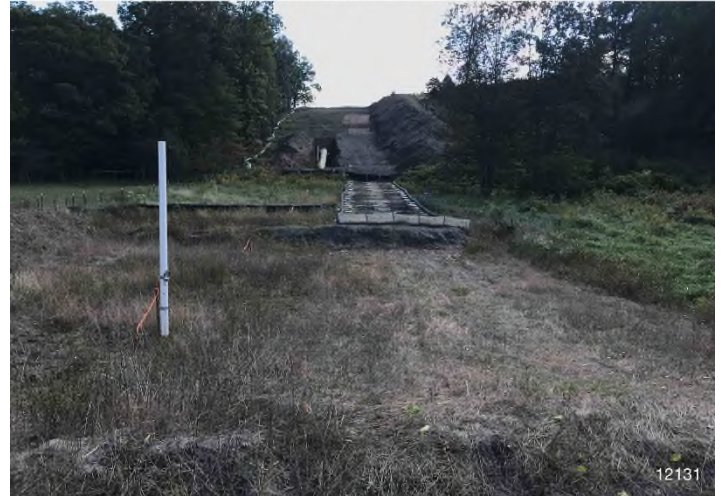
**Figure 2: STA 12131+00** – Controls in place and functioning properly. Area stabilized with straw and erosion matting.

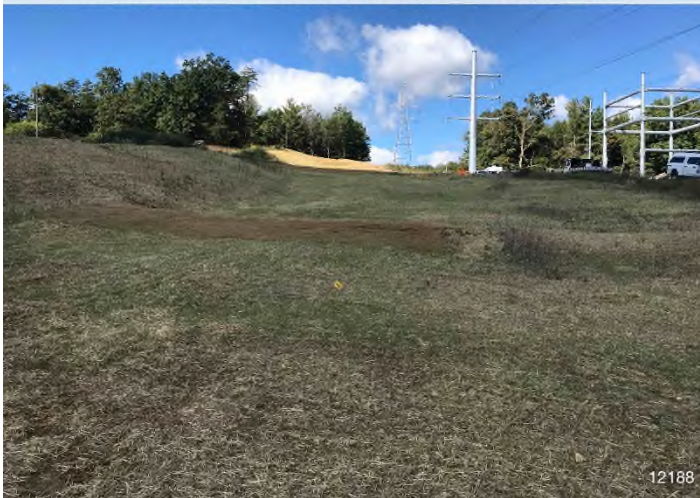
**Figure 3: STA 12188+00** – Controls in place and functioning properly. Area stabilized with straw.

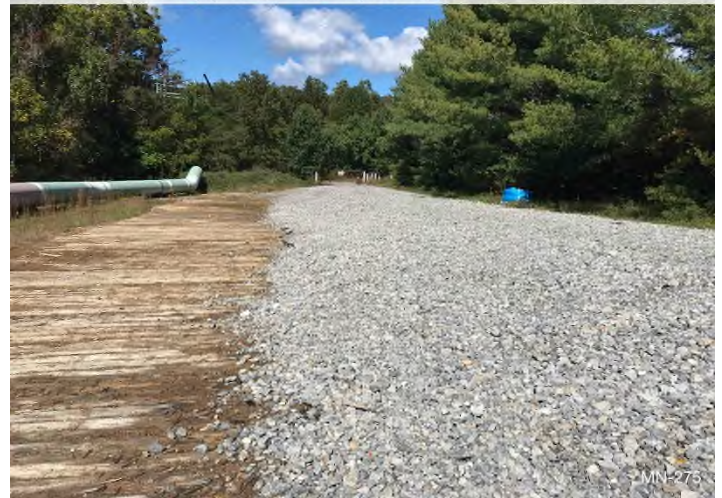
**Figure 4: MVP-MN-275** – Controls in place and functioning properly.
