FIELD INSPECTION REPORT

Project Name:	Mountain Valley Pipeline	Inspector:	Marshall Willis
Inspection Date:	Monday, September 28, 2020	Project Contact:	Brian Clauto, Cory Chalmers
Spread I: Franklin County	STA 14062+17 – 14171+36 ATWS 1472/1473/1478/1479/1480	Weather:	Wet

FIELD INSPECTION PHOTO LOG

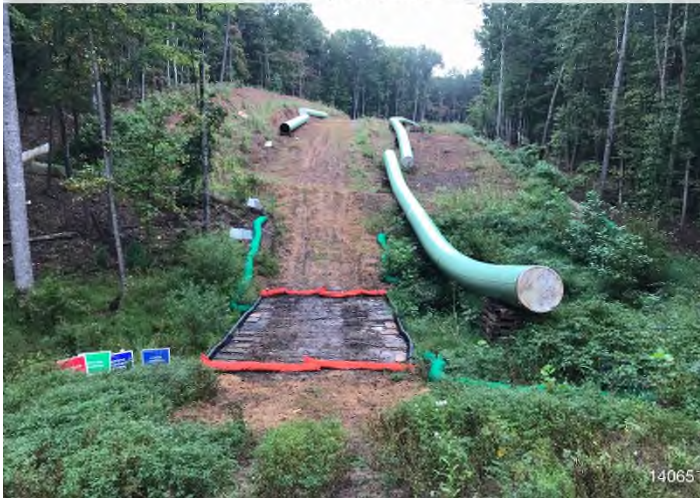
Figure 1: STA 14065+00 – Controls in place and functioning properly. Area stabilized with straw.

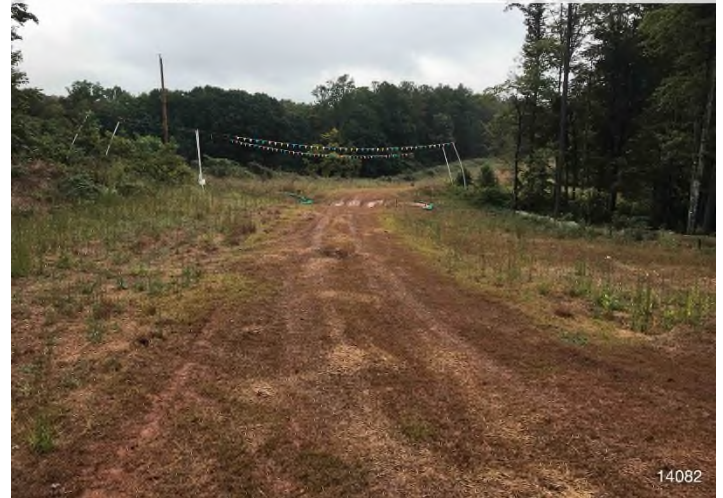
Figure 2: STA 14082+00 – Controls in place and functioning properly. Area stabilized with straw.

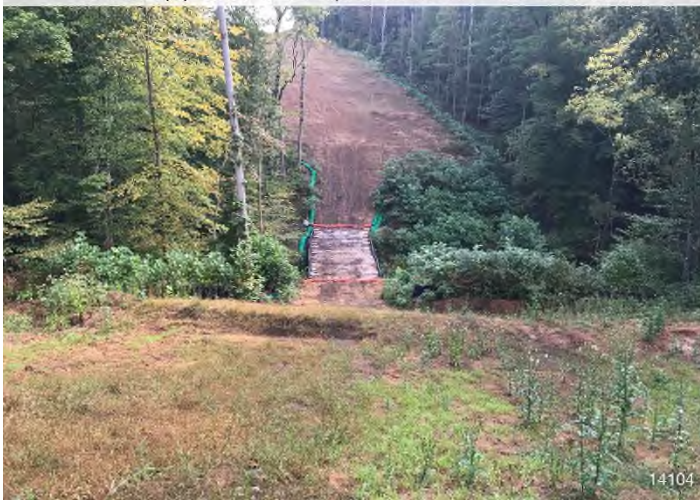
Figure 3: STA 14104+00 – Controls in place and functioning properly. Area stabilized with straw and erosion matting.

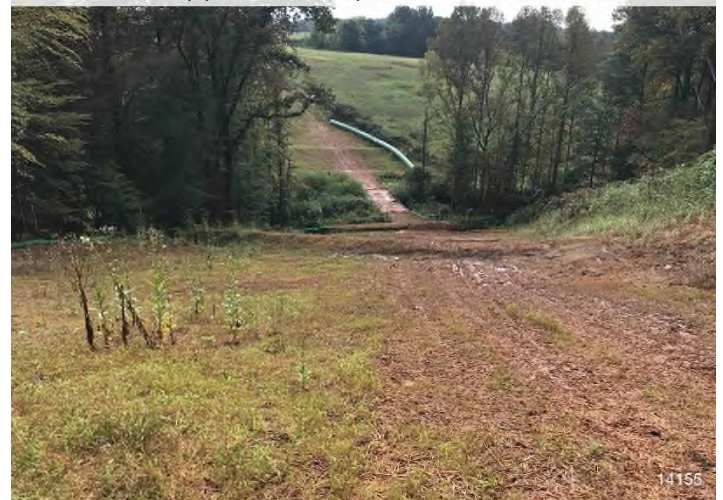
Figure 4: STA 14155+00 – Controls in place and functioning properly. Area stabilized with straw and erosion matting.
