## FIELD INSPECTION REPORT

Project Name:	Mountain Valley Pipeline	Inspector:	Marshall Willis
Inspection Date:	Friday, September 25, 2020	Project Contact:	Brian Clauto, Cory Chalmers
Spread I: Franklin County	STA 13539+00 – 13551+50 STA 13562+63 – 13575+21 STA 13632+25 – 13645+00	Weather:	Rainy

## FIELD INSPECTION PHOTO LOG

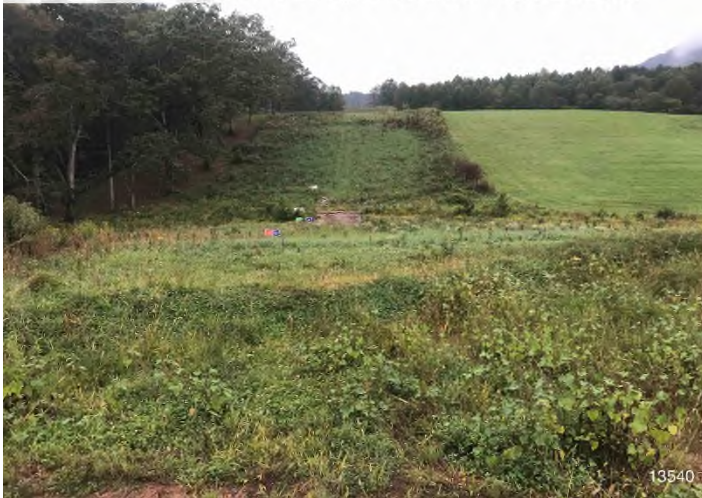
**Figure 1: STA 13540+00** – Controls in place and functioning properly.

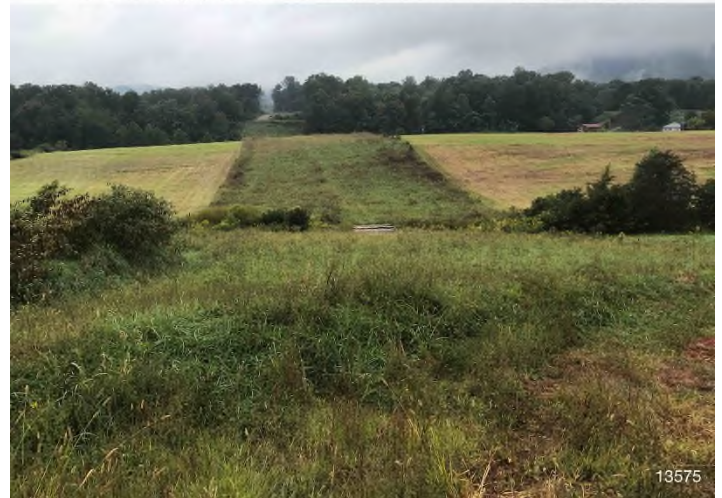
**Figure 2: STA 13575+00** – Controls in place and functioning properly.

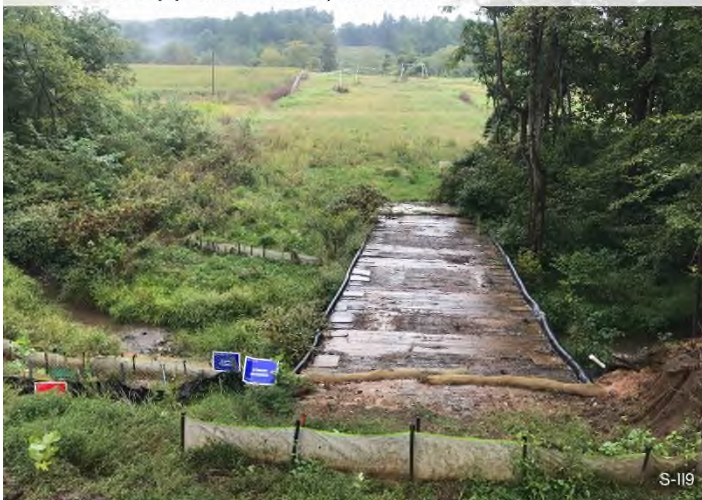
**Figure 3: Stream S-II9** – Controls in place and functioning properly around S-II9 crossing.

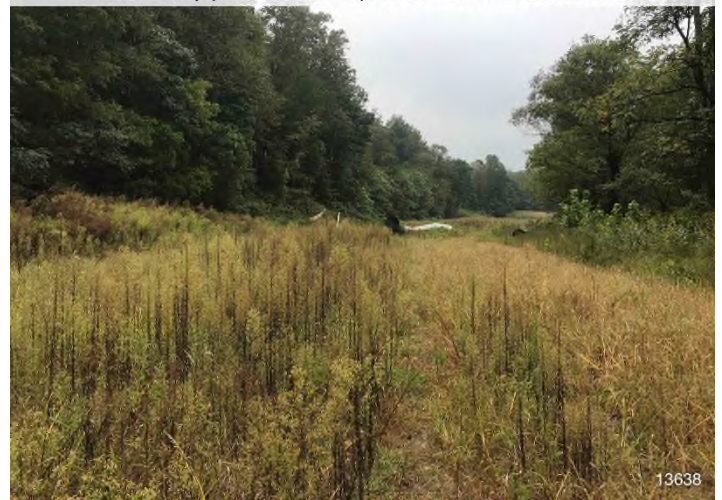
**Figure 4: STA 13638+00** – Controls in place and functioning properly.
