## FIELD INSPECTION REPORT

| Project Name: | Mountain Valley Pipeline | Inspector: | Marshall Willis |

## FIELD INSPECTION PHOTO LOG

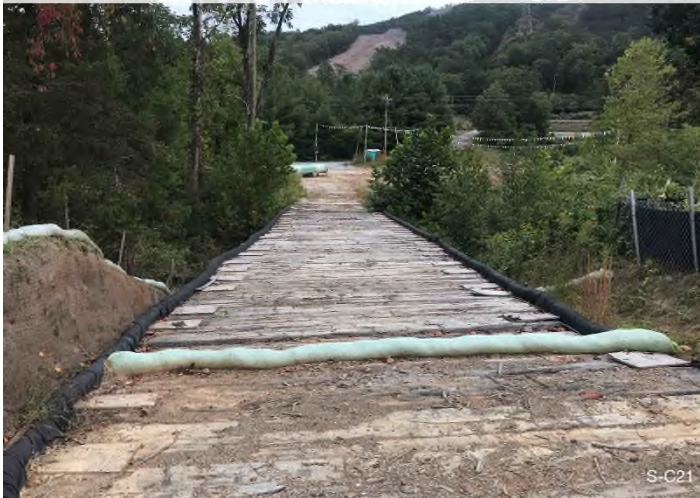
**Figure 1: Stream S-C21** – Controls in place and functioning properly around Bradshaw Creek crossing.

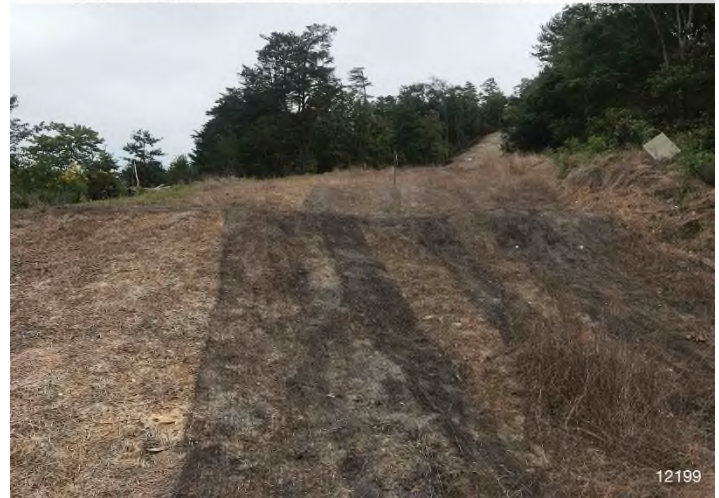
**Figure 2: STA 12199+00** – Controls in place and functioning properly. Area stabilized with straw and erosion matting.

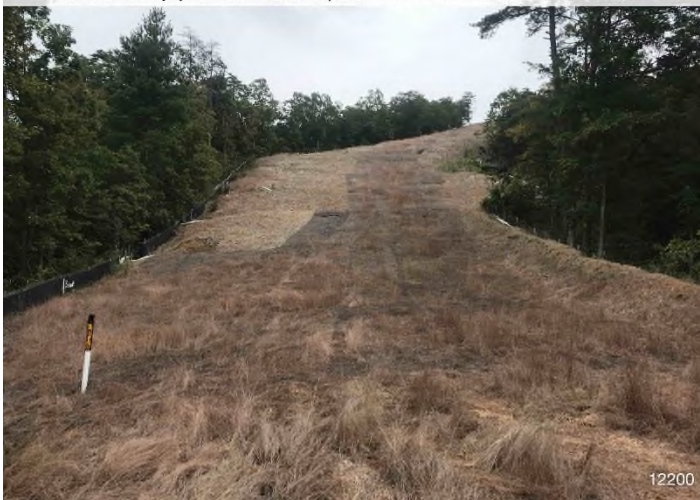
**Figure 3: STA 12200+00** – Controls in place and functioning properly. Area stabilized with straw and erosion matting.

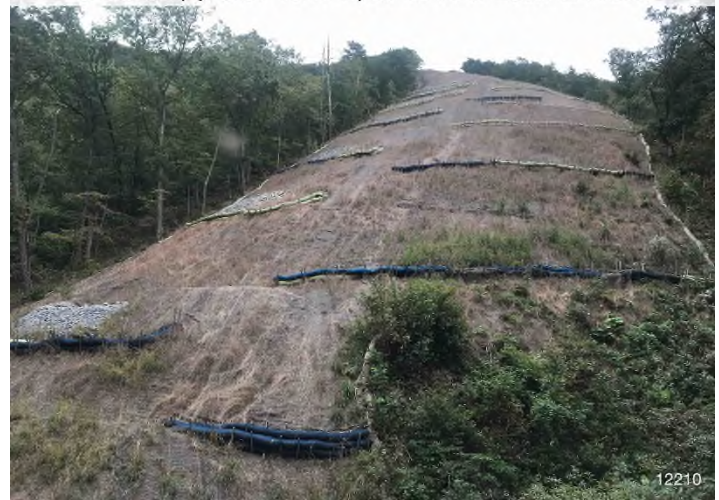
**Figure 4: STA 12210+00** – Controls in place and functioning properly. Area stabilized with straw and erosion matting.
