FIELD INSPECTION REPORT

Project Name:	Mountain Valley Pipeline	Inspector:	Marshall Willis
Inspection Date:	Wednesday, September 23, 2020	Project Contact:	Brian Clauto, Cory Chalmers
Spread I: Franklin County	STA 14170+00 – 14200+00 ATWS 1479/1480/1481/521	Weather:	Dry

FIELD INSPECTION PHOTO LOG

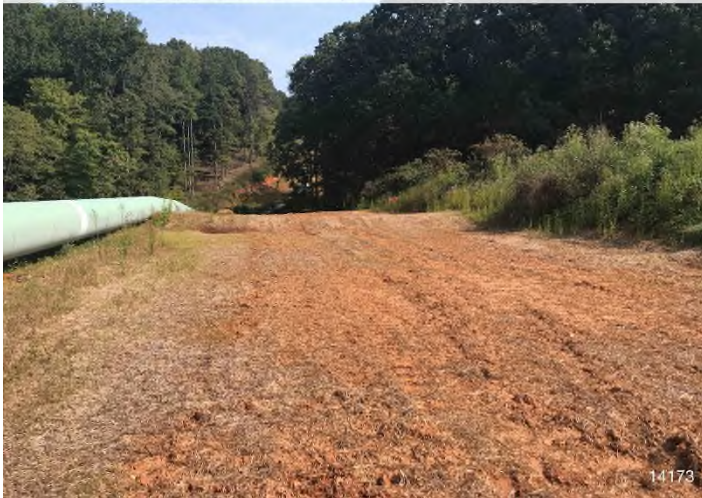
Figure 1: STA 14173+00 – Controls in place and functioning properly. Area stabilized with straw.

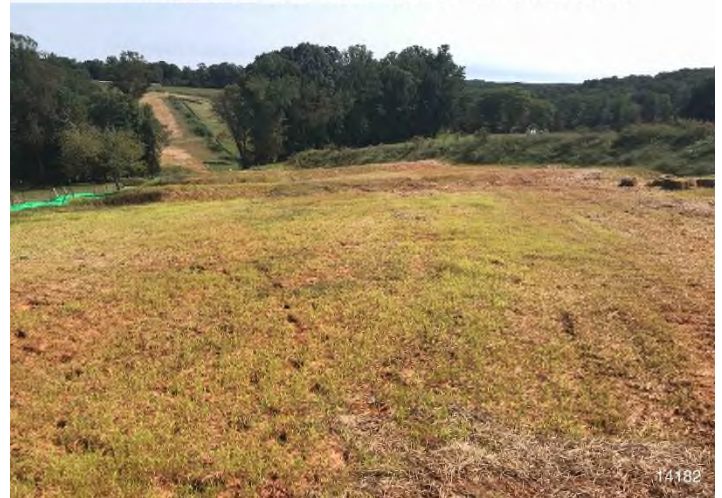
Figure 2: STA 14182+00 – Controls in place and functioning properly. Area stabilized with straw.

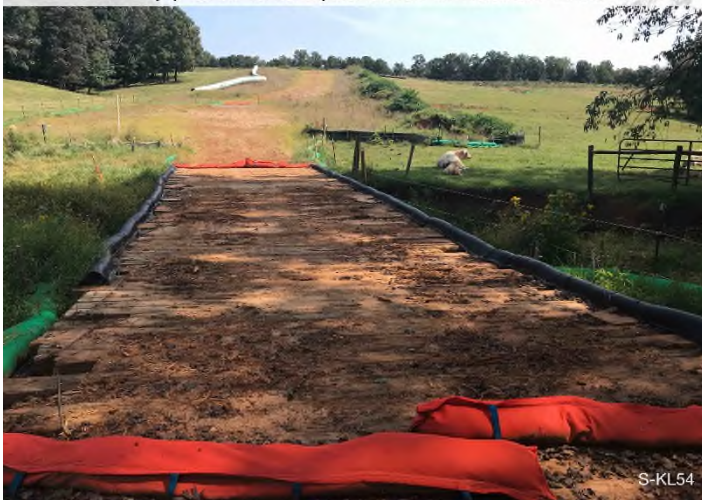
Figure 3: Stream S-KL54 – Controls in place and functioning properly around S-KL54 crossing.

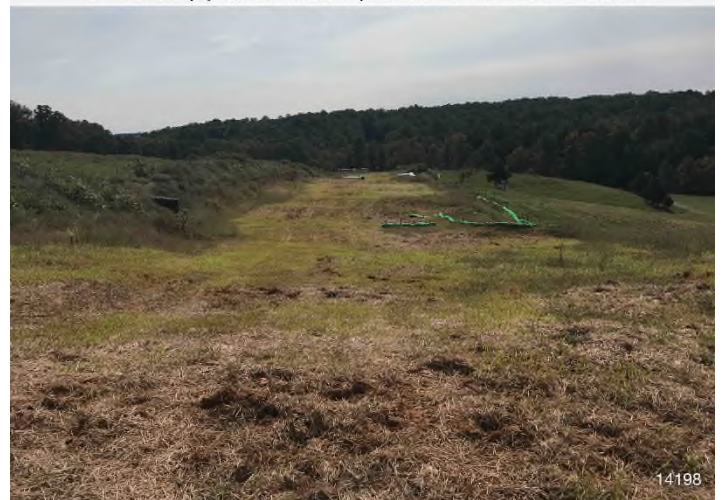
Figure 4: STA 14198+00 – Controls in place and functioning properly. Area stabilized with straw.
