FIELD INSPECTION REPORT

Project Name:	Mountain Valley Pipeline	Inspector:	Marshall Willis
Inspection Date:	Friday, September 18, 2020	Project Contact:	Brian Clauto, Cory Chalmers
Spread I: Pittsylvania County	STA 15296+00 – 15370+62 ATWS 389/389A/391/392/492/492A	Weather:	Wet

FIELD INSPECTION PHOTO LOG

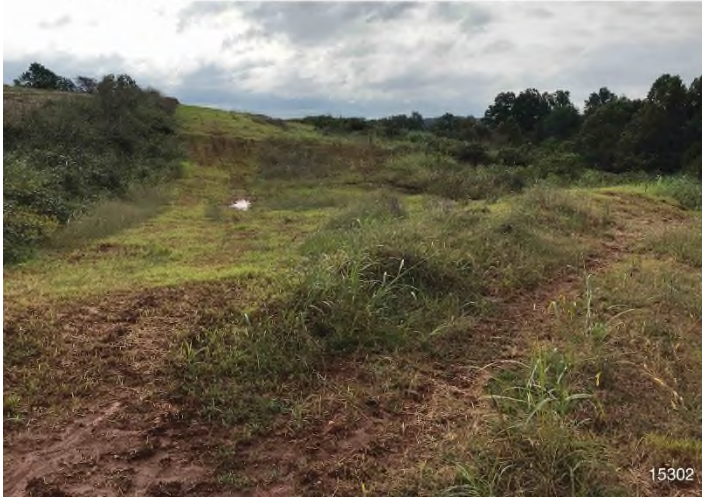
15302

Figure 1: STA 15302+00 – Controls in place and functioning properly.

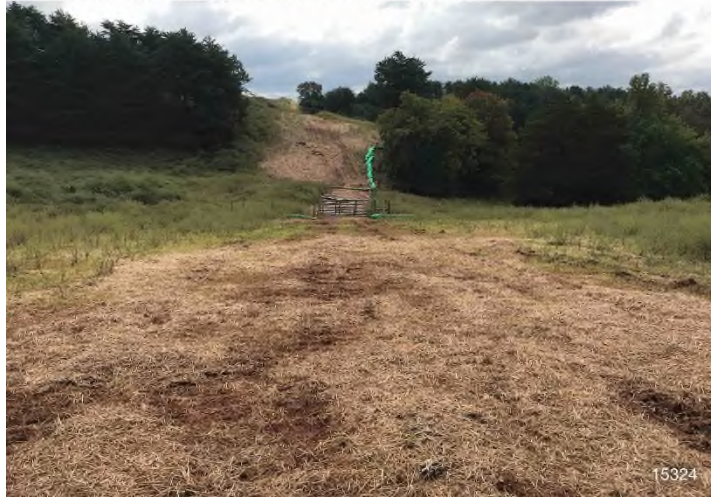
15324

Figure 2: STA 15324+00 – Controls in place and functioning properly.

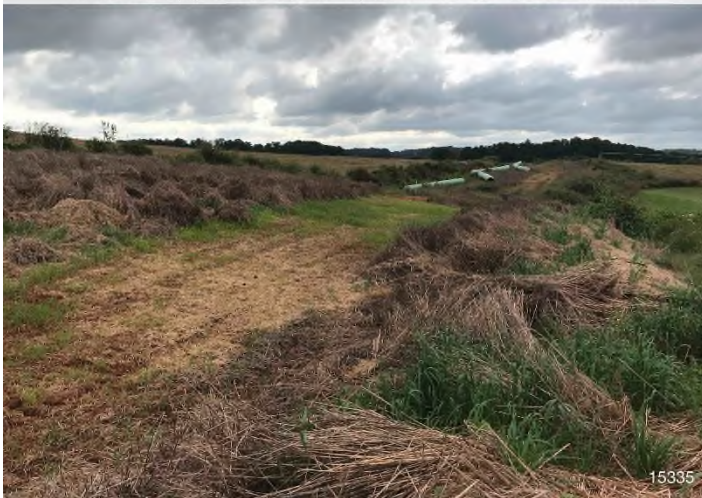
15335

Figure 3: STA 15335+00 – Controls in place and functioning properly.

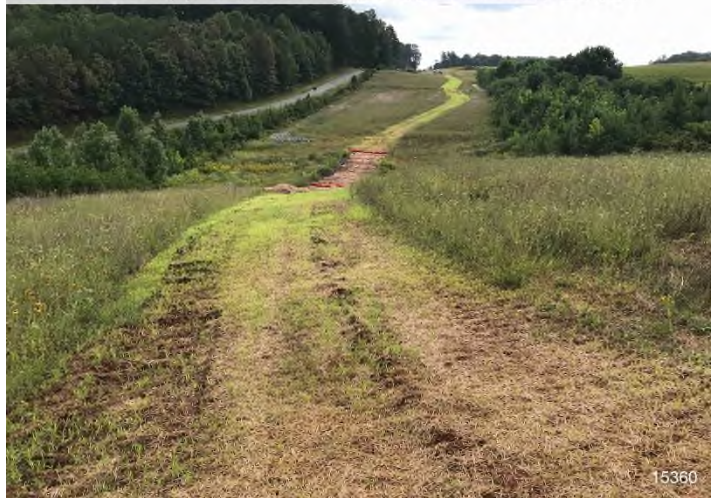
15360

Figure 4: STA 15360+00 – Controls in place and functioning properly.
