## FIELD INSPECTION REPORT

| <b>Project Name:</b> | Mountain Valley Pipeline | <b>Inspector:</b> | Marshall Willis |
| <b>Spread H:<br/>Montgomery County</b> | STA 12448+00 – 12464+25<br>STA 12480+75 – 12485+00<br>MVP-MLV-AR-28 | <b>Weather:</b> | Rainy |

## FIELD INSPECTION PHOTO LOG

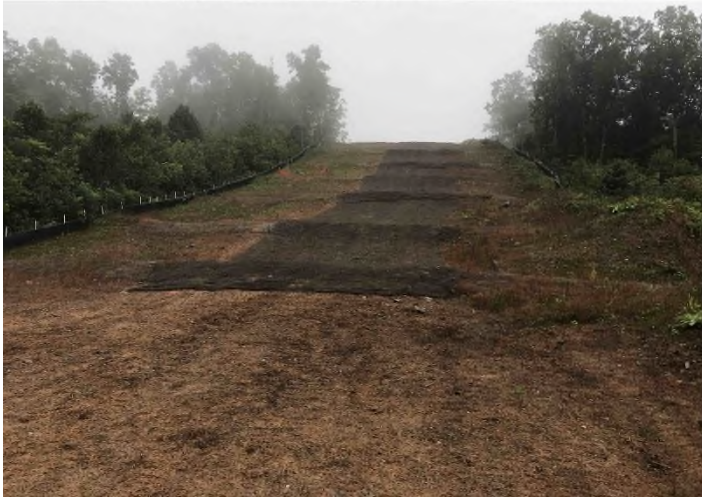
**Figure 1: STA 12483+00** – Controls in place and functioning properly. Area stabilized with erosion matting and hydro-mulch.

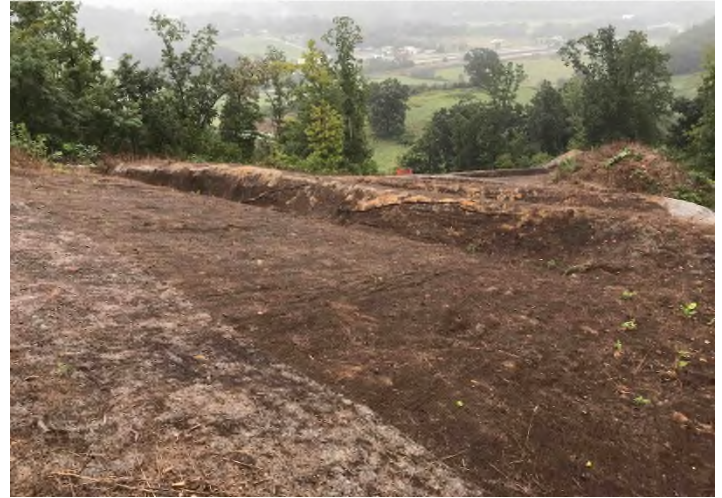
**Figure 2: STA 12480+00** – Controls in place and functioning properly. Area stabilized with erosion matting and hydro-mulch.

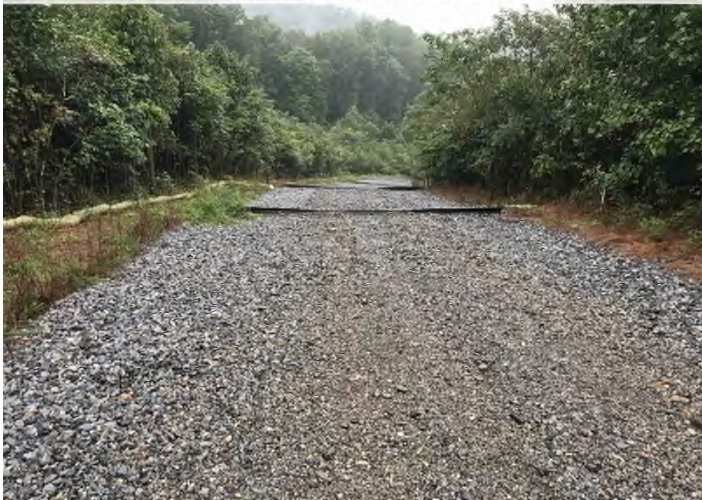
**Figure 3: STA MVP-MLV-AR-28** – Controls in place and functioning properly.

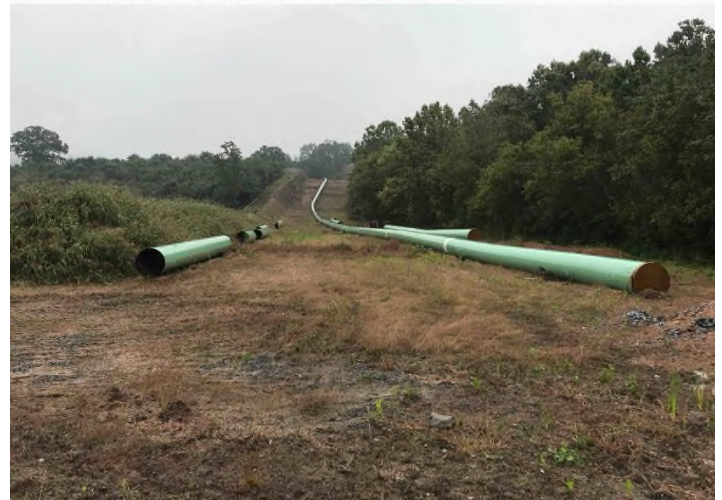
**Figure 4: STA 12464+00** – Controls in place and functioning properly.
