## FIELD INSPECTION REPORT

| Project Name: | Mountain Valley Pipeline | Inspector: | Marshall Willis |
| Inspection Date: | Wednesday, September 16, 2020 | Project Contact: | Brian Clauto, Cory Chalmers |

## FIELD INSPECTION PHOTO LOG

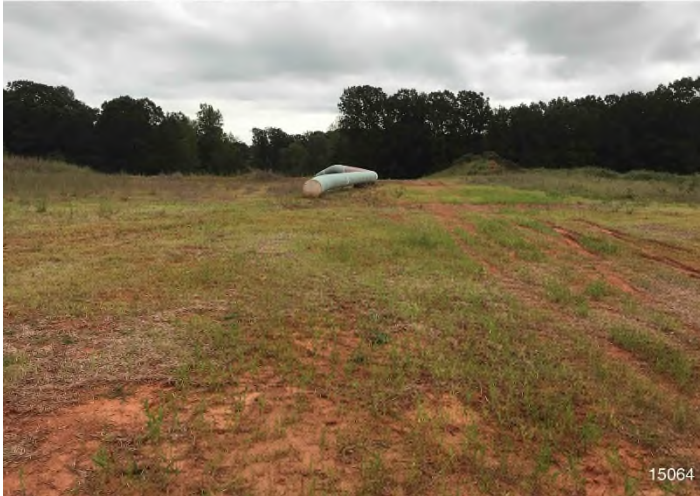
**Figure 1: STA 15064+00** – Controls in place and functioning properly.

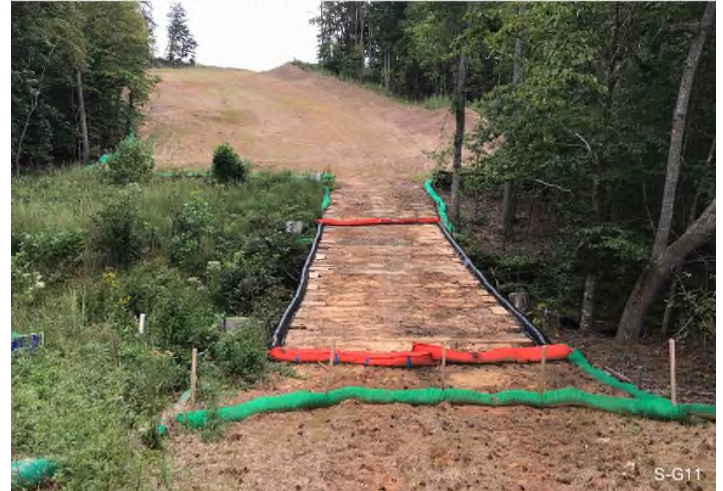
**Figure 2: Stream S-G11** – Controls in place and functioning properly around stream S-G11 crossing. Area stabilized with straw.

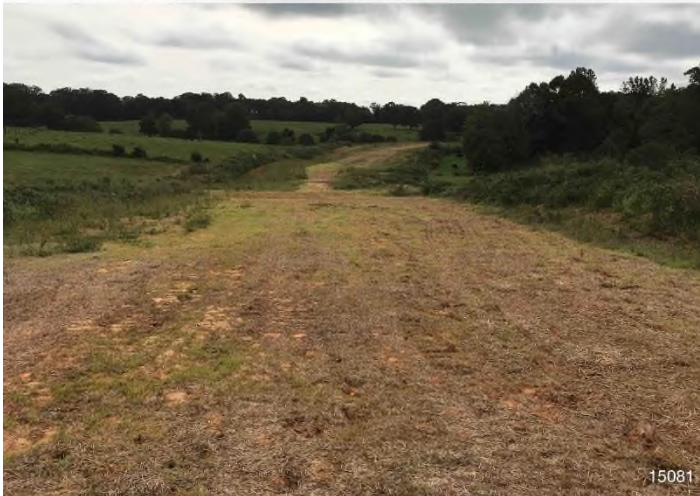
**Figure 3: STA 15081+00** – Controls in place and functioning properly. Area stabilized with straw.

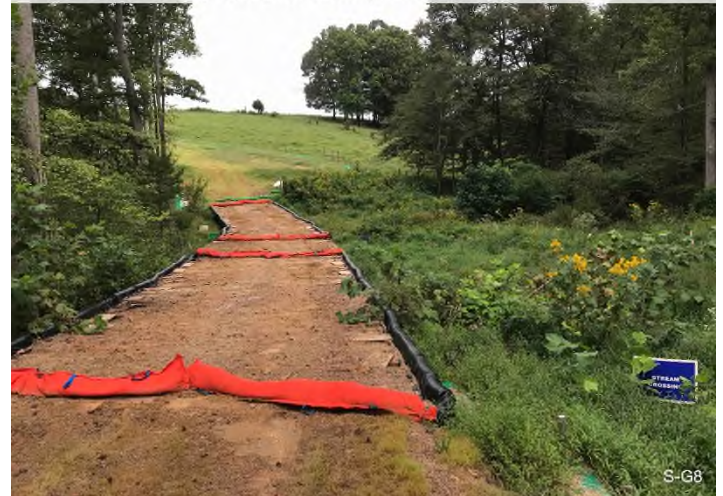
**Figure 4: Stream S-G8** – Controls in place and functioning properly around stream S-G8 crossing.
