FIELD INSPECTION REPORT

Project Name:	Mountain Valley Pipeline	Inspector:	Marshall Willis
Inspection Date:	Thursday, November 19, 2020	Project Contact:	Brian Clauto, Cory Chalmers
Spread H: Franklin County	STA 13253+00 – 13263+50 ATWS 1055	Weather:	Dry

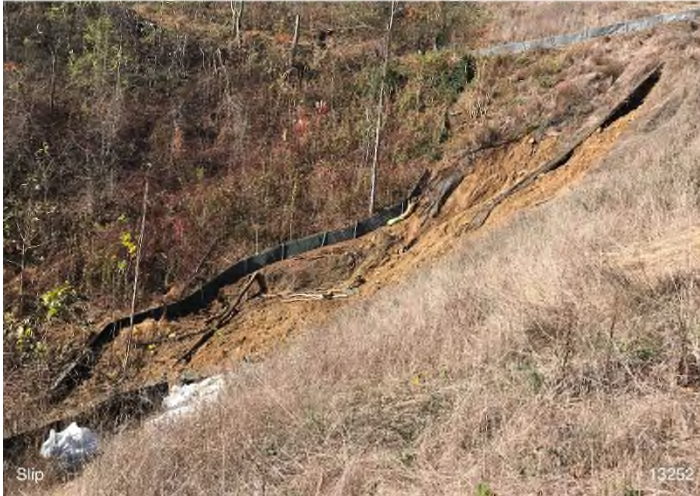
Investigation of slope failure from excessive precipitation event last week. Area of concern is at final grade with permanent stabilization applied. Slip material moved outside of the LOD. Contractor has installed SSF around the material to prevent further movement. Site is currently undergoing geotechnical review for repair.

Figure 1: STA 13252+00 – Looking west at the slip area from within the ROW. SSF perimeter installed around the area.

Recommended Corrective Action: Stabilize area where slip has occurred.

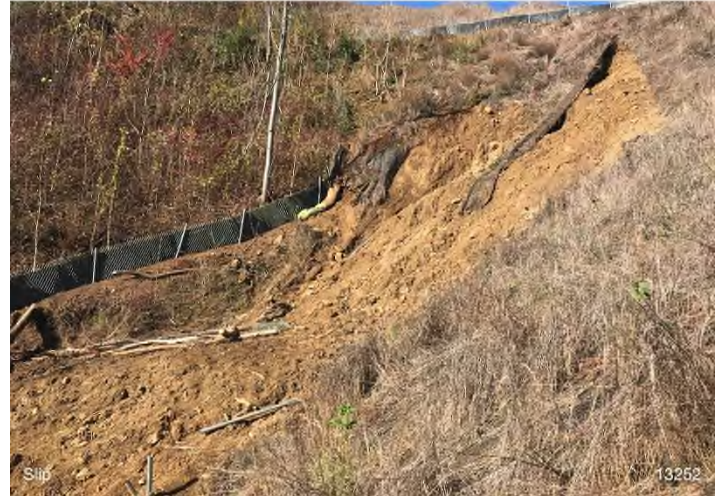
Figure 2: STA 13252+00 – Looking west at the slip area from within the ROW. SSF perimeter installed around the area.

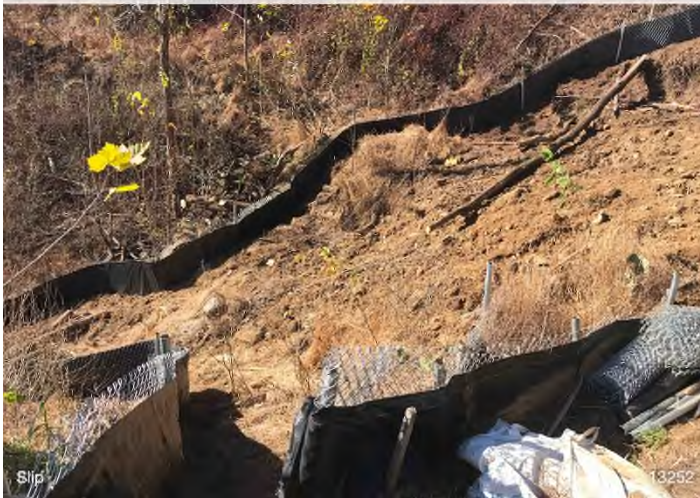
Figure 3: STA 13252+00 – Looking southwest at the slip area from within the ROW. SSF perimeter installed around the area.

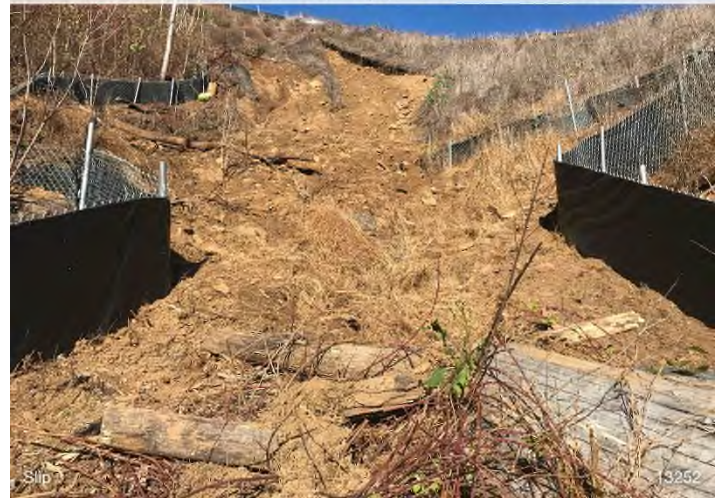
Figure 4: STA 13252+00 – Looking northwest toward the slope failure. SSF perimeter installed around the area.
