FIELD INSPECTION REPORT

Project Name:	Mountain Valley Pipeline	Inspector:	Marshall Willis
Inspection Date:	Wednesday, November 18, 2020	Project Contact:	Brian Clauto, Cory Chalmers
Spread H: Franklin County	STA 13342+67 – 13415+51 ATWS 1352	Weather:	Dry

FIELD INSPECTION PHOTO LOG

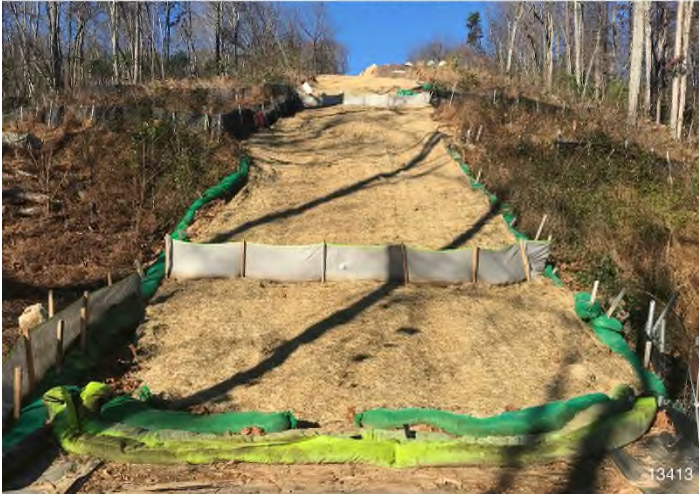
Figure 1: STA 13413+00 – Controls in place and functioning properly. Area stabilized with erosion control matting.

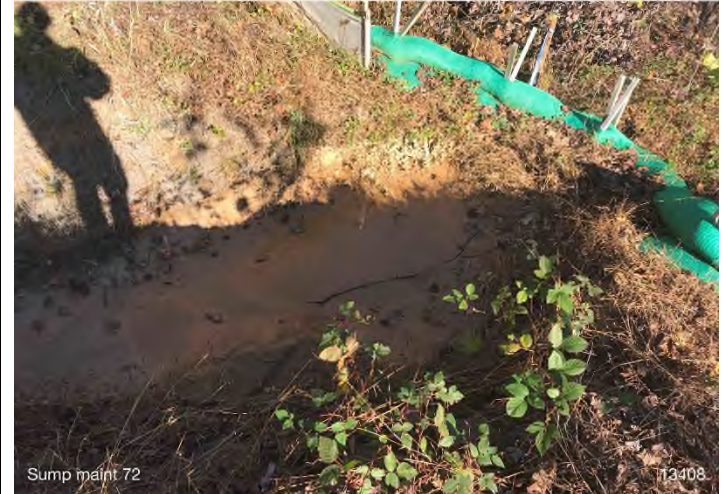
Routine Maintenance: (72-Hour Deadline from Notification)
STA 13408+00: Sump maintenance needed.

Figure 2: STA 13408+00 – Sump maintenance needed.

Recommended Corrective Action: Maintain and install all controls per the approved PSS&S.

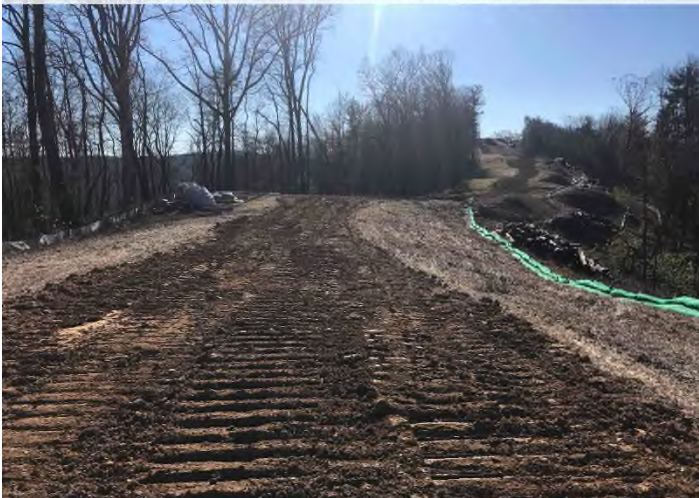
Figure 3: STA 13385+00 – Controls in place and functioning properly. Travel lane active and disturbed.

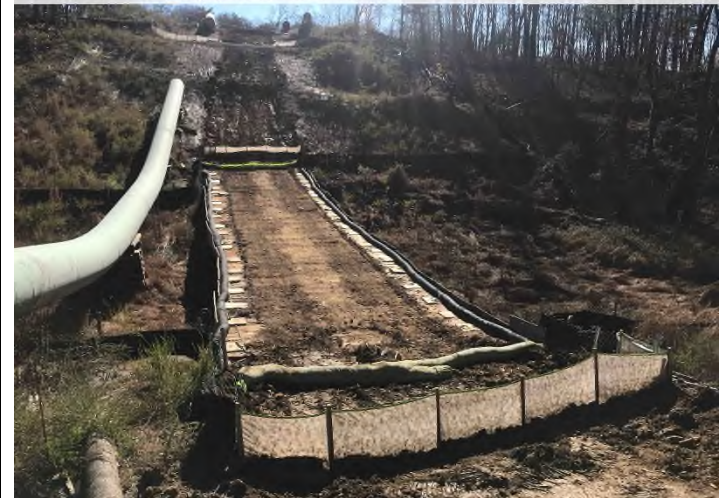
Figure 4: STA 13331+00 – Controls in place and functioning properly. Travel lane active and disturbed
