FIELD INSPECTION REPORT

Project Name:	Mountain Valley Pipeline	Inspector:	Marshall Willis
Inspection Date:	Thursday, November 12, 2020	Project Contact:	Brian Clauto, Cory Chalmers
Spread H: Franklin County	STA 13342+67 – 13316+13	Weather:	Rainy

FIELD INSPECTION PHOTO LOG

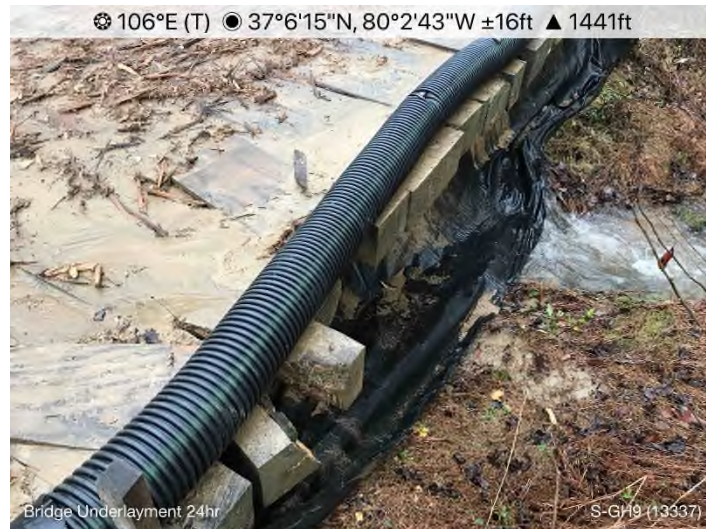
Figure 1: STA 13337+00 – Stream S-GH9 bridge underlayment repair needed.

Recommended Corrective Action: Maintain and install all controls per the approved PSS&S.

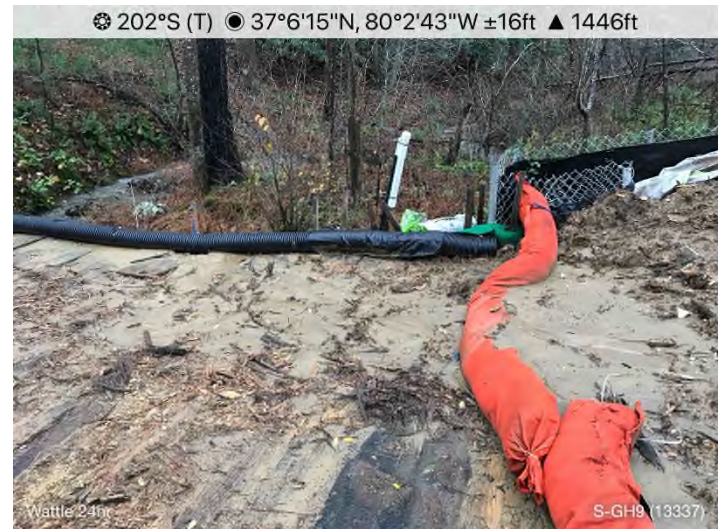
Figure 2: STA 13337+00 – Stream S-GH9 bridge wattle cleanout needed.

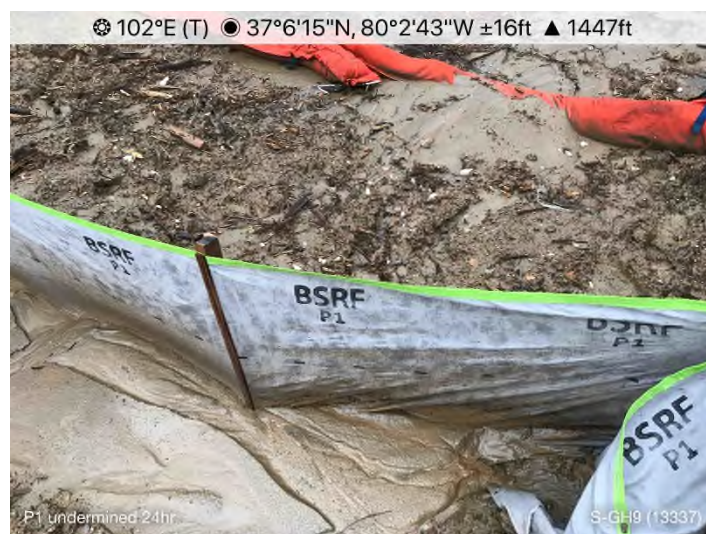
Figure 3: STA 13337+00 – P1 undermined.

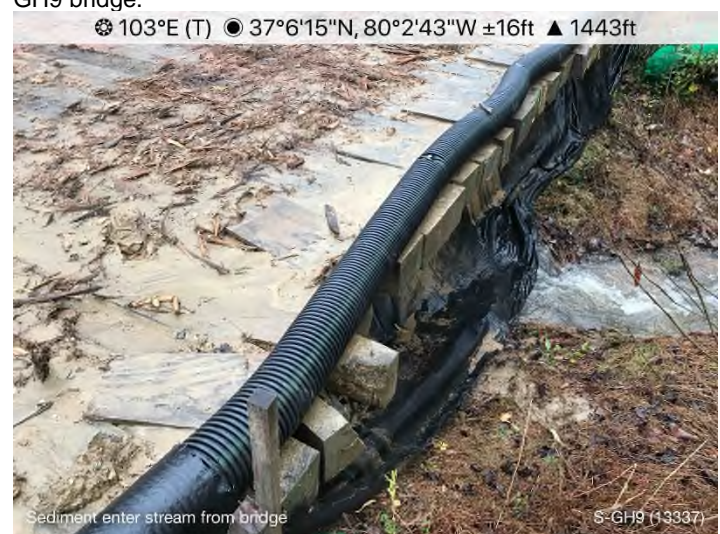
Figure 4: STA 13337+00 – Sediment impacting stream from S-GH9 bridge.

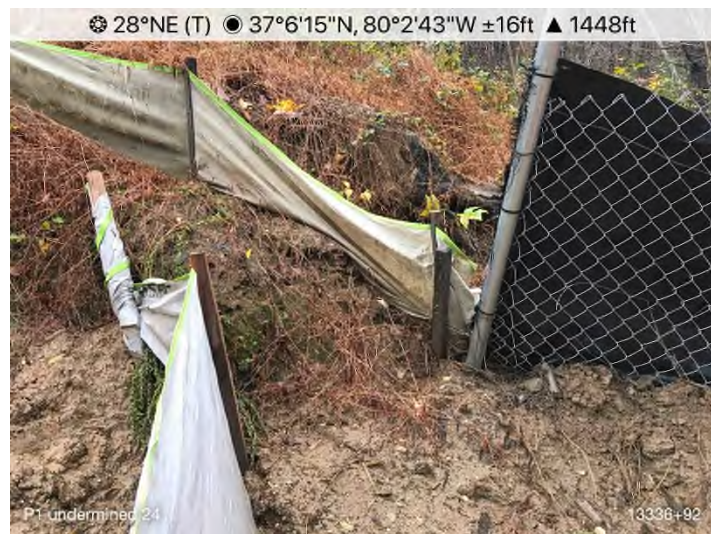
Figure 5: STA 13336+92 – P1 undermined.

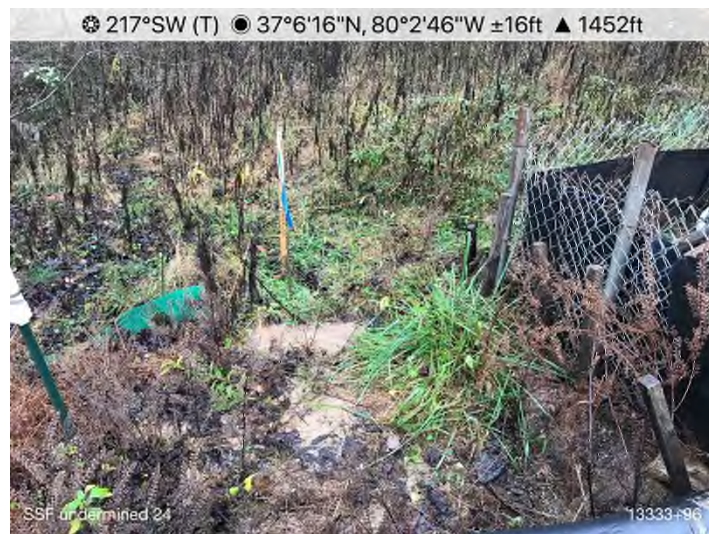
Figure 6: STA 13333+96 – SSF undermined.

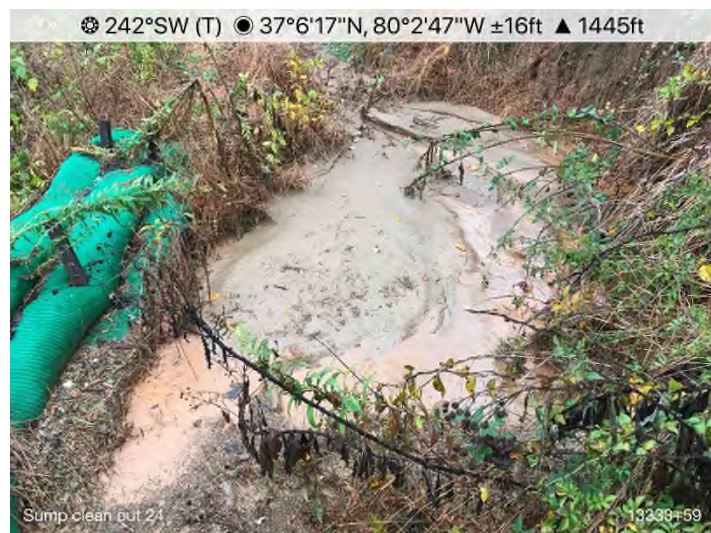
Figure 7: STA 13333+59 – Sump cleanout needed.

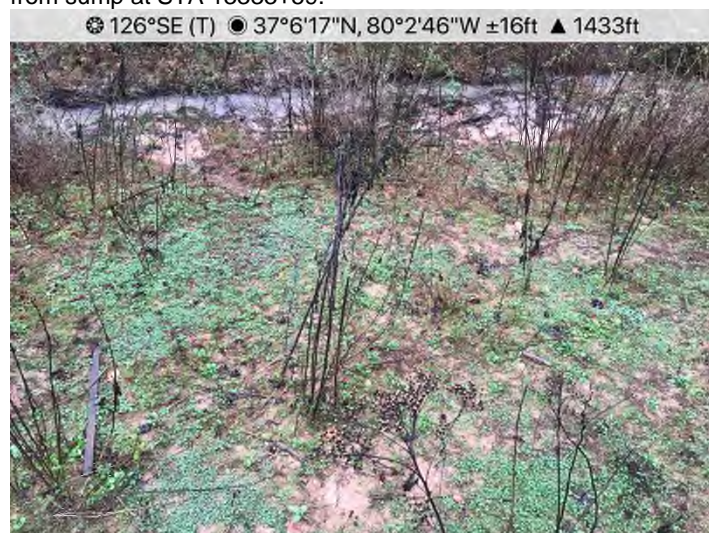
Figure 8: STA 13334+17 – Sediment impacted stream S-GH11 from sump at STA 13333+59.

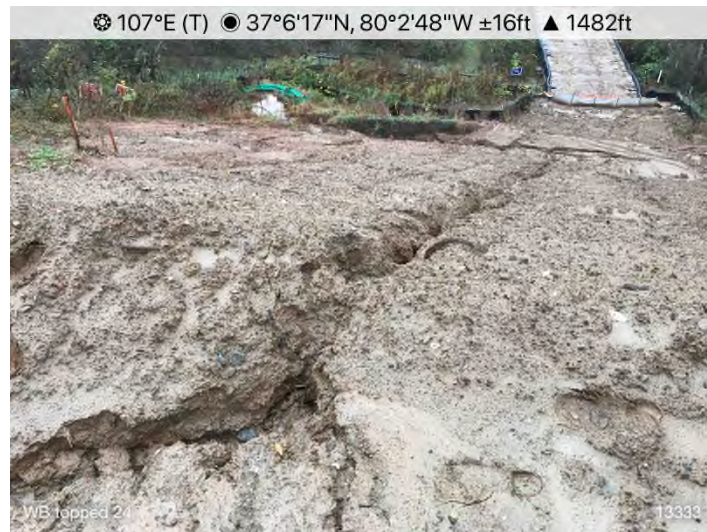
Figure 9: STA 13333+00 – Waterbar overtopped, repair needed.

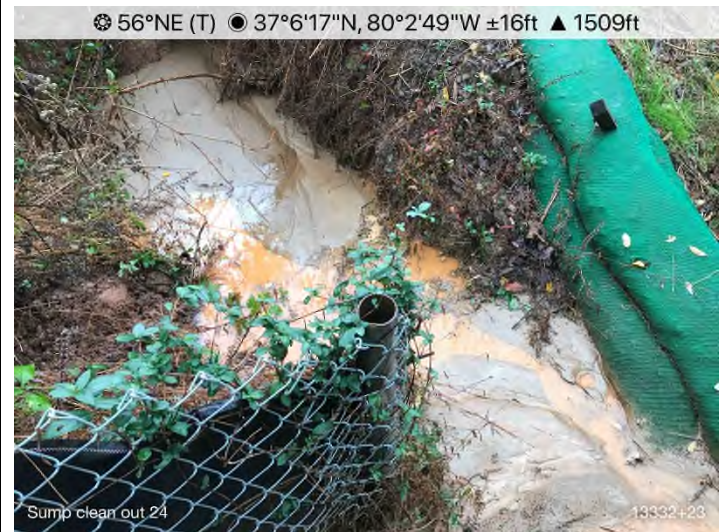
Figure 10: STA 13332+23 – Sump cleanout needed.

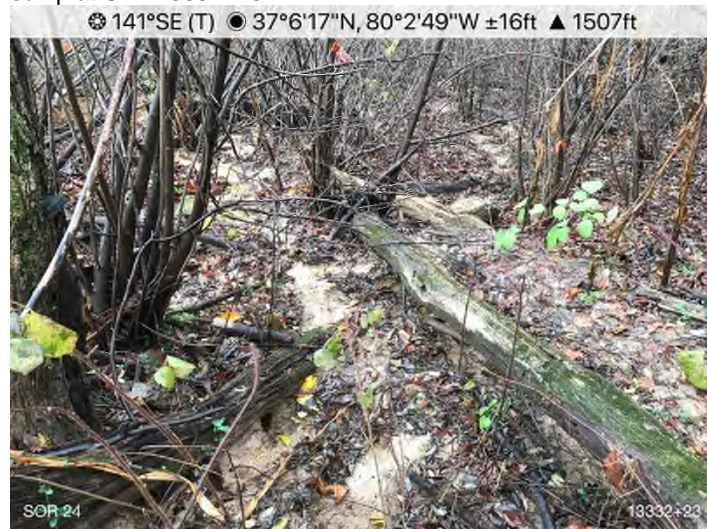
Figure 11: STA 13332+33 – Sediment discharged off ROW from sump at STA 13332+23.

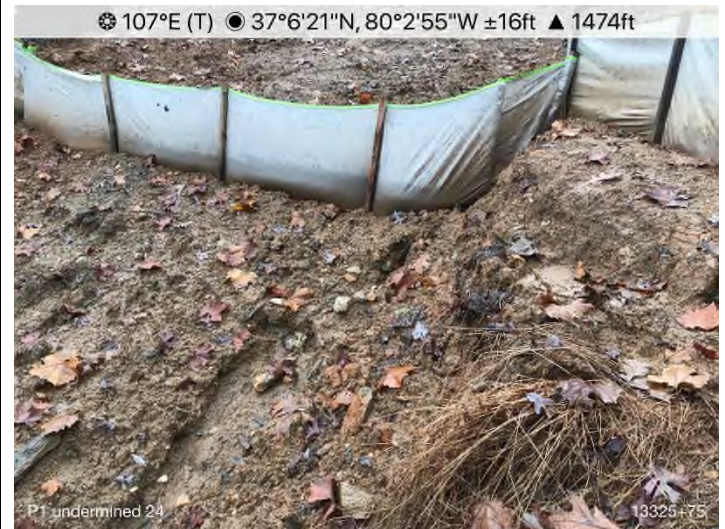
Figure 12: STA 13325+75 – P1 undermined.

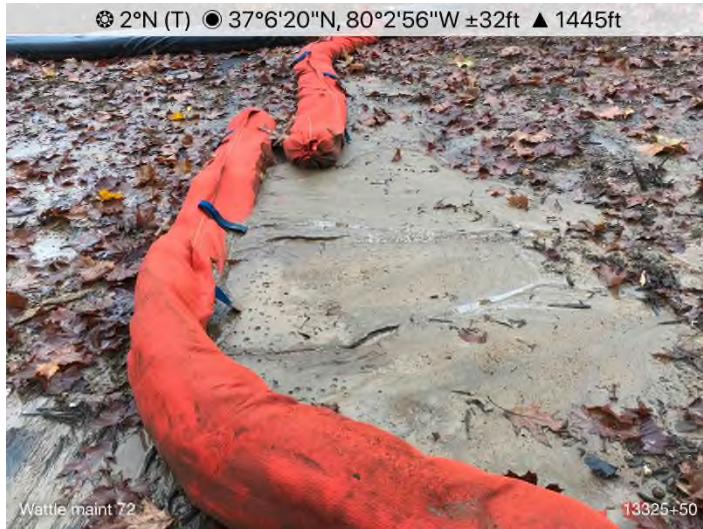
Figure 13: **STA 13325+50** – Stream S-GH11 bridge wattle cleanout needed.
