FIELD INSPECTION REPORT

Project Name:	Mountain Valley Pipeline	Inspector:	Marshall Willis
Inspection Date:	Tuesday, November 10, 2020	Project Contact:	Brian Clauto, Cory Chalmers
Spread H: Roanoke County Franklin County	STA 13113+83 – 13120+00 STA 12960+60 – 12980+75 MVP-FR-291 MVP-RO-288	Weather:	Dry

FIELD INSPECTION PHOTO LOG

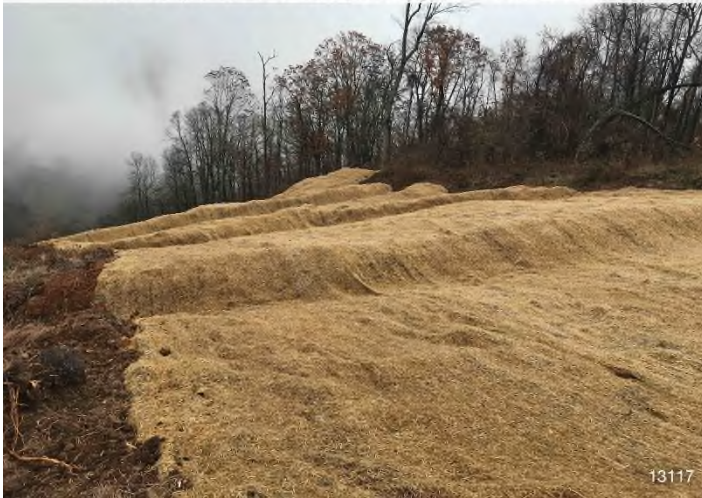
Figure 1: STA 13117+00 – Controls in place and functioning properly. Area stabilized with erosion control matting.

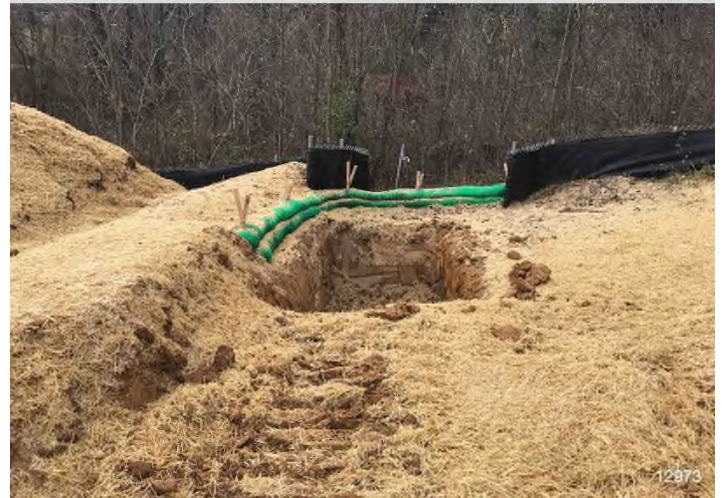
Figure 2: STA 12973+00 – Temp. end-treatments installed properly. Topsoil stockpiles properly stabilized.

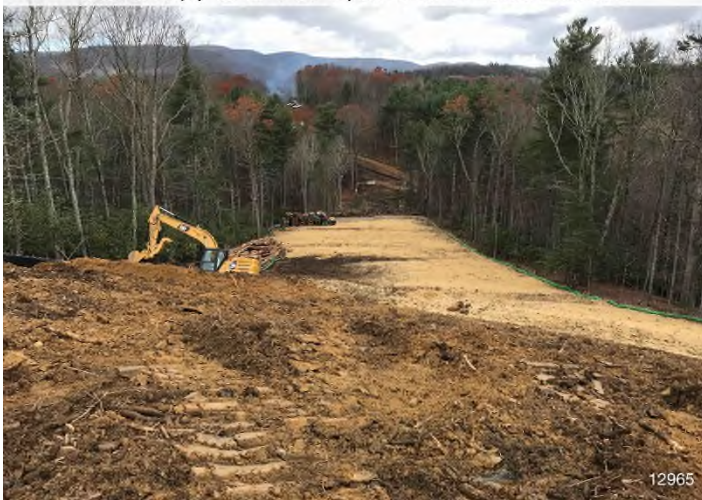
Figure 3: STA 12965+00 – Contractor stripping topsoil and building temp. waterbars. Perimeter controls in place.

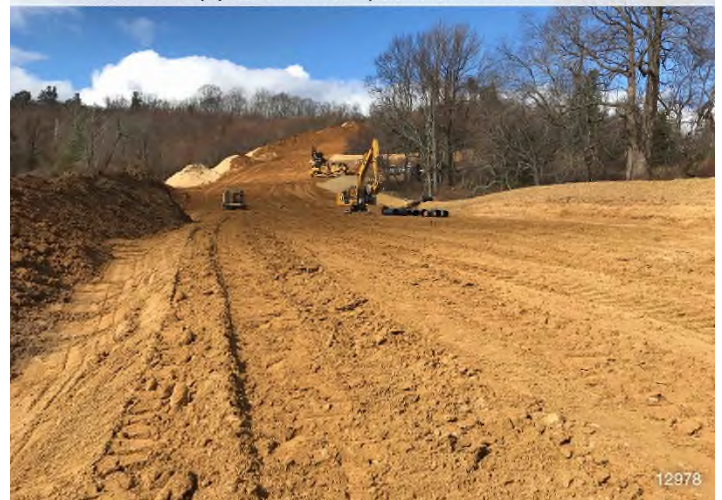
Figure 4: STA 12978+00 – Contractor installing Clean Water Diversion pipe and stabilizing stockpiles.
