## FIELD INSPECTION REPORT

| <b>Project Name:</b> | Mountain Valley Pipeline | <b>Inspector:</b> | Marshall Willis |
| <b>Spread I:<br/>Pittsylvania County</b> | STA 15693+89 – 15741+92<br>STA 15760+91 – 15826+77<br>MVP-PI-338.01 | <b>Weather:</b> | Dry |

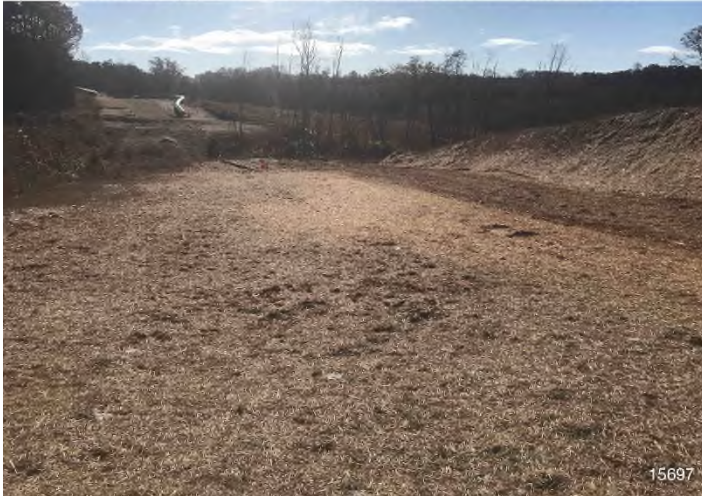
**Figure 1: STA 15697+00** – Controls in place and functioning properly. Area stabilized with straw.

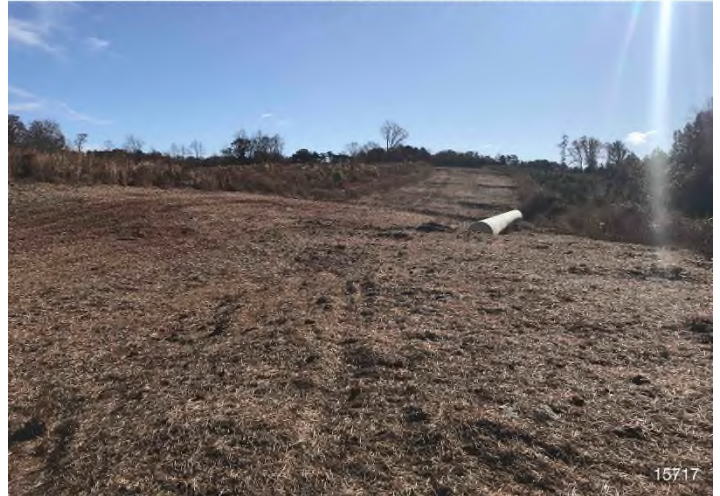
**Figure 2: STA 15717+00** – Controls in place and functioning properly. Area stabilized with straw.

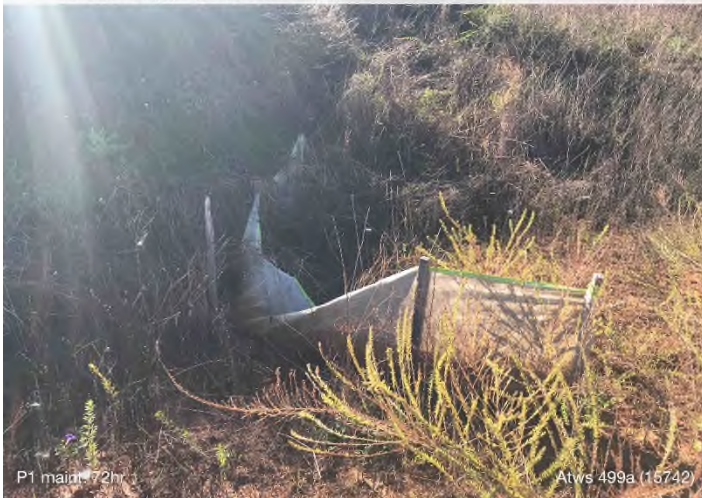
- STA 15742+00: P1 maintenance needed along the south side of ATWS 499A.

**Figure 3: STA 15742+00** – P1 maintenance needed along south side of ATWS 499A.

**Recommended Corrective Action:** Maintain and install all controls per the approved PSS&S.

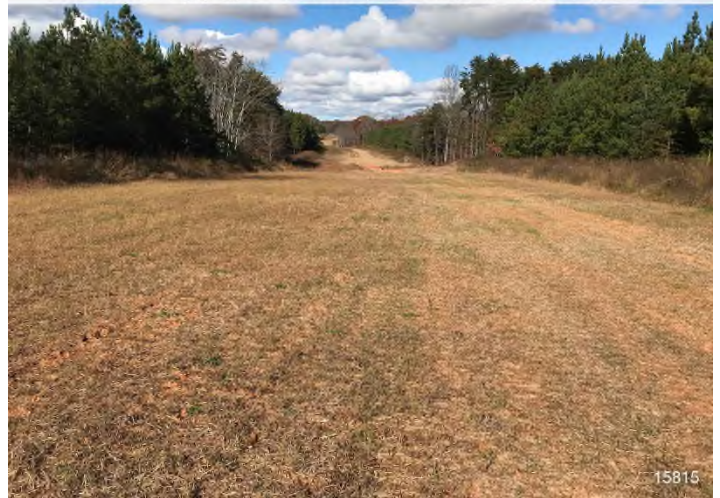
**Figure 4: STA 15815+00** – Controls in place and functioning properly. Area stabilized with straw.
