FIELD INSPECTION REPORT

Project Name:	Mountain Valley Pipeline	Inspector:	Marshall Willis
Inspection Date:	Thursday, November 5, 2020	Project Contact:	Brian Clauto, Cory Chalmers
Spread H: Roanoke County	STA 12807+43 MVP-RO-283 ATWS 1447/1448	Weather:	Dry

FIELD INSPECTION PHOTO LOG

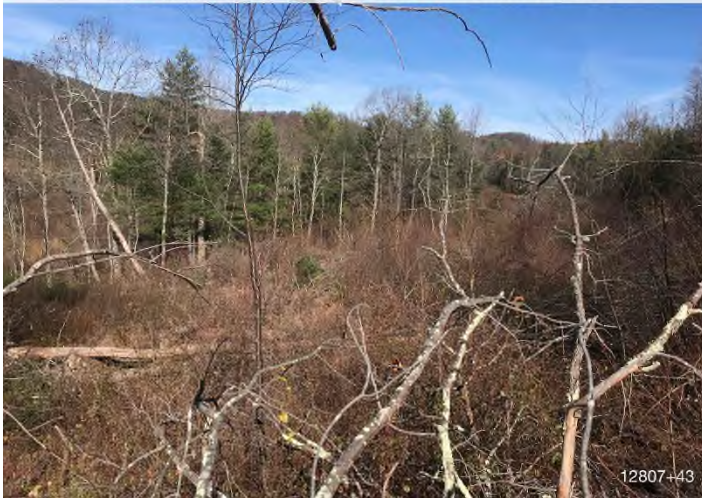
Figure 1: STA 12807+43 – No ground disturbance to date. Trees felled. Looking N down ROW.

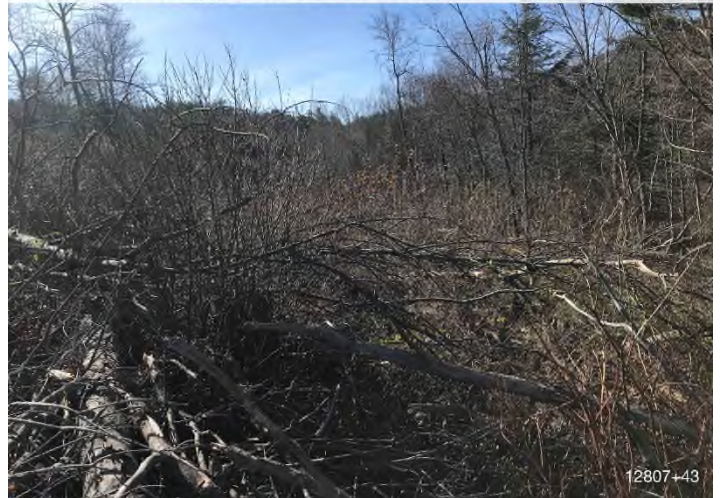
Figure 2: STA 12807+43 – No ground disturbance to date. Trees felled. Looking SW down ROW.

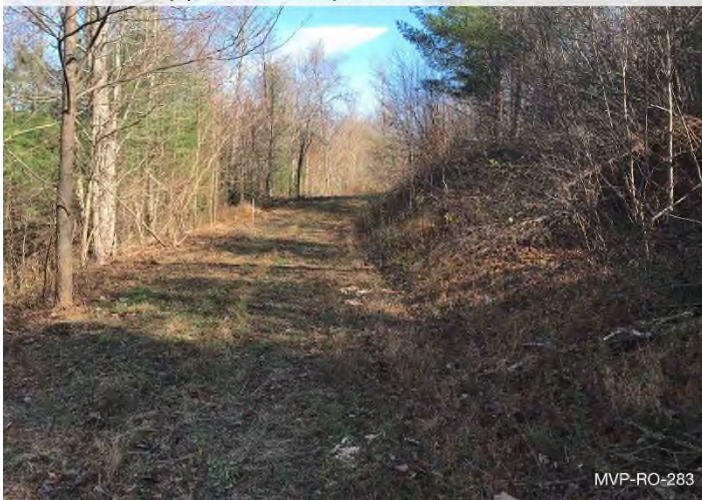
Figure 3: MVP-RO-283 – Access road has not been installed or utilized by construction traffic. No active ground disturbance.

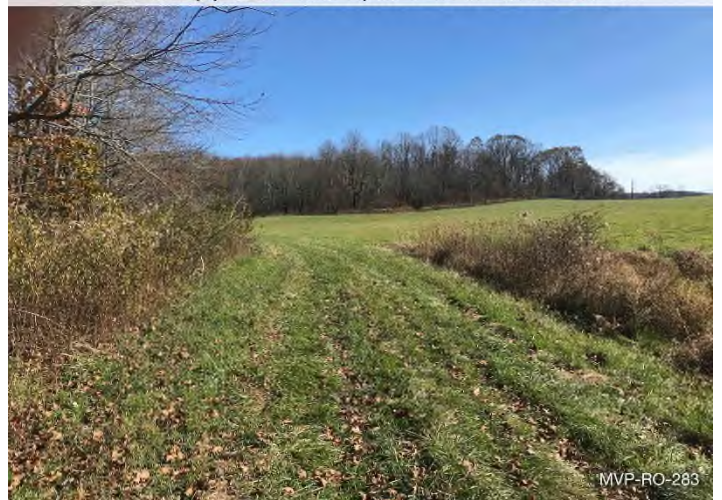
Figure 4: MVP-RO-283 – Access road has not been installed or utilized by construction traffic. No active ground disturbance.
