## FIELD INSPECTION REPORT

| Project Name: | Mountain Valley Pipeline | Inspector: | Marshall Willis |
| Spread H:<br>Montgomery County | STA 12190+85 – 12236+71<br>MVP-MN-276.03 | Weather: | Dry |

## FIELD INSPECTION PHOTO LOG

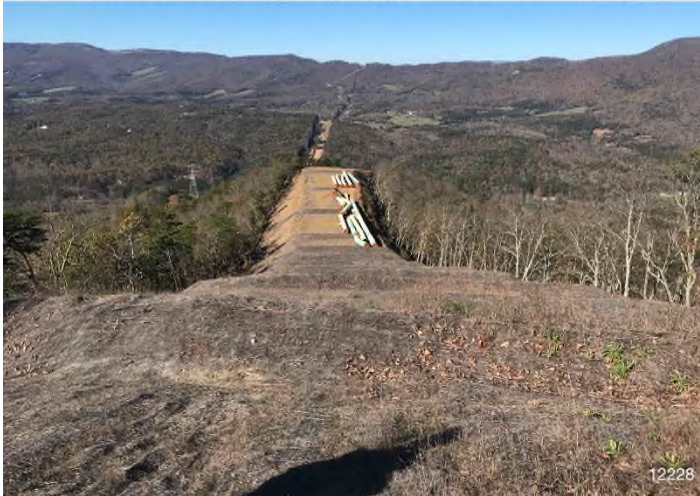
**Figure 1: STA 12228+00** – Controls in place and functioning properly. Area stabilized with straw and erosion matting.

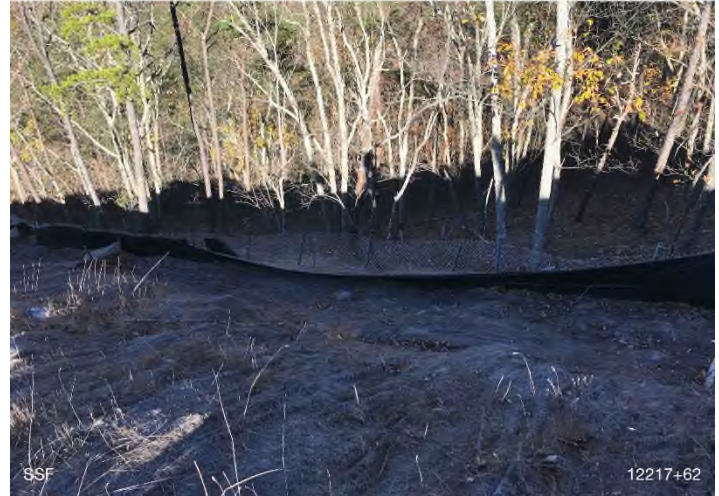
- STA 12217+62: SSF maintenance needed.

**Figure 2: STA 12217+62** – Maintenance needed on SSF.

**Recommended Corrective Action:** Maintain and install all controls per the approved PSS&S.

**Deadline:** Within 72-Hour of Notification

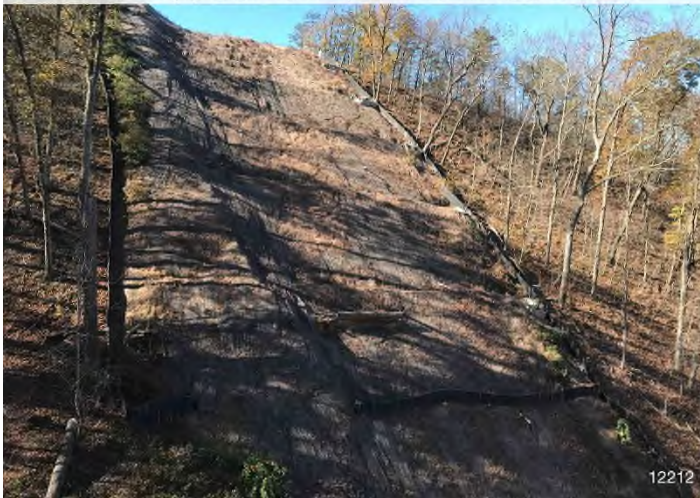
**Figure 3: STA 12212+00** – Controls in place and functioning properly. Area stabilized with straw and erosion matting.

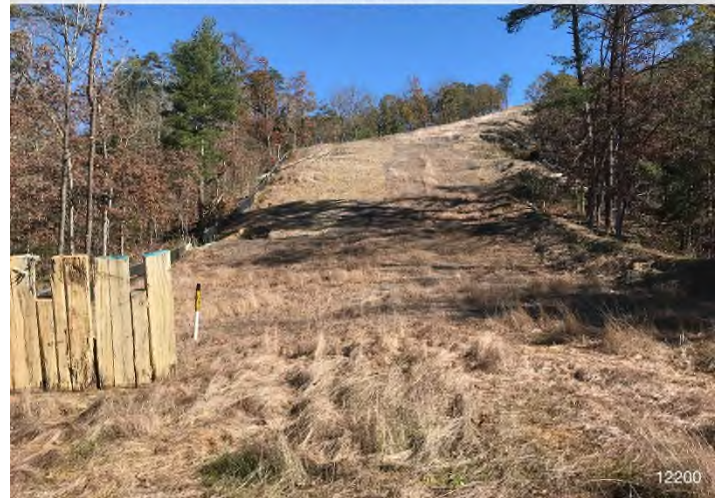
**Figure 4: STA 12200+00** – Controls in place and functioning properly. Area stabilized with straw and erosion matting.
