## FIELD INSPECTION REPORT

| Project Name: | Mountain Valley Pipeline | Inspector: | Marshall Willis |
| Spread I:<br>Franklin County | STA 14649+67 – 14719+41<br>MVP-FR-321 | Weather: | Wet |

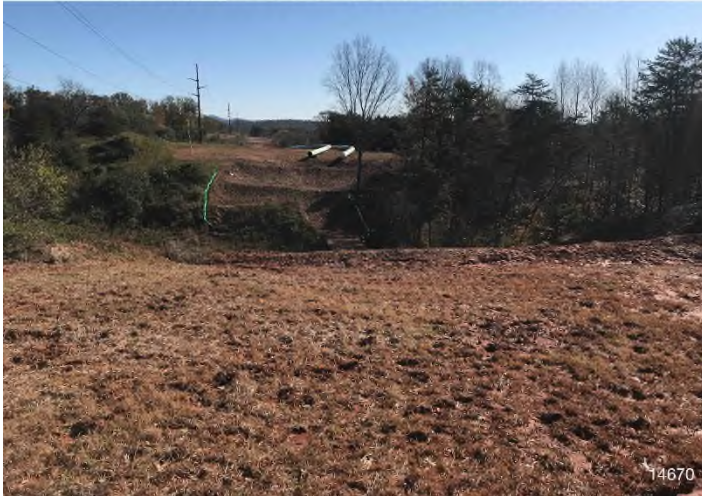
**Figure 1: STA 14670+00** – Controls in place and functioning properly. Area stabilized with straw.

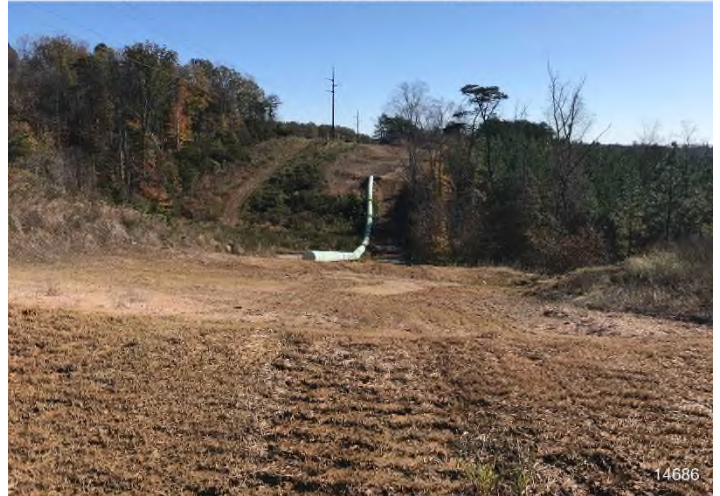
**Figure 2: STA 14686+00** – Controls in place and functioning properly. Area stabilized with straw.

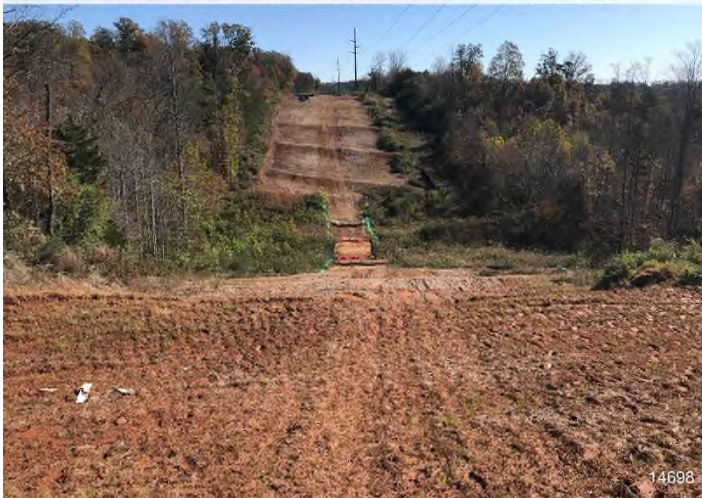
**Figure 3: STA 14698+00** – Controls in place and functioning properly. Area stabilized with straw.

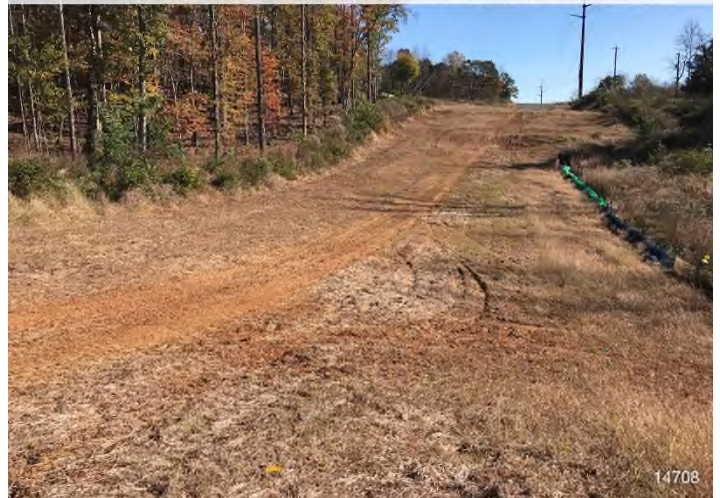
**Figure 4: STA 14708+00** – Controls in place and functioning properly. Area stabilized with straw.
