## FIELD INSPECTION REPORT

| Project Name: | Mountain Valley Pipeline | Inspector: | Marshall Willis |
| Spread I:<br>Franklin County | STA 14333+27 – 14454+22<br>MVP-FR-315 | Weather: | Wet |

## FIELD INSPECTION PHOTO LOG

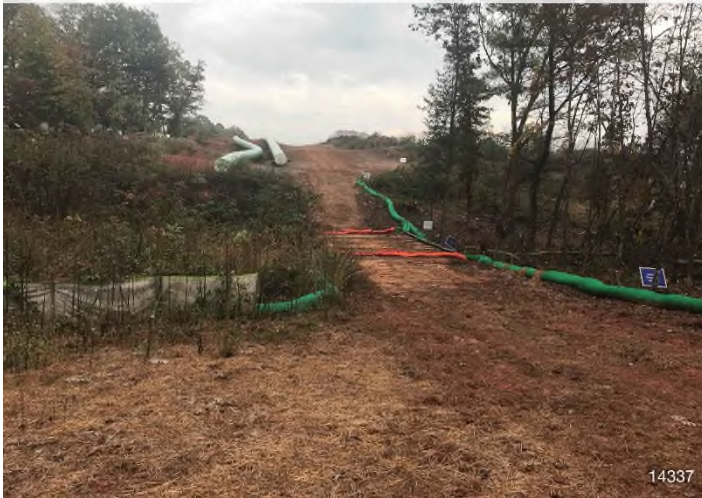
**Figure 1: STA 14337+00** – Controls in place and functioning properly. Area stabilized with straw.

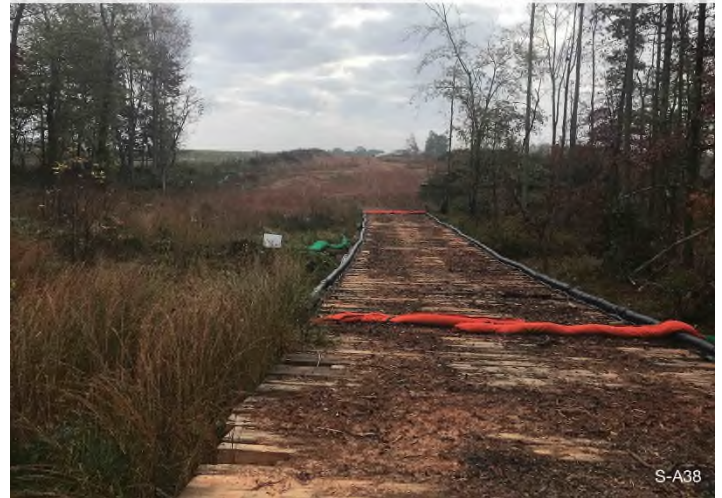
**Figure 2: Stream S-A38** – Controls in place and functioning properly around S-A38 crossing.

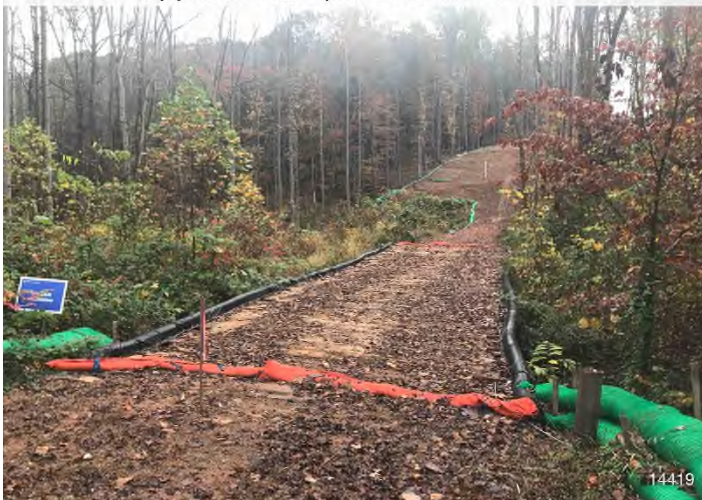
**Figure 3: STA 14419+00** – Controls in place and functioning properly.

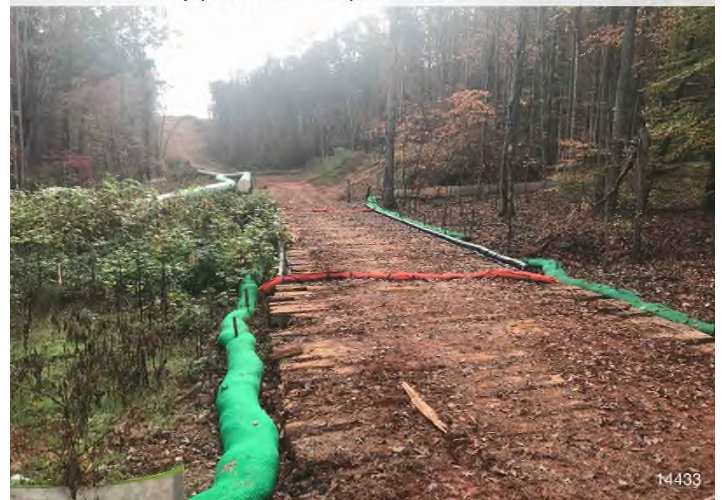
**Figure 4: STA 14433+00** – Controls in place and functioning properly.
