## FIELD INSPECTION REPORT

| Project Name: | Mountain Valley Pipeline | Inspector: | Marshall Willis |
| Inspection Date: | Thursday, October 22, 2020 | Project Contact: | Brian Clauto, Cory Chalmers |
| Spread I:<br>Franklin County | STA 14333+27 – 14441+04<br>MVP-FR-315 | Weather: | Dry |

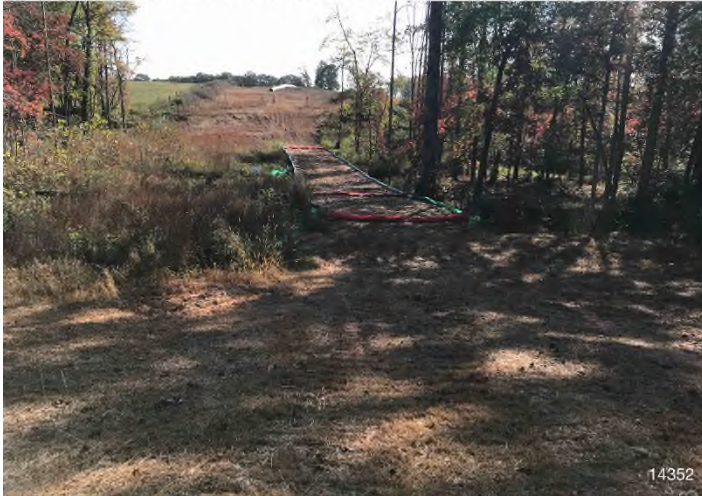
**Figure 1: STA 14352+00** – Controls in place and functioning properly. Area stabilized with straw.

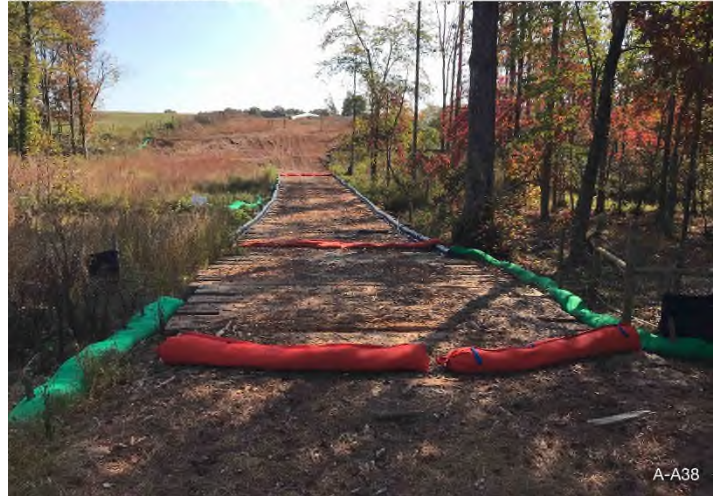
**Figure 2: Stream S-A38** – Controls in place and functioning properly around S-A38 crossing.

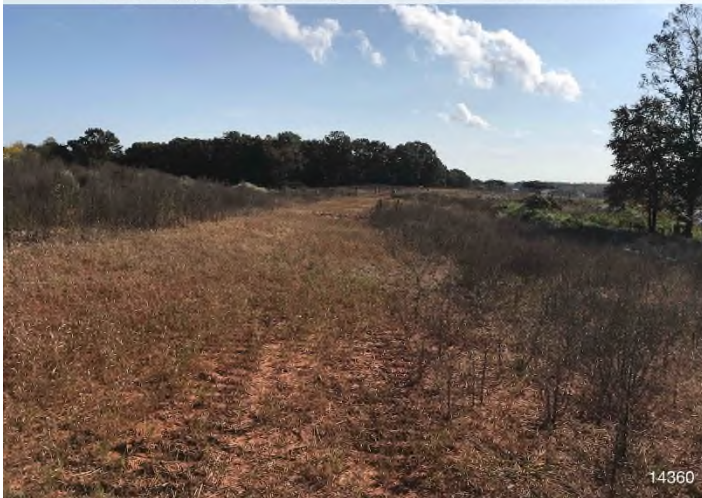
**Figure 3: STRA 14360+00** – Controls in place and functioning properly. Area stabilized with straw.

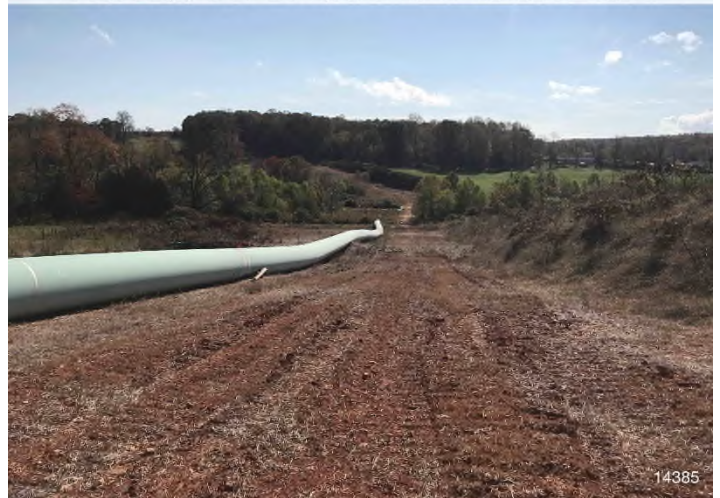
**Figure 4: STRA 14385+00** – Controls in place and functioning properly. Area stabilized with straw.
