## FIELD INSPECTION REPORT

| <b>Project Name:</b> | Mountain Valley Pipeline | <b>Inspector:</b> | Marshall Willis |
| <b>Inspection Date:</b> | Tuesday, December 22, 2020 | <b>Project Contact:</b> | Brian Clauto, Cory Chalmers |

## FIELD INSPECTION PHOTO LOG

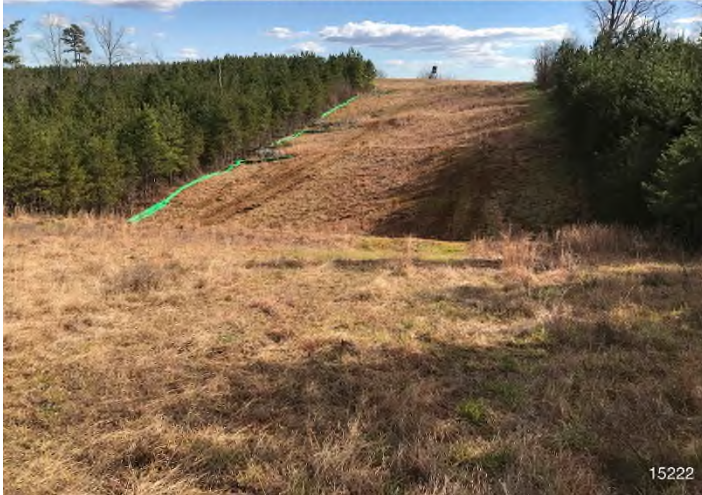
**Figure 1: STA 15222+00** – Controls in place functioning properly. Area stabilized with straw.

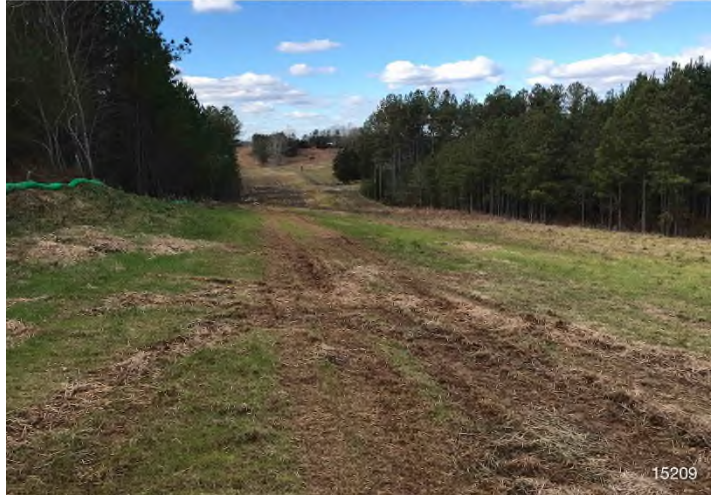
**Figure 2: STA 15209+00** – Controls in place functioning properly. Area stabilized with straw.

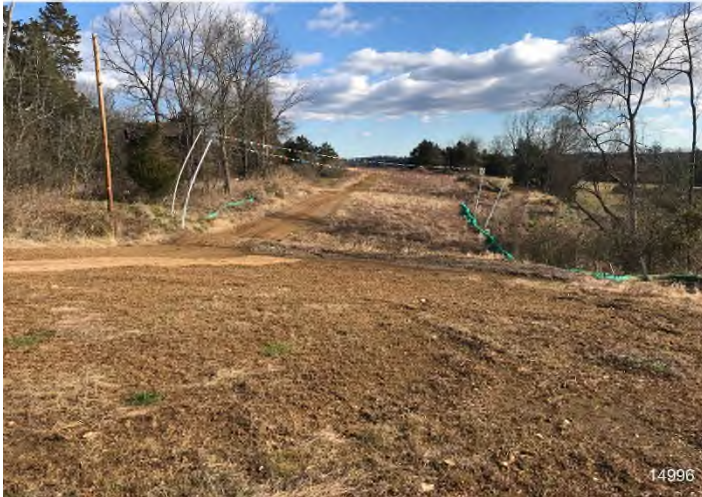
**Figure 3: STA 14996+00** – Controls in place functioning properly. Area stabilized with straw.

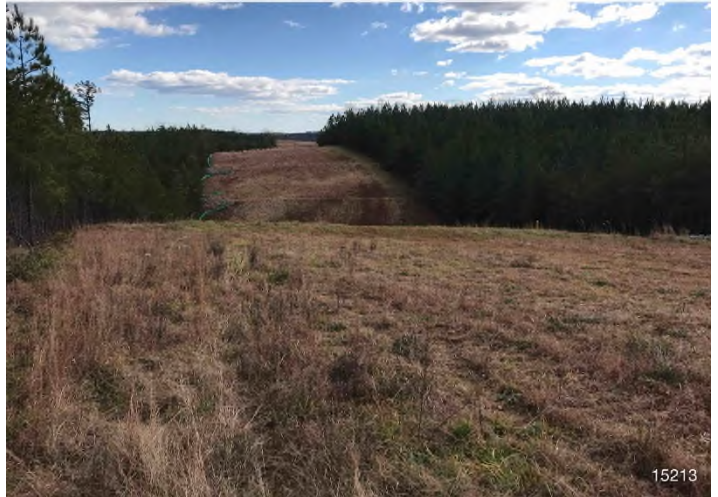
**Figure 4: STA 15213+00** – Controls in place functioning properly. Area stabilized with straw.
