## FIELD INSPECTION REPORT

Project Name:	Mountain Valley Pipeline	Inspector:	Marshall Willis
Inspection Date:	Monday, December 21, 2020	Project Contact:	Brian Clauto, Cory Chalmers
Spread H: Montgomery County	STA 12445+19 – 12487+50 MVP-MLV-AR-28	Weather:	Wet

## FIELD INSPECTION PHOTO LOG

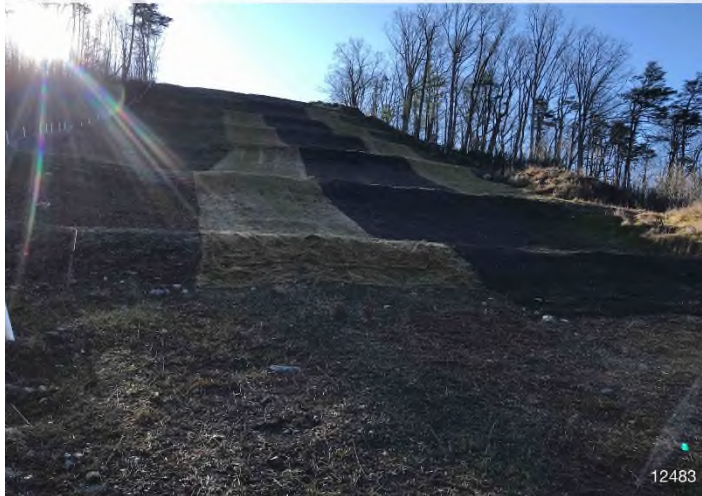
**Figure 1: STA 12483+00** – Controls in place functioning properly. Area stabilized with straw and erosion matting.

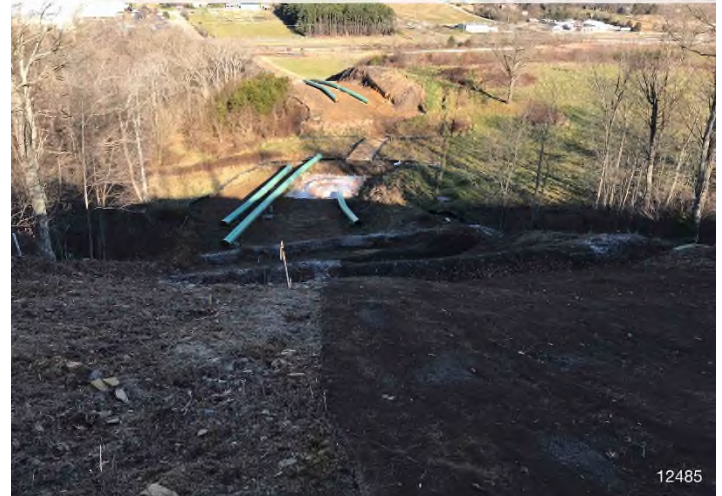
**Figure 2: STA 12485+00** – Controls in place functioning properly. Area stabilized with straw and erosion matting.

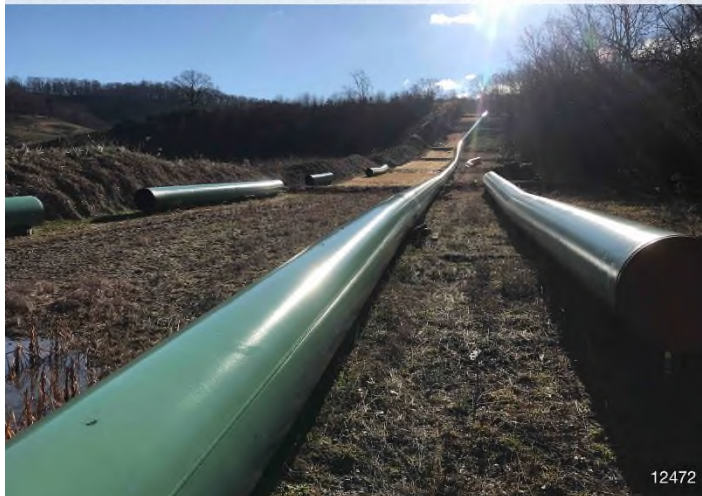
**Figure 3: STA 12472+00** – Controls in place functioning properly. Area stabilized with straw and erosion matting.

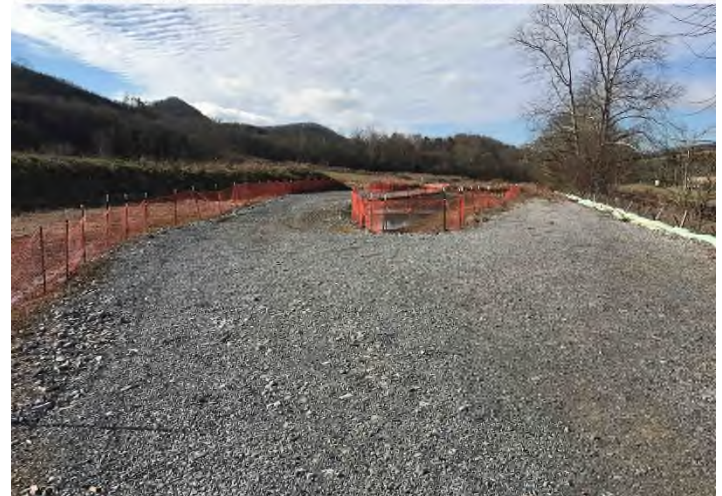
**Figure 4: MVP-MLV-AR-28** – Controls in place functioning properly along access road.
