FIELD INSPECTION REPORT

Project Name:	Mountain Valley Pipeline	Inspector:	Marshall Willis
Inspection Date:	Friday, December 18, 2020	Project Contact:	Brian Clauto, Cory Chalmers
Spread H: Montgomery County	STA 12119+17 – 12155+00 MVP-MN-272/273	Weather:	Dry

FIELD INSPECTION PHOTO LOG

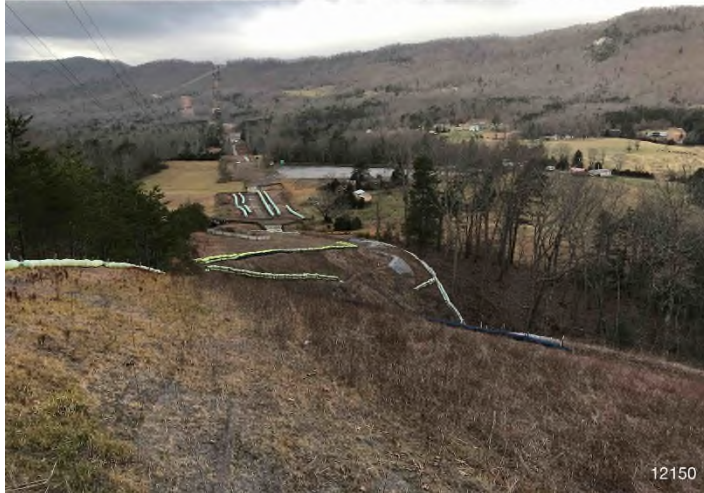
Figure 1: STA 12150+00 – Controls in place functioning properly. Area stabilized with straw.

BRG: 294°NW (T) LAT: 37.254928 LON: -80.272211 ±16ft ALT: 1534ft

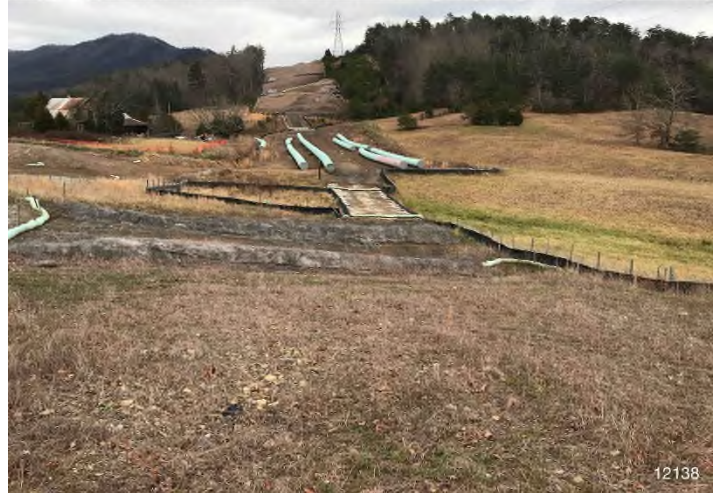
Figure 2: STA 12138+00 – Controls in place functioning properly. Area stabilized with straw.

BRG: 116°SE (T) LAT: 37.257680 LON: -80.276356 ±1686ft ALT: 1427ft

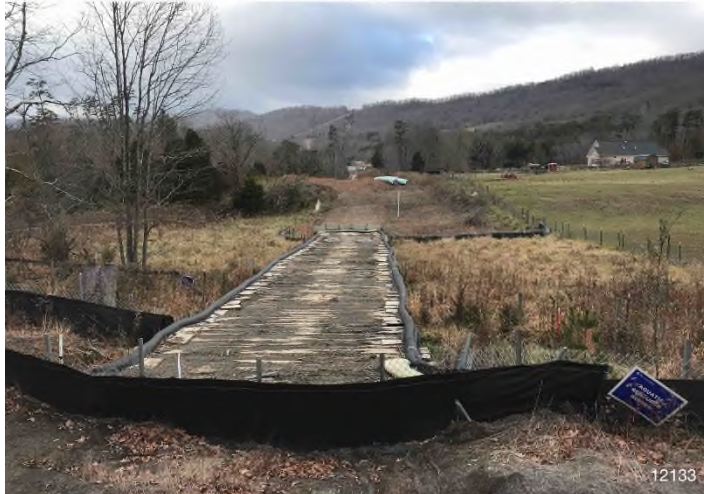
Figure 3: STA 12133+00 – Controls in place functioning properly. Area stabilized with straw.

BRG: 286°W (T) LAT: 37.256431 LON: -80.277685 ±98ft ALT: 1430ft

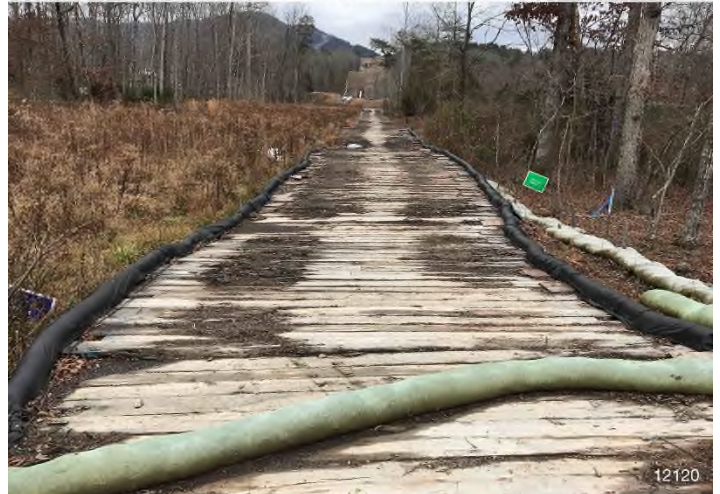
Figure 4: STA 12120+00 – Controls in place functioning properly.

BRG: 84°E (T) LAT: 37.257264 LON: -80.282002 ±16ft ALT: 1442ft
