FIELD INSPECTION REPORT

Project Name:	Mountain Valley Pipeline	Inspector:	Marshall Willis
Inspection Date:	Thursday, December 17, 2020	Project Contact:	Brian Clauto, Cory Chalmers
Spread I: Franklin County	STA 13690+91 – 13748+05 STA 13811+81 – 13840+00 MVP-FR-302	Weather:	Wet

FIELD INSPECTION PHOTO LOG

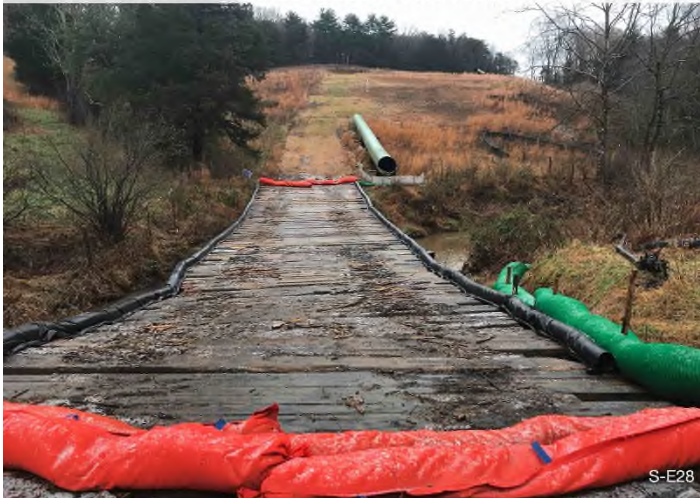
Figure 1: Stream S-E28 – Controls in place functioning properly around S-E28 crossing

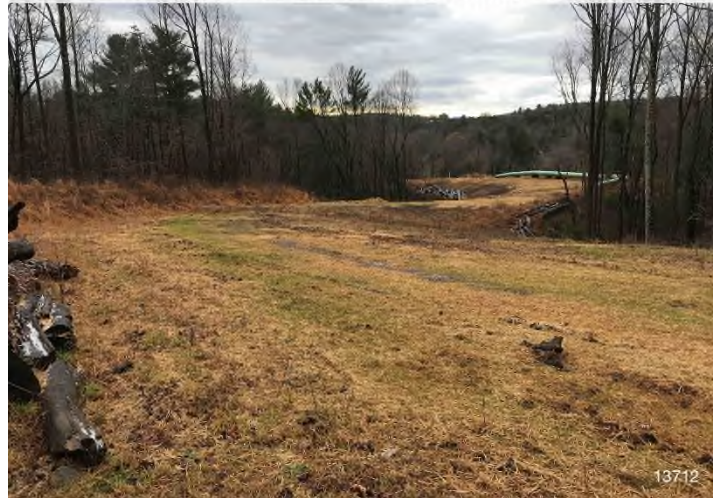
Figure 2: STA 13712+00 – Controls in place functioning properly. Area stabilized with straw.

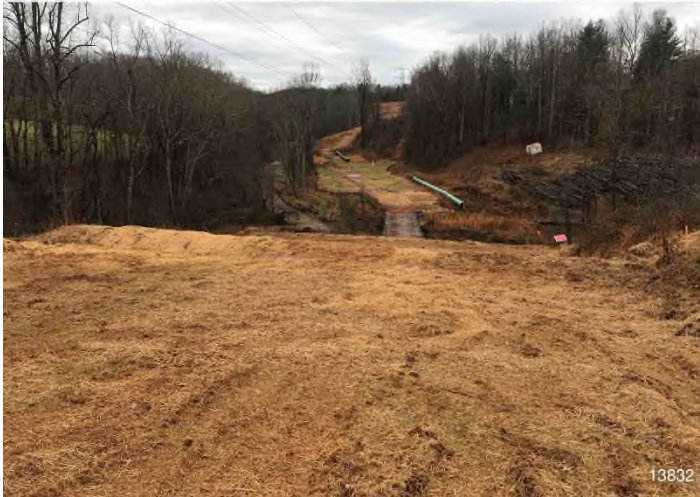
Figure 3: STA 13832+00 – Controls in place functioning properly. Area stabilized with straw.

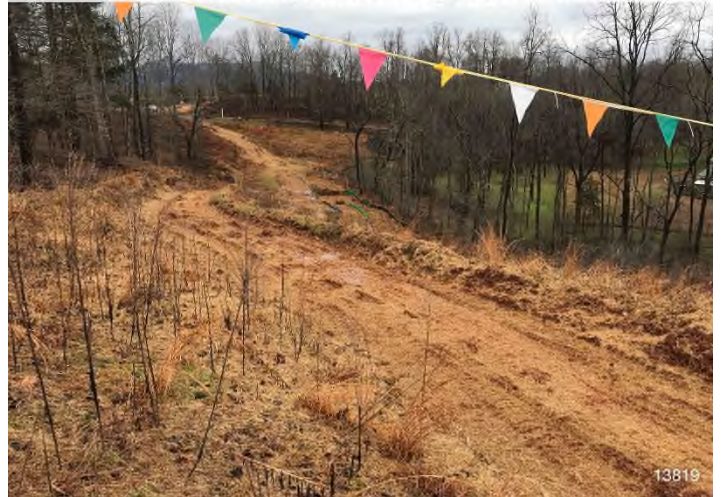
Figure 4: STA 13819+00 – Controls in place functioning properly. Area stabilized with straw.
