## FIELD INSPECTION REPORT

| Project Name: | Mountain Valley Pipeline | Inspector: | Marshall Willis |
| Inspection Date: | Tuesday, December 15, 2020 | Project Contact: | Brian Clauto, Cory Chalmers |

## FIELD INSPECTION PHOTO LOG

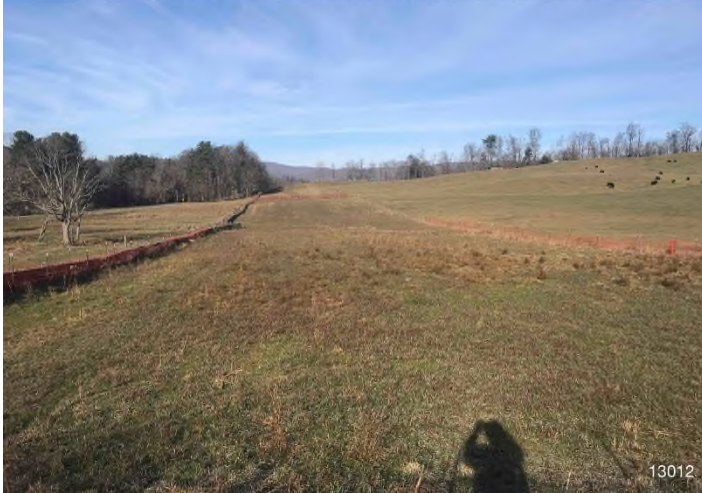
**Figure 1: STA 13012+00** – Controls in place functioning properly.  
 ☼ 330°NW (T) ● 37°7'33"N, 80°7'31"W ±32ft ▲ 2735ft

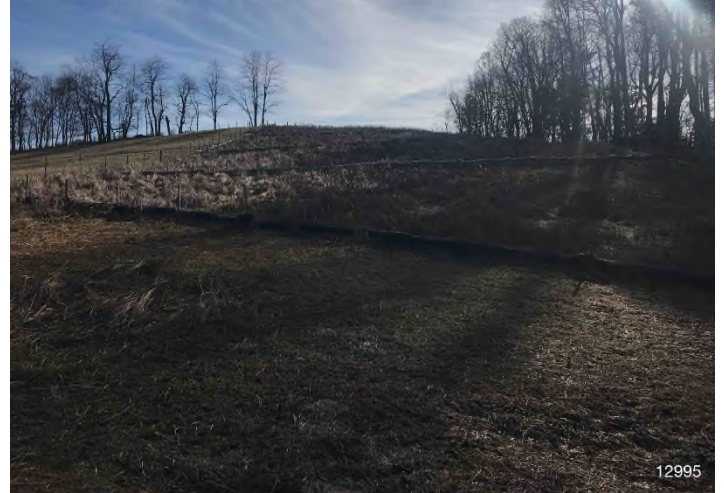
**Figure 2: STA 12995+00** – Controls in place functioning properly.  
 ☼ 126°SE (T) ● 37°7'43"N, 80°7'47"W ±16ft ▲ 2665ft

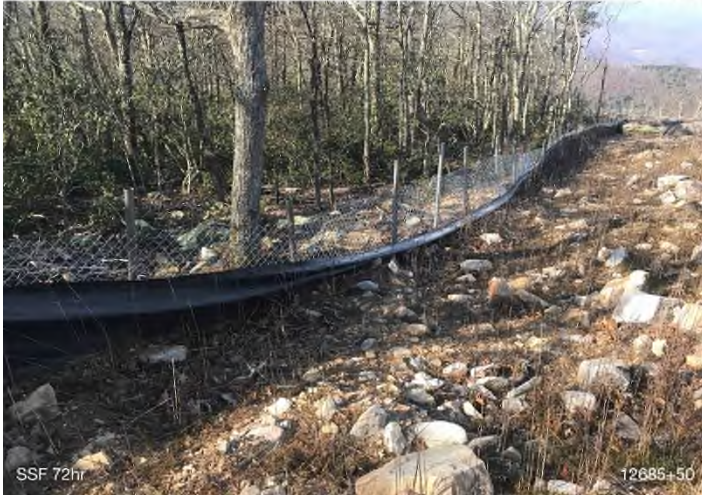
- STA 12685+50: SSF maintenance needed.

**Figure 3: STA 12685+50** – SSF maintenance needed.

**Recommended Corrective Action:** Maintain and install all controls per the approved PSS&S.

**Deadline:** Within 72-Hour of Notification

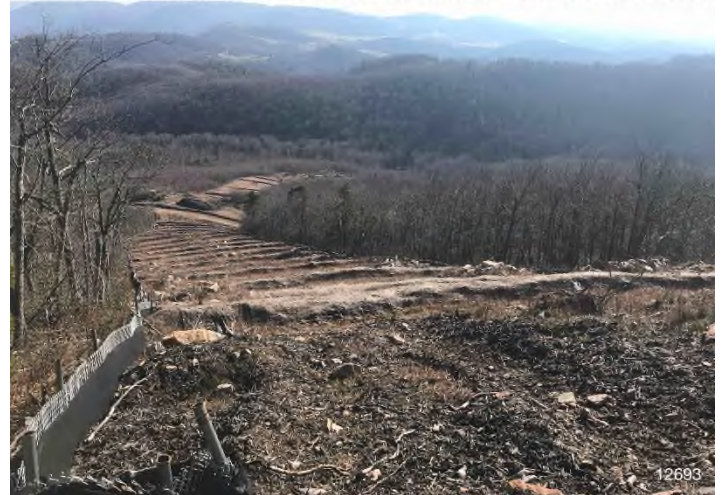
**Figure 4: STA 12693+00** – Controls in place and functioning properly.
