FIELD INSPECTION REPORT

Project Name:	Mountain Valley Pipeline	Inspector:	Marshall Willis
Inspection Date:	Friday, December 11, 2020	Project Contact:	Brian Clauto, Cory Chalmers
Spread H: Roanoke County	STA 12960+00 – 12981+86 MVP-RO-288/281	Weather:	Dry

FIELD INSPECTION PHOTO LOG

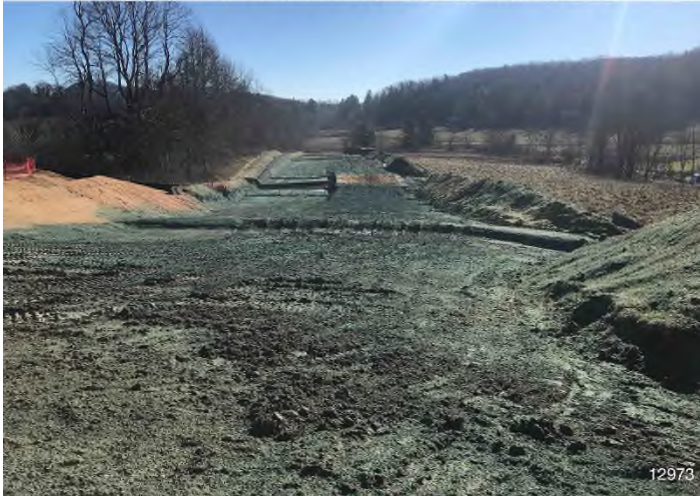
Figure 1: STA 12973+00 – Controls in place functioning properly. Area stabilized with Earth-Guard.

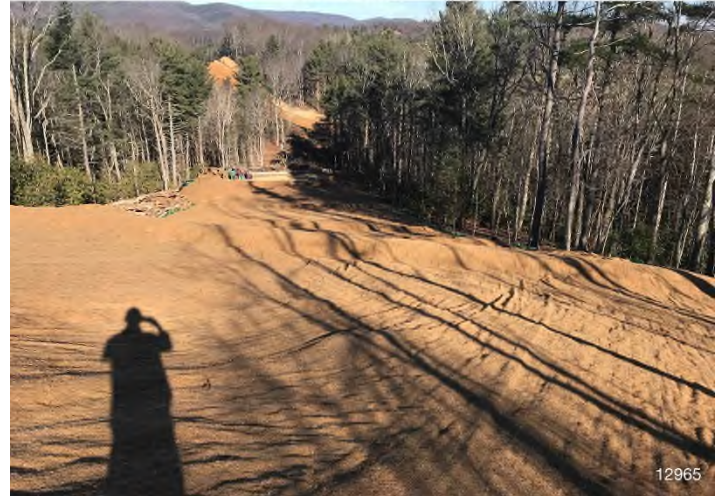
Figure 2: STA 12965+00 – Controls in place functioning properly. Area stabilized with erosion control matting.

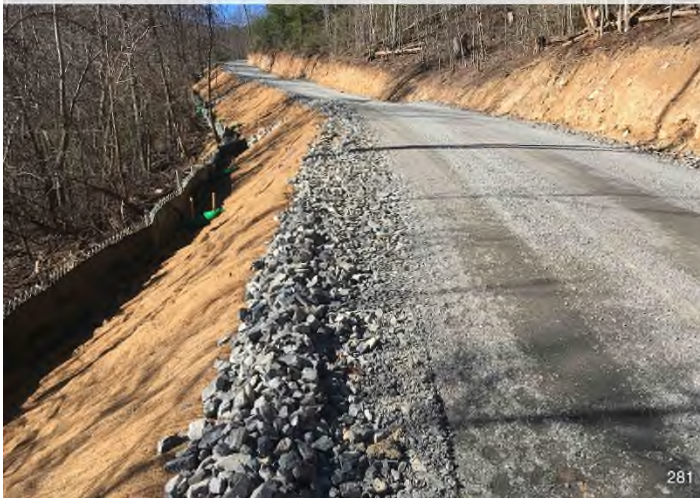
Figure 3: MVP-RO-281 – Controls in place and functioning properly. Contractor installing access road.

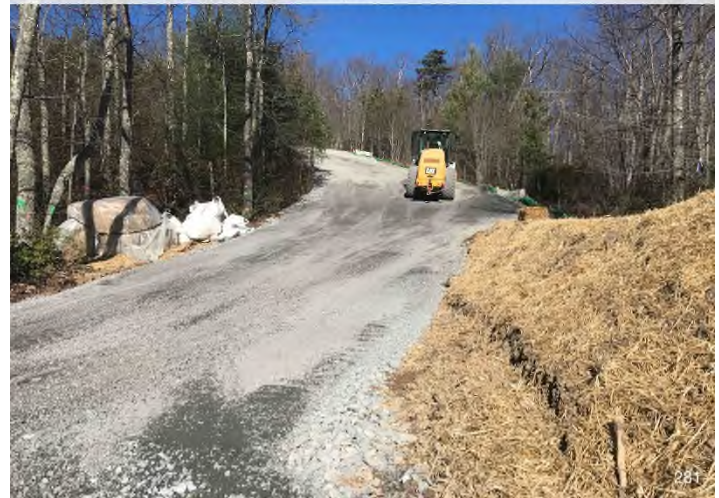
Figure 4: MVP-RO-281 – Controls in place and functioning properly. Contractor installing access road.
