FIELD INSPECTION REPORT

Project Name:	Mountain Valley Pipeline	Inspector:	Marshall Willis
Inspection Date:	Thursday, December 10, 2020	Project Contact:	Brian Clauto, Cory Chalmers
Spread I: Franklin County	STA 13541+66 – 13575+21 STA 13632+00 – 13645+00 ATWS 1416/1417/1067	Weather:	Dry

FIELD INSPECTION PHOTO LOG

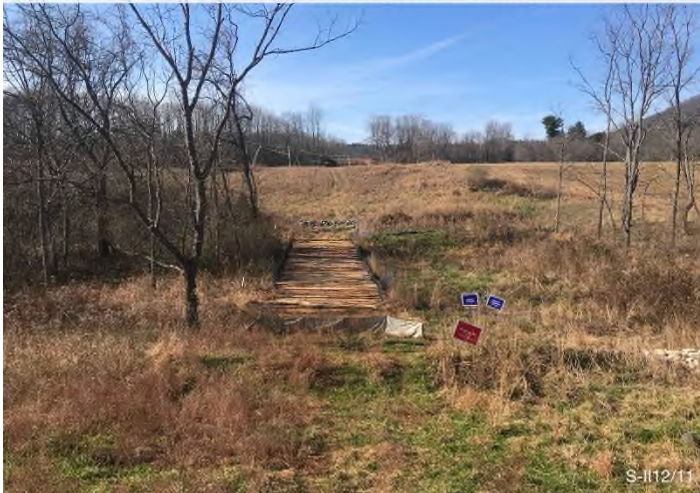
Figure 1: Stream S-II12/11 – Controls in place functioning properly around stream crossings.

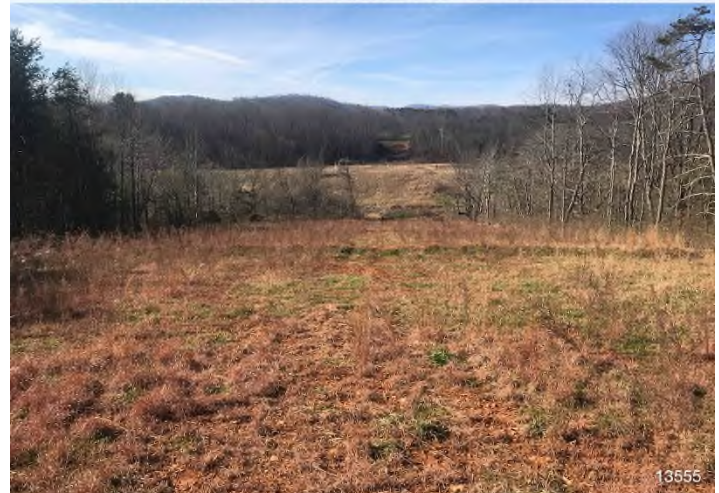
Figure 2: STA 13555+00 – Controls in place functioning properly.

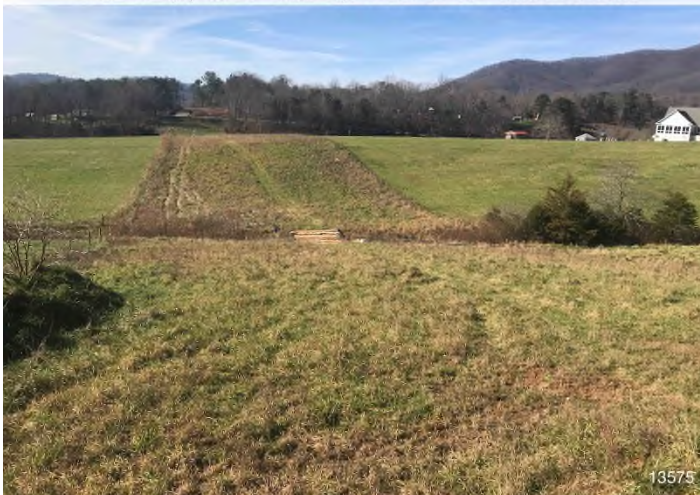
Figure 3: STA 13575+00 – Controls in place functioning properly.

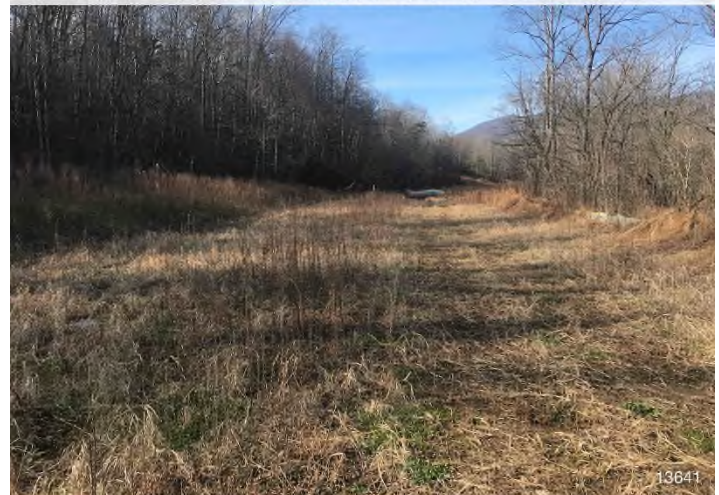
Figure 4: STA 13641+00 – Controls in place functioning properly.
