FIELD INSPECTION REPORT

Project Name:	Mountain Valley Pipeline	Inspector:	Marshall Willis
Inspection Date:	Wednesday, December 9, 2020	Project Contact:	Brian Clauto, Cory Chalmers
Spread I: Pittsylvania County	STA 15496+70 – 15619+48 ATWS 820/819/813/1445	Weather:	Dry

FIELD INSPECTION PHOTO LOG

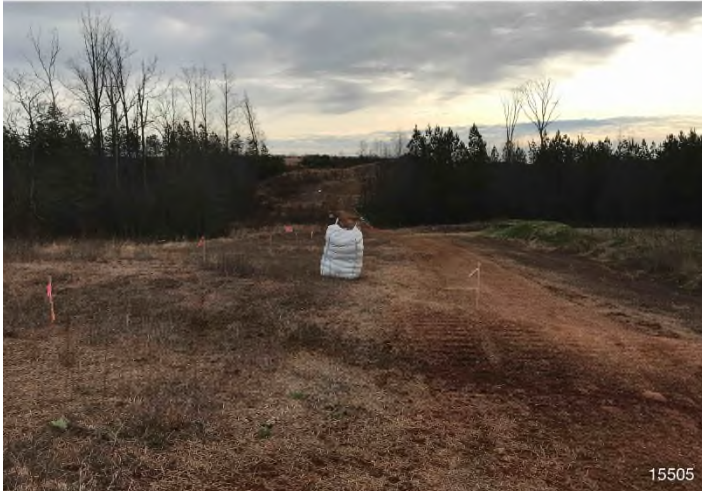
15505

Figure 1: STA 15505+00 – Controls in place functioning properly. Area stabilized with straw.

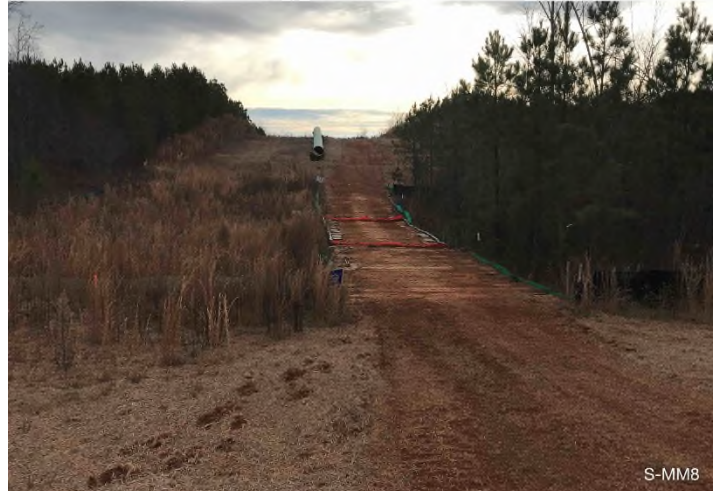
Figure 2: Stream S-MM8 – Controls in place functioning properly around stream S-MM8.

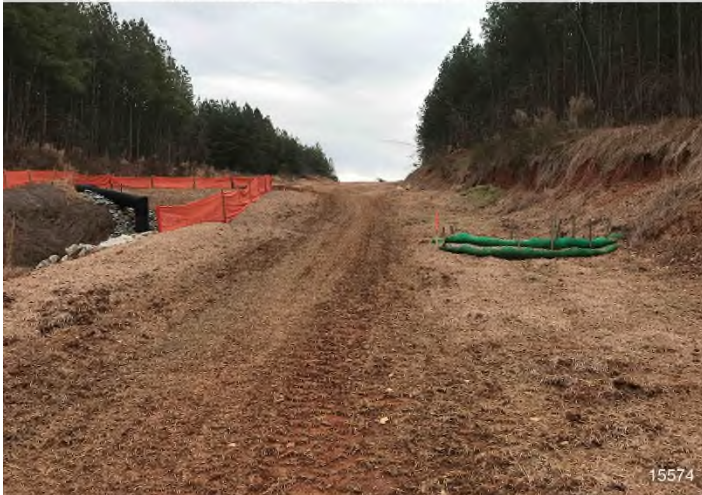
15574

Figure 3: STA 15574+00 – Controls in place functioning properly. Area stabilized with straw.

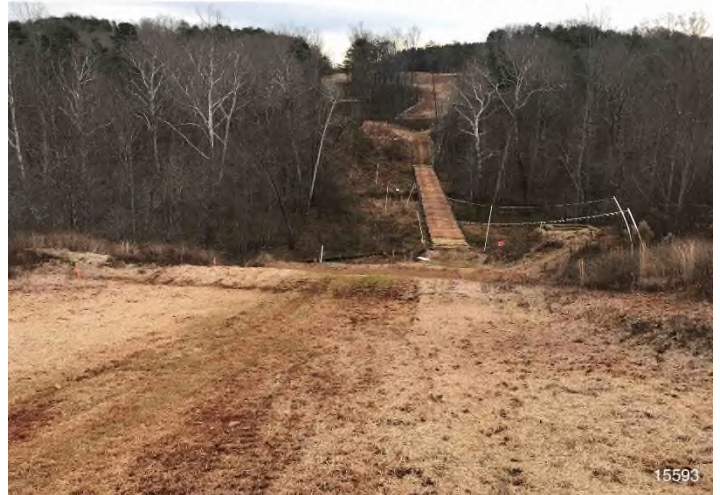
15593

Figure 4: STA 15593+00 – Controls in place functioning properly. Area stabilized with straw.
