## FIELD INSPECTION REPORT

| <b>Project Name:</b> | Mountain Valley Pipeline | <b>Inspector:</b> | Matthew Grant |
| <b>Spread I: Pittsylvania</b> | ST 15584+33- 15619+48<br>ATWS 813, 1445 | <b>Weather:</b> | Dry |

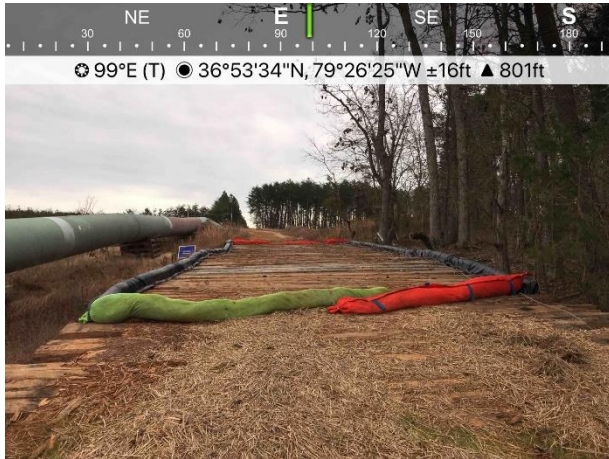
- Figure 1: Designated crossing S-PP5, ESC's are in place.

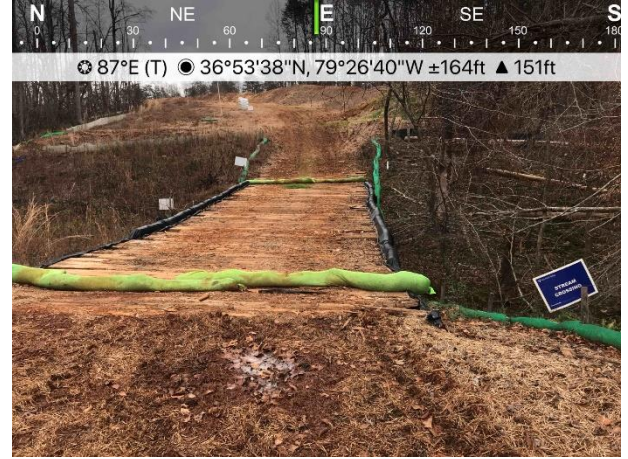
- Figure 2: Designated crossing S-CC3, ESC's are in place.

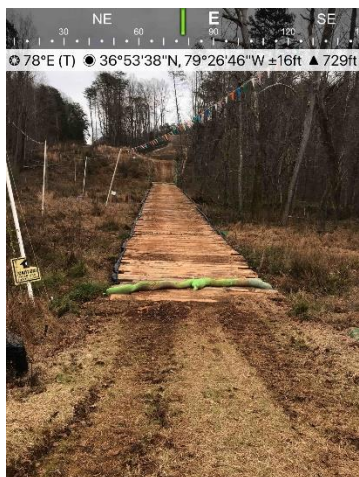
- Figure 3: Designated crossing S-CC1, ESC's are in place.

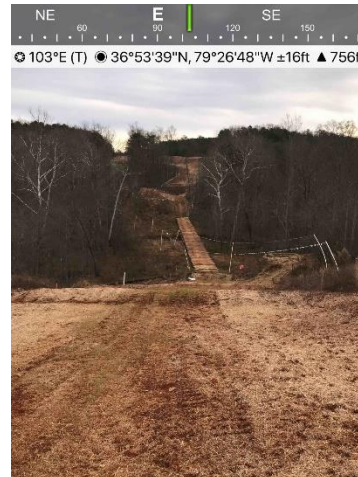
- Figure 4: St15593 area is stabilized and ESC's are in place.
