FIELD INSPECTION REPORT

Project Name:	Mountain Valley Pipeline	Inspector:	Marshall Willis
Inspection Date:	Thursday, December 3, 2020	Project Contact:	Brian Clauto, Cory Chalmers
Spread I: Franklin County	STA 13906+50 – 13940+00 STA 13845+00 – 13892+00 MVP-FR-305/303.01	Weather:	Wet

FIELD INSPECTION PHOTO LOG

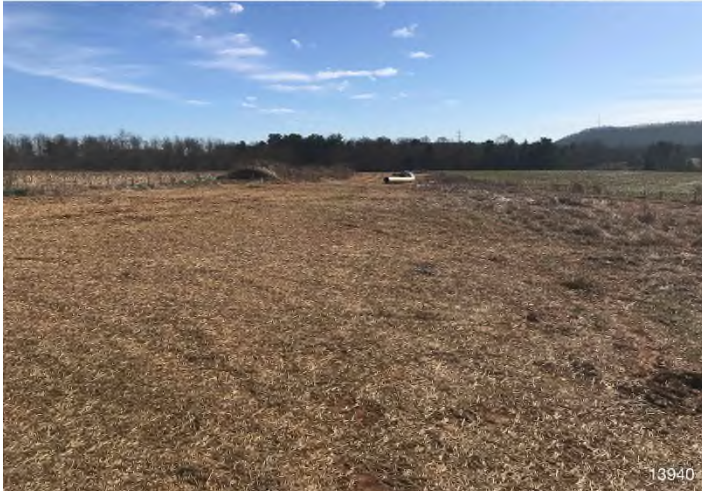
13940

Figure 1: STA 13940+00 – Controls in place functioning properly. Area stabilized with straw.

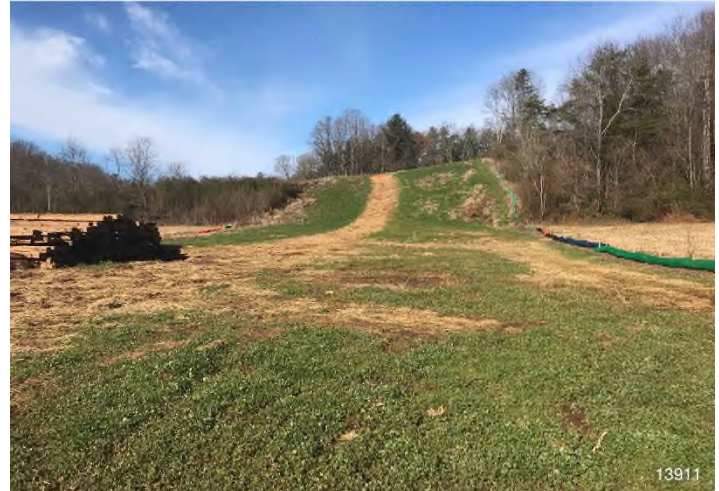
13911

Figure 2: STA 13911+00 – Controls in place functioning properly.

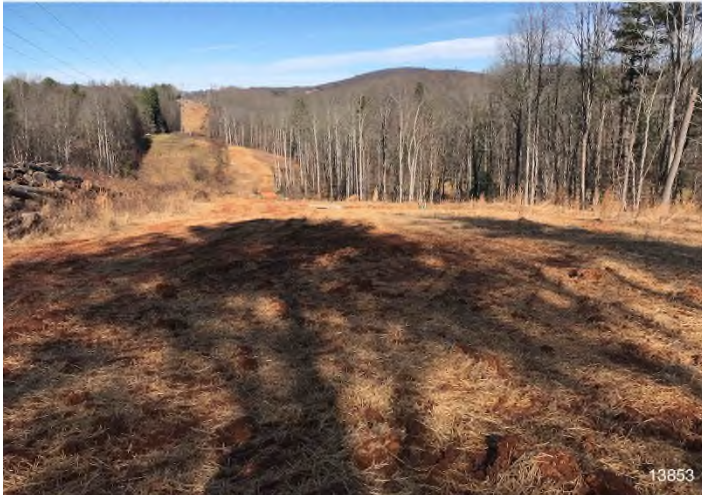
13853

Figure 3: STA 13853+00 – Controls in place functioning properly. Area stabilized with straw.

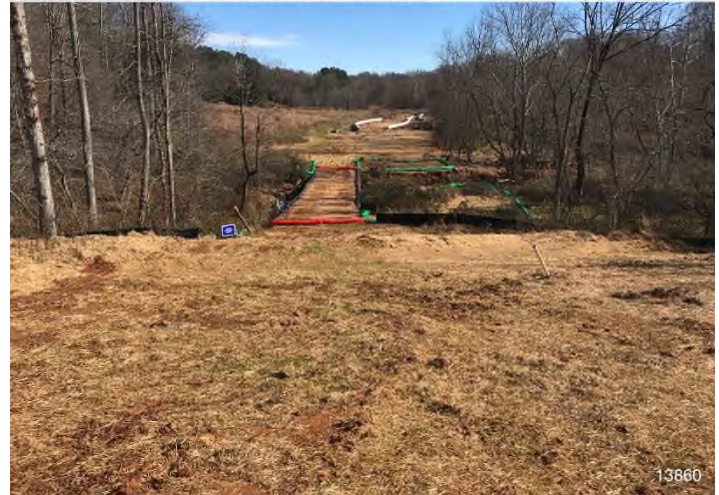
13860

Figure 4: STA 13860+00 – Controls in place functioning properly. Area stabilized with straw.
