FIELD INSPECTION REPORT

Project Name:	Mountain Valley Pipeline	Inspector:	Marshall Willis
Inspection Date:	Tuesday, December 1, 2020	Project Contact:	Brian Clauto, Cory Chalmers
Spread I: Franklin County	STA 14649+67 – 14758+16 ATWS 367/533/535/368/536A/370	Weather:	Wet

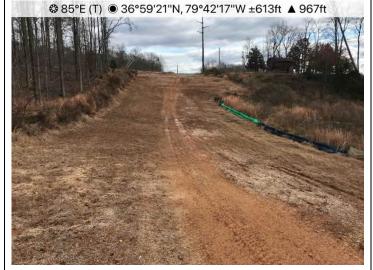
Figure 4: **STA 14745+00** – Controls in place functioning properly. Area stabilized with straw.
